The City of Sedona, Arizona is issuing **Addendum #5** to the plans, specifications, and Special Conditions as originally issued at the time of solicitation for bids for the **Improvements at Ranger Station Project**. For any bid to be considered responsible and responsive, receipt of this addendum must be acknowledged.

**BUILDING CONDITION
ASSESSMENT REPORT**

**SEDONA RANGER STATION
Ranger Residence and Barn**

Prepared by
Otwell Associates, Architects

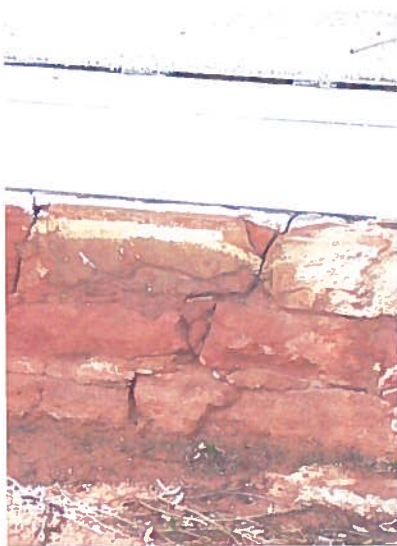
Ranger Station Residence -
Sandstone Foundation

The Ranger Station Residence is constructed from the local red sandstone, which is ubiquitous in Sedona. The sandstone is mortared in place in a random ashlar pattern. This red color gives the foundation a unique look that ties it to the red sand around the house, and the dramatic red rock buttes and canyon walls in the Sedona area.

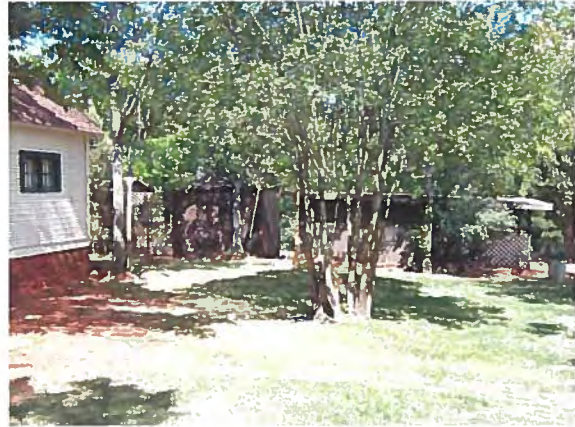
Front (south) yard - Ranger Residence

The site is relatively flat, dropping approximately 6 feet from south to north across the property. Native plant materials have been removed from the site and the land surrounding the Ranger Residence, which has been developed with an urban-type residential landscape. This includes irrigated non-native deciduous trees, shrubs, and a mowed grass lawn, along with fences of various styles, including split rail and chain link, and low native stone walls. The area around the Barn is a gravel drive and parking area that extends to the front lawn of the Ranger Residence. There is also a parking lot that parallels Brewer Road on the south side of the property.

Remove non-native species from the site and thin the overgrowth along the creek to permit a view of the red rocks. Some adjustment of the grading is advised to insure positive drainage away from both buildings.

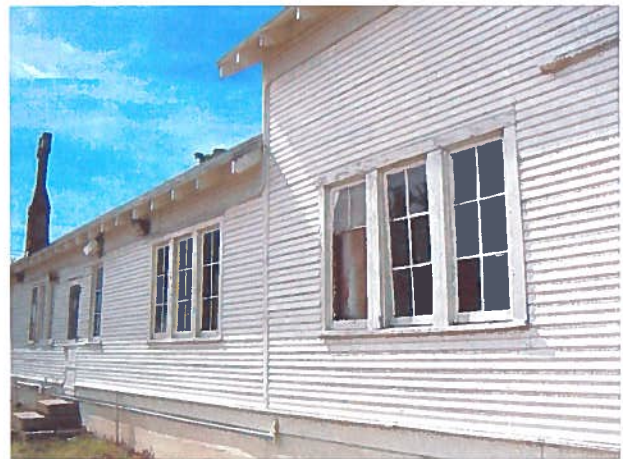
Exterior Wall - Barn

The exterior walls of both buildings are conventionally framed wood stud construction with horizontal clapboard siding and corner trim boards. The corner trim on the Ranger Station is wide and a narrower corner board is used on the Barn. The rear porch addition to the Ranger Station Residence (1930's) is sided with a combination of vertical board and batten (lower half) and horizontal clapboard siding.

Barn: Seriously damaged siding should be removed completely and replaced, and superficially damaged siding should be repaired. The damaged trim should be carefully examined and repaired or replaced as necessary. Any replaced siding and trim should match existing material. Prepare and paint all repaired and replaced wood siding and trim.

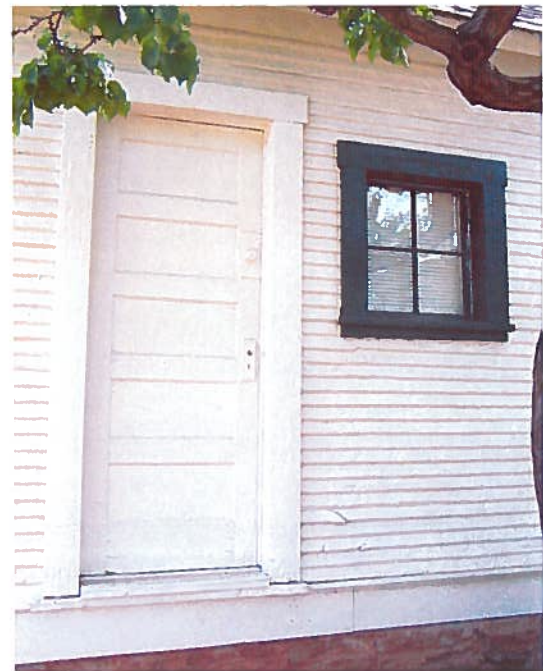
Door and window at Ranger Residence

The original wood windows of both buildings are multi-paned in a variety of operation types. These include sliders, fixed, awnings and casement units. The windows in Ranger Residence are wood frame and include multi-paned fixed, 1 over 1 double hung and six pane sliders in pairs and groups. All of these windows appear to be original to their time period. The wood frame windows of the Barn are set in pairs and banded groups. The awning units in the Barn are hinged at the top and swing in. In the Ranger Residence there are six-pane sliding, fixed and double-hung windows, four-pane casement windows, two-pane casement and double-hung, and one bronze aluminum two-pane sliding sash window. The windows in the Barn are awning, casement and fixed with 1 inch frames.

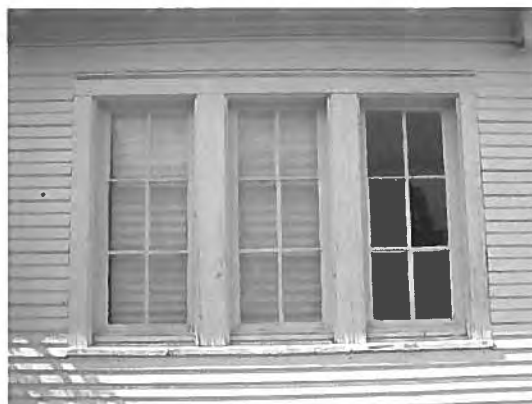
Triple casement window - Barn

Barn: The windows in the Barn are in various stages of deterioration, with the window openings on the west elevation being in the worst condition. Some of the windows have been painted closed. Most of the glazing compound needs replacement. Some of the glass is broken and/or missing in windows at the south side of the building. See the Window Schedules in Appendix D for specific window conditions.

The deteriorated window frames should be repaired, if possible, or replaced if necessary. See the Window Schedules in Appendix D for specific recommended window treatments. Protect and maintain all door hardware and wood trim. Replace broken and missing glass at the Barn. Prepare and paint all repaired wood windows and trim.

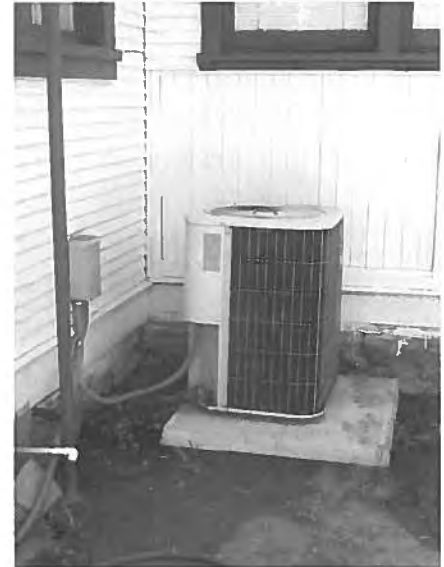
Ranger Residence A/C compressor

Ranger Residence: The HVAC systems for the Ranger Residence consist of a fireplace, gas furnace (60,000 BTU), and an electric central air conditioning system (approx. 2 tons). The ductwork is located in the attic with one ceiling mounted grille in the kitchen and bedroom, two ceiling mounted grilles in the living room, one wall mounted grille in the bathroom and porch. Visible portions of the ducts are insulated with fiberglass. There is one ceiling fan in the kitchen and one on the porch. A wood stove was removed in the 1990's.

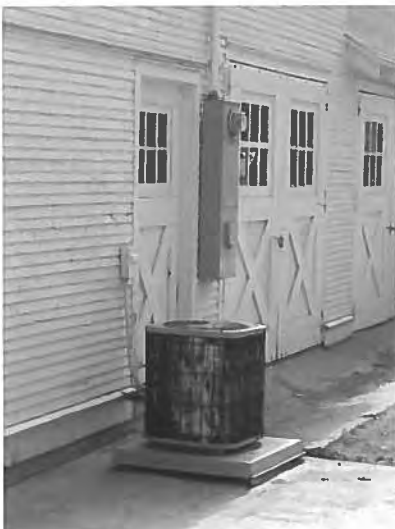
A/C compressor at the Barn

Barn: The HVAC systems in the Barn consist of a fireplace (currently boxed in and not used); a natural gas furnace in the second story loft (for the forced air heating system- 50,000 BTU), a hanging natural gas space heater in the work room, and an electric air conditioning system (approx. 2 tons). The ductwork is exposed at the ceiling from the loft to the second bay.
