REPORT OF GEOTECHNICAL INVESTIGATION

SEDONA HOTEL BUILDINGS

725 HIGHWAY 179
SEDONA, ARIZONA 86336
ACS PROJECT NO. 2101203

April 23, 2021

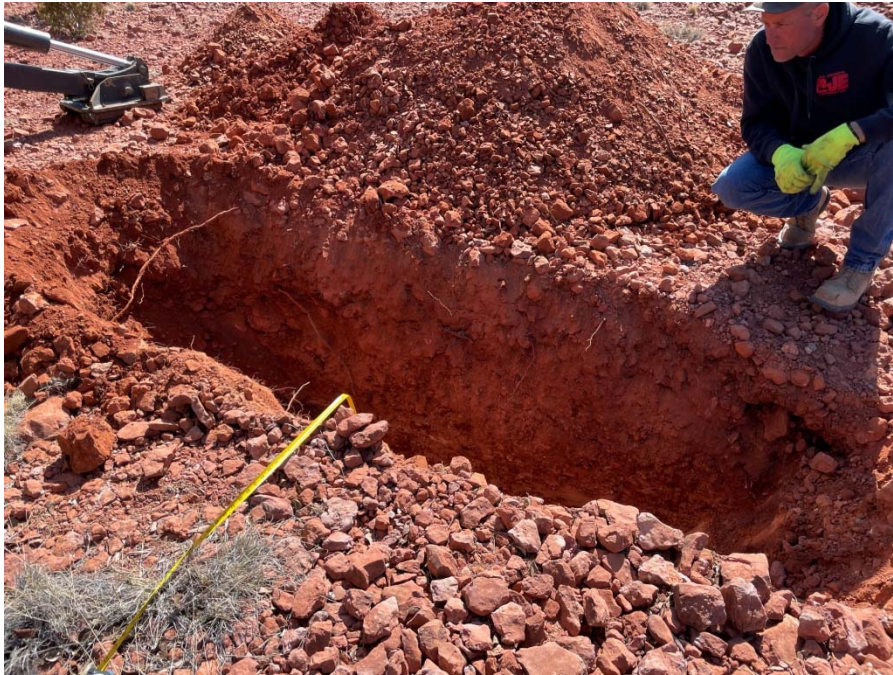
Photo 1 – Excavated Test Pit 1. Test Pit 1 was terminated at a depth of 4.0 feet due to backhoe refusal on hard mudstone bedrock. The soils encountered to a depth of 1.5 feet consist of red sandy gravelly silt, stiff, slightly damp, low PI. From 1.5 to 4.0 feet, the soils became lighter in color and dense, probable highly weathered mudstone bedrock.

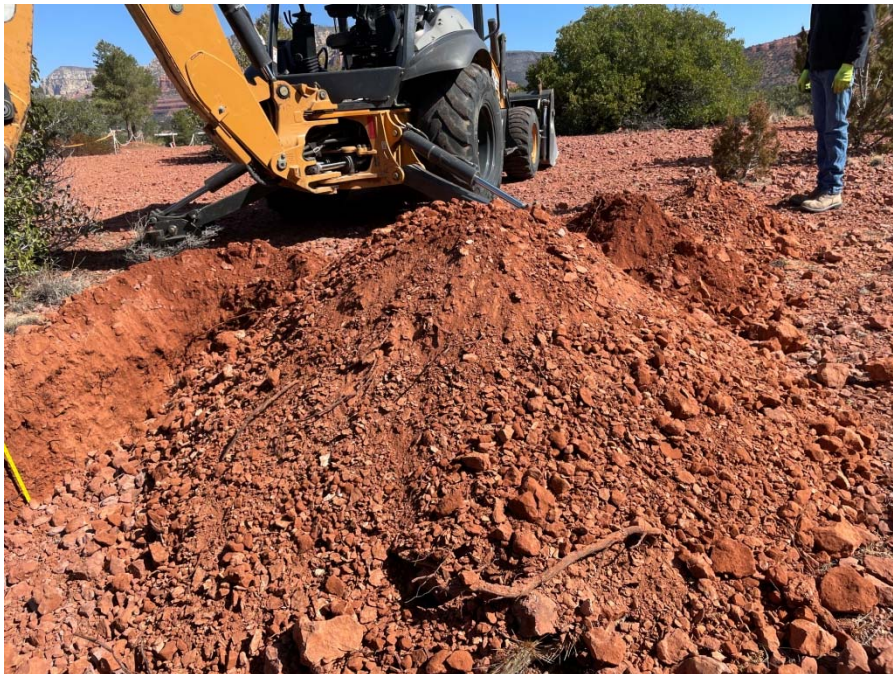
Photo 2 – View of material excavated from Test Pit 1 over the depth range of 0.0 to 4.0 feet.

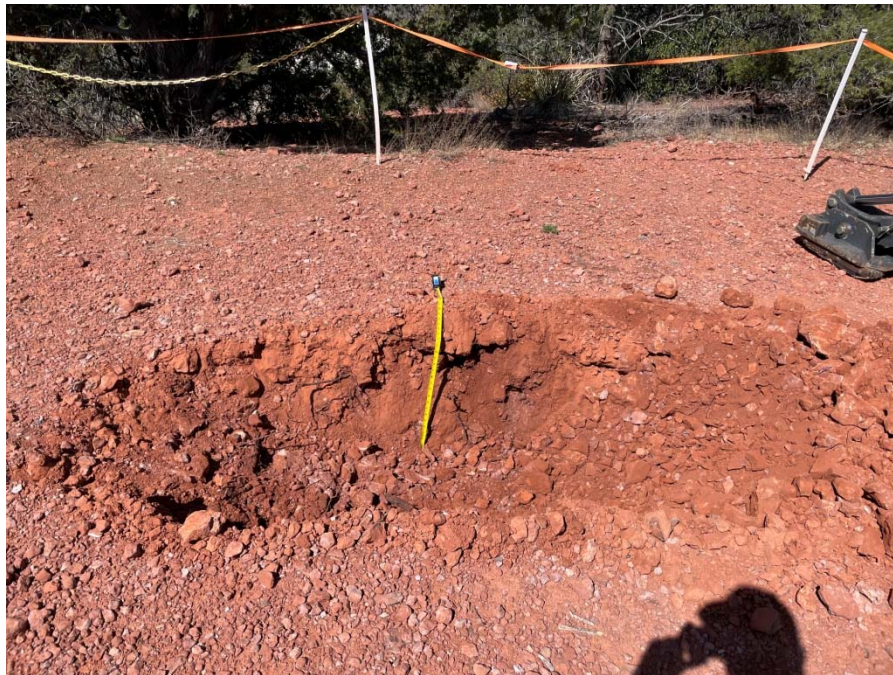
Photo 3 – Excavated Test Pit 2. Test Pit 2 was terminated at a depth of 1.5 feet due to backhoe refusal on hard mudstone bedrock – Supai Formation. . The upper 1.5 feet of red clayey silty gravel with cobbles, some sand is dense, probable highly weathered mudstone bedrock.

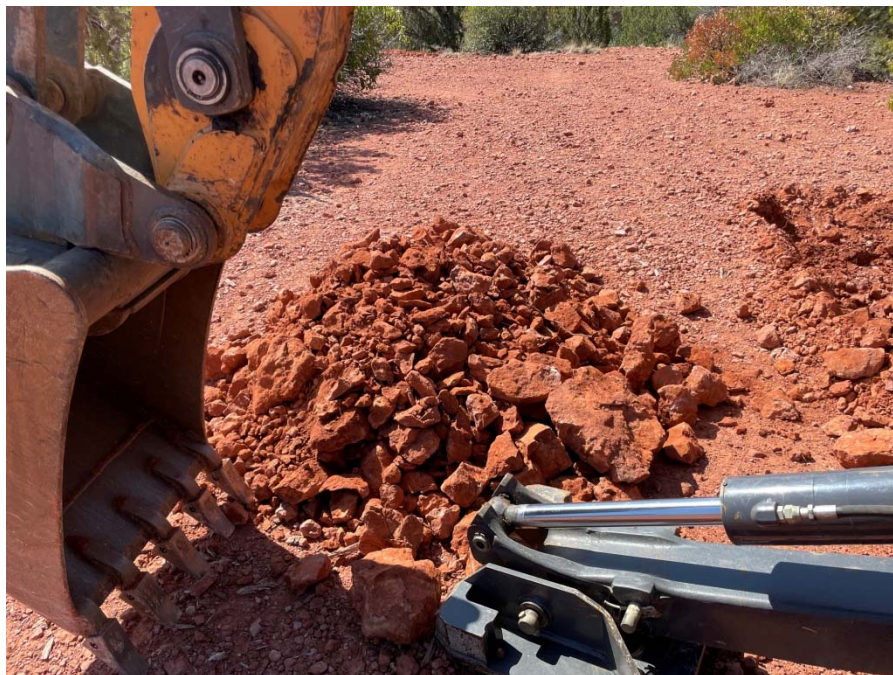
Photo 4 – View of material excavated from Test Pit 2 over the depth range of 0.0 to 1.5 feet, which appears to be primarily excavated mudstone bedrock.

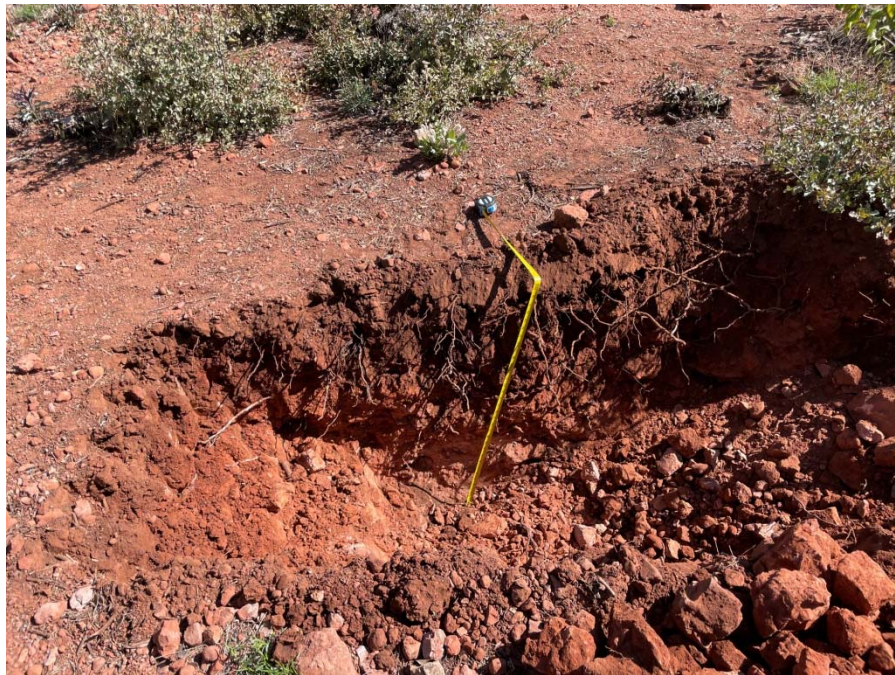
Photo 5 – Excavated Test Pit 3. Test Pit 3 was terminated at a depth of 2.5 feet due to backhoe refusal on hard mudstone bedrock. The soils encountered to a depth of 1.0 feet consist of red clayey silty gravel with cobbles, some sand, medium dense, damp, low PI. From 1.0 to 2.5 feet, the soils became lighter in color and dense, probable highly weathered mudstone bedrock.

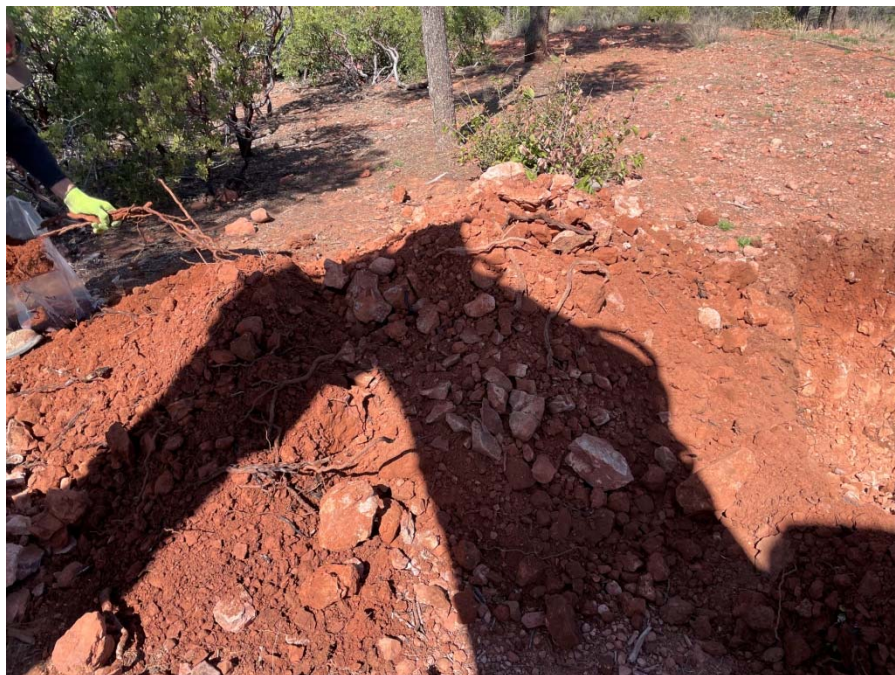
Photo 6 – View of material excavated from Test Pit 3 over the depth range of 0.0 to 2.5 feet, which appears to be primarily excavated mudstone bedrock.

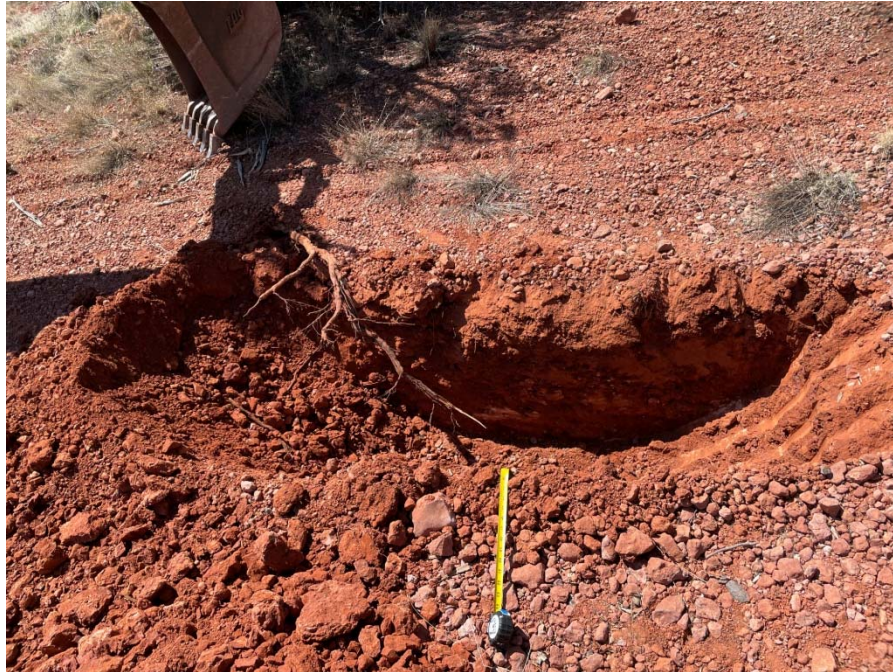
Photo 7 – Excavated Test Pit 4. Test Pit 4 was terminated at a depth of 2.0 feet due to backhoe refusal on hard mudstone bedrock – Supai Formation. . The upper 2.0 feet of red clayey silty gravel with sand and cobbles are medium dense, damp, PI of 5.

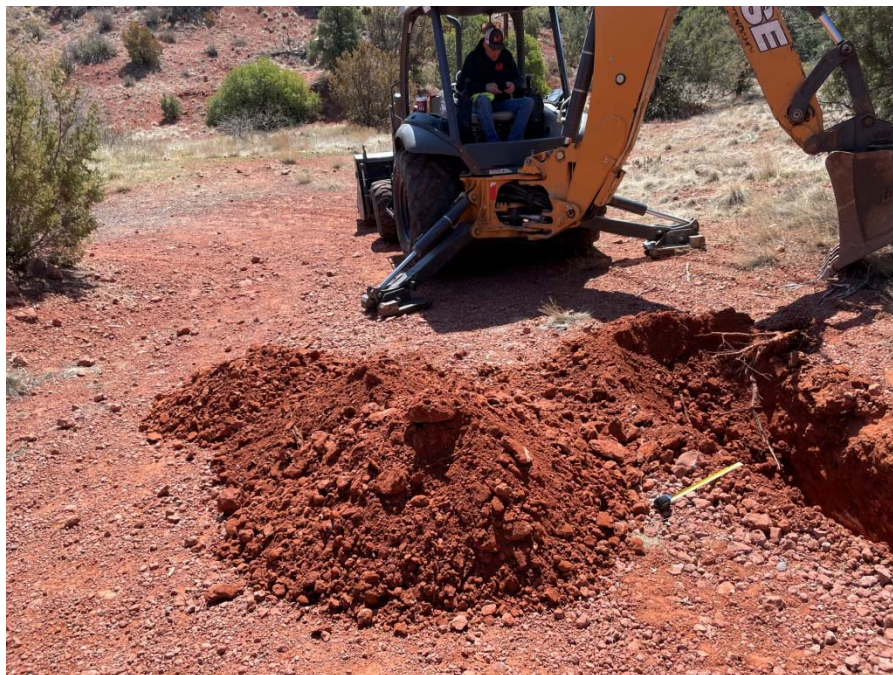
Photo 8 – View of material excavated from Test Pit 4 over the depth range of 0.0 to 2.0 feet, which appears to primarily native soils over the mudstone bedrock.

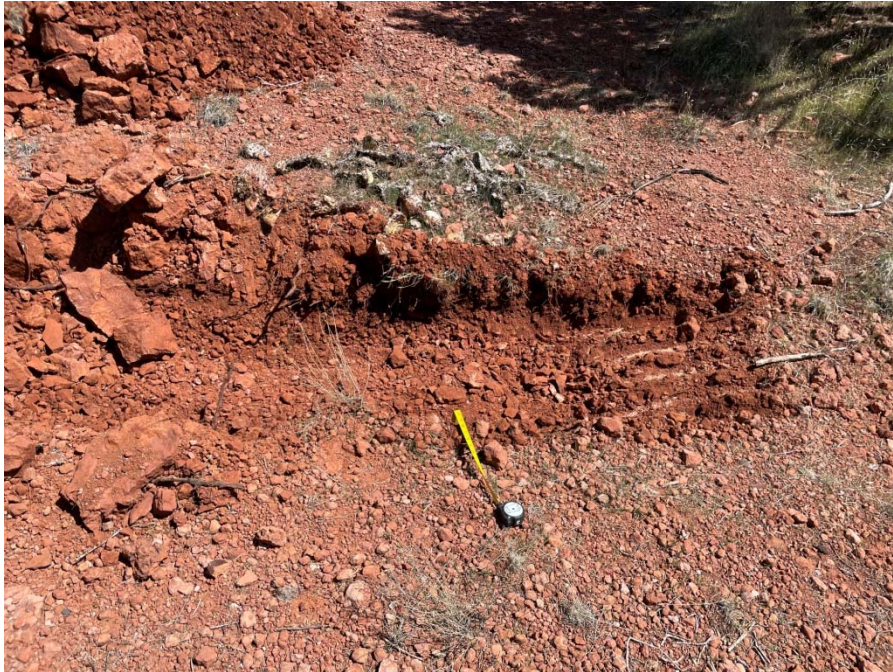
Photo 9 – Excavated Test Pit 5. Test Pit 5 was terminated at a depth of 1.0 feet due to backhoe refusal on hard mudstone bedrock – Supai Formation. . The upper 1.0 feet of red silty gravel with sand and cobbles is medium dense, damp, PI of 2 .

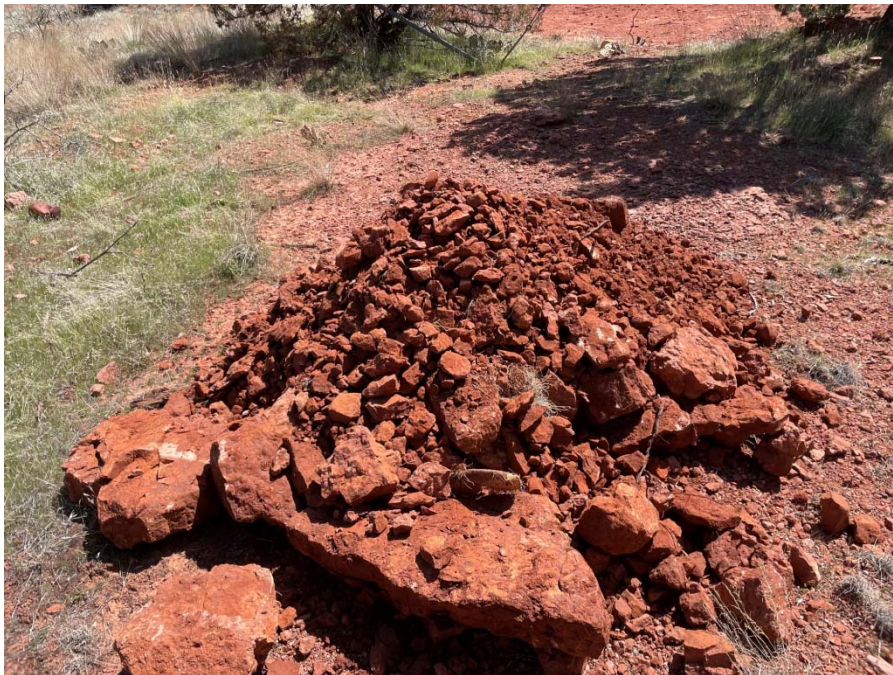
Photo 10 – View of material excavated from Test Pit 5 over the depth range of 0.0 to 1.0 feet, which appears to be primarily native soil and mudstone bedrock. Fragments of excavated mudstone bedrock can be seen in the

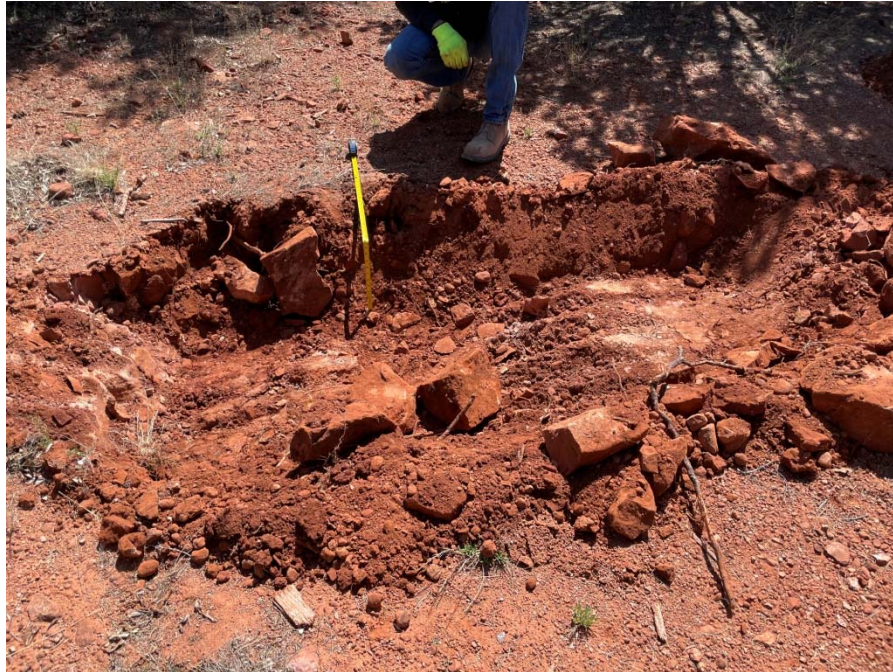
Photo 11 – Excavated Test Pit 6. Test Pit 6 was terminated at a depth of 1.0 feet due to backhoe refusal on hard mudstone bedrock – Supai Formation. . The upper 1.0 feet of red clayey gravel with sand and cobbles is medium dense, damp, PI of 10.

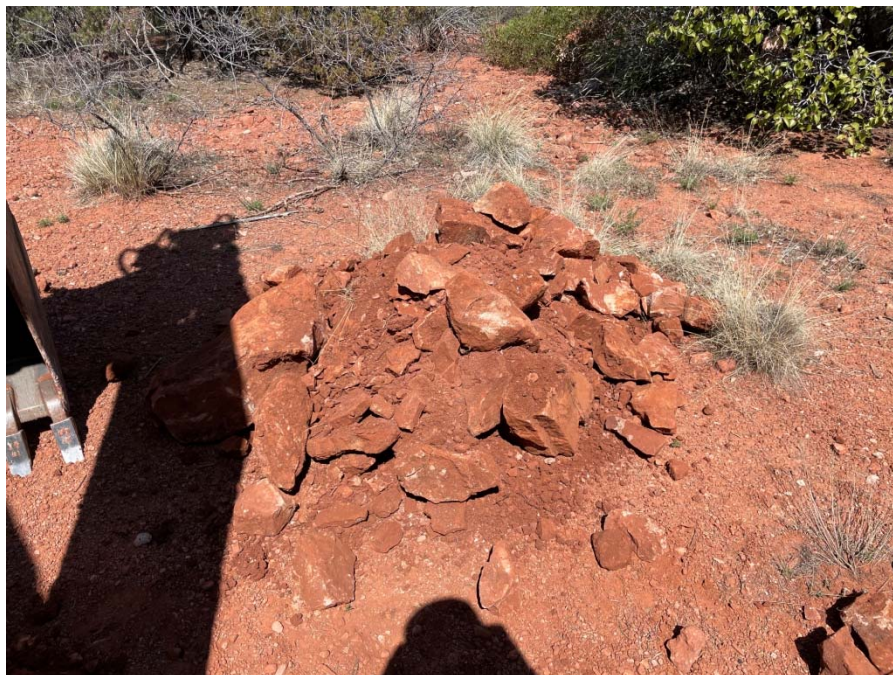
Photo 12 – View of material excavated from Test Pit 6 over the depth range of 0.0 to 1.0 feet, which appears to be primarily excavated mudstone bedrock.

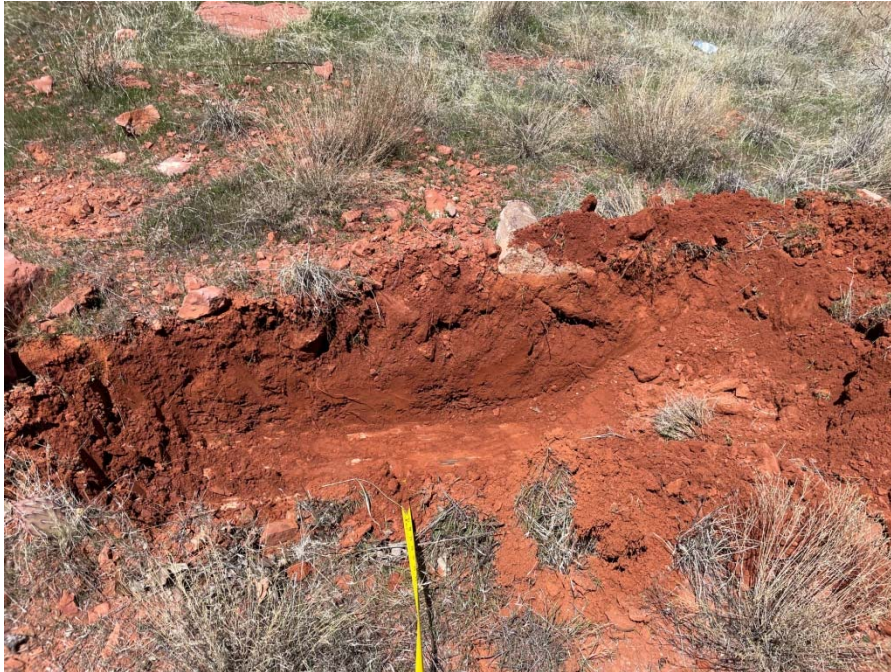
Photo 13 – Excavated Test Pit 7. Test Pit 7 was terminated at a depth of 1.0 feet due to backhoe refusal on hard mudstone bedrock – Supai Formation. . The upper 1.0 feet of red clayey silty sandy gravel with cobbles is medium dense, damp, PI of 4.

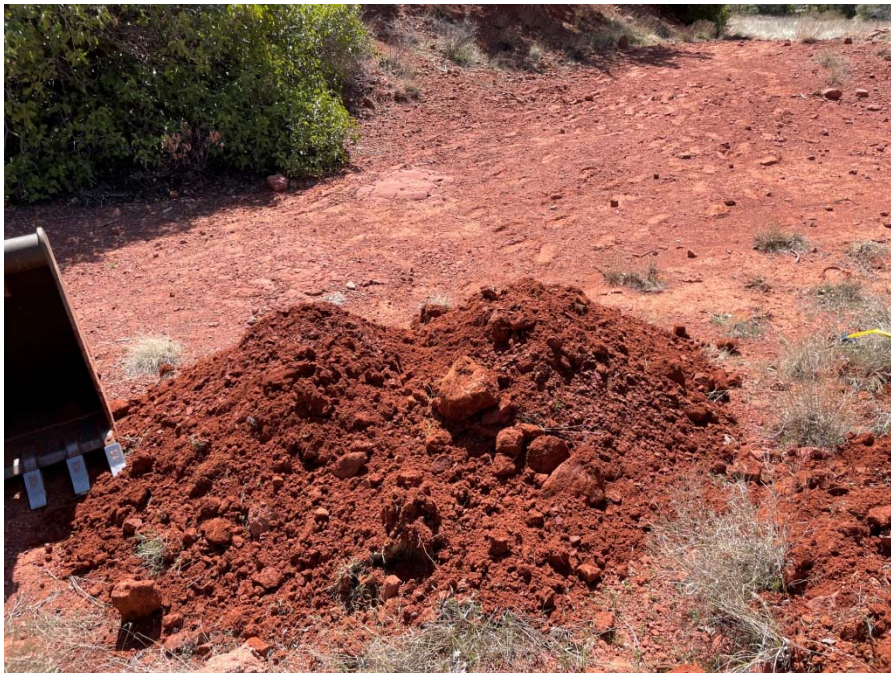
Photo 14 – View of material excavated from Test Pit 7 over the depth range of 0.0 to 1.0 feet, which appears to be primarily excavated native soil over the mudstone bedrock.

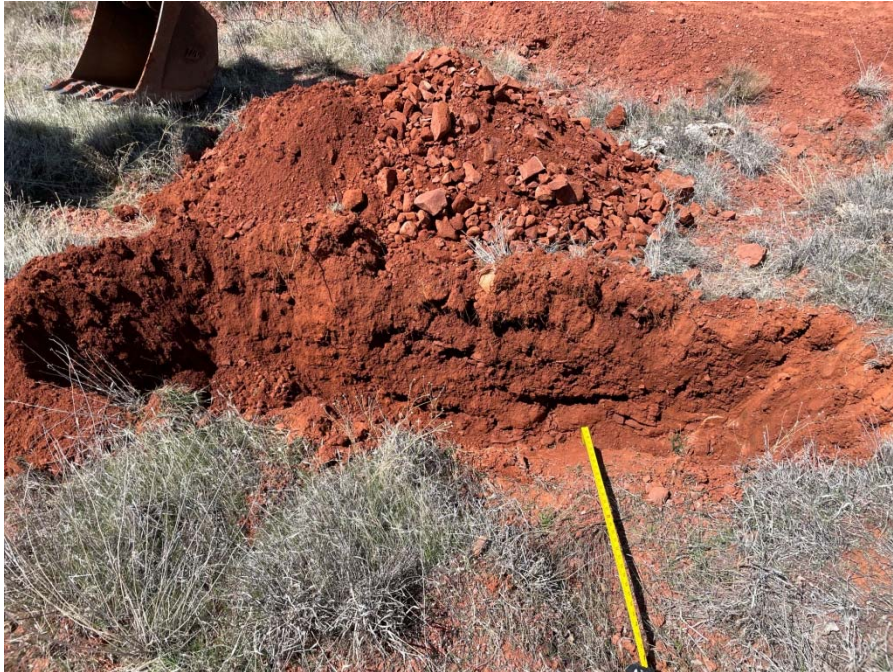
Photo 15 – Excavated Test Pit 8. Test Pit 8 was terminated at a depth of 2.5 feet due to backhoe refusal on hard mudstone bedrock. The soils encountered to a depth of 1.5 feet consist of red clayey silty gravel with cobbles, some sand, medium dense, damp, low PI. From 1.5 to 2.5 feet, the soils became lighter in color and dense, probable highly weathered mudstone bedrock.

It is recommended that all vegetation, inclusive of significant root systems, any soft soils or organics (in the area of Test Pits 8 and 9), and all other deleterious matter be removed from the proposed structure and pavement areas at the commencement of site grading activities.

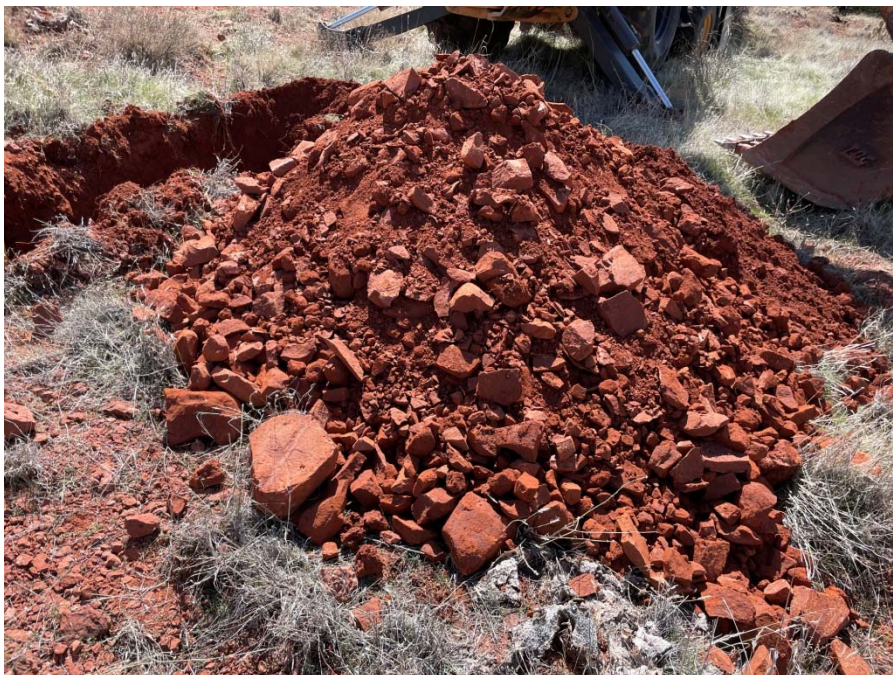
Photo 16 – View of material excavated from Test Pit 8 over the depth range of 0.0 to 2.5 feet, which appears to be primarily excavated native soils and mudstone bedrock.

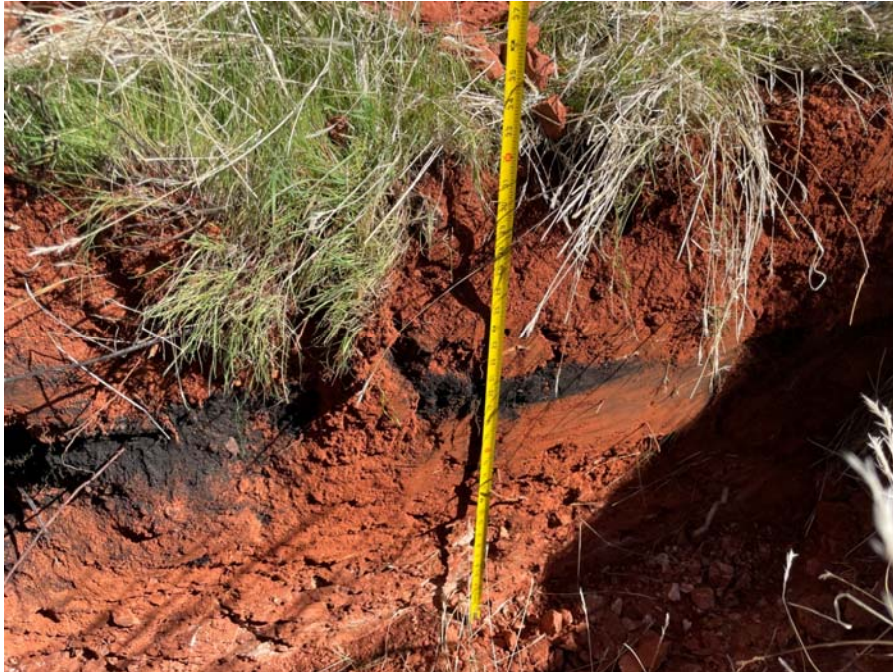
Photo 17 – Excavated Test Pit 9. Test Pit 9 was terminated at a depth of 2.5 feet due to backhoe refusal on hard mudstone bedrock – Supai Formation. . The upper 1.0 feet of red silty sandy gravel with cobbles is loose, moist, NP. A black layer of clayey sand with possible organics was encountered from 1.0 to 1.5 feet. Below 1.5 feet the soils became lighter in color, dense, and slightly damp, probable highly weathered mudstone bedrock.

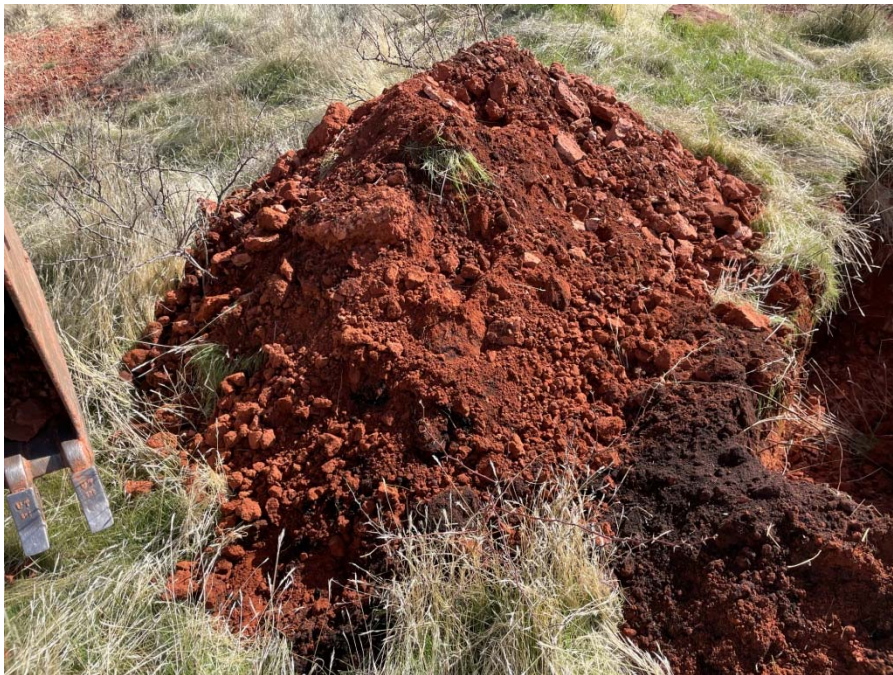
Photo 18 – View of material excavated from Test Pit 9 over the depth range of 0.0 to 2.5 feet.

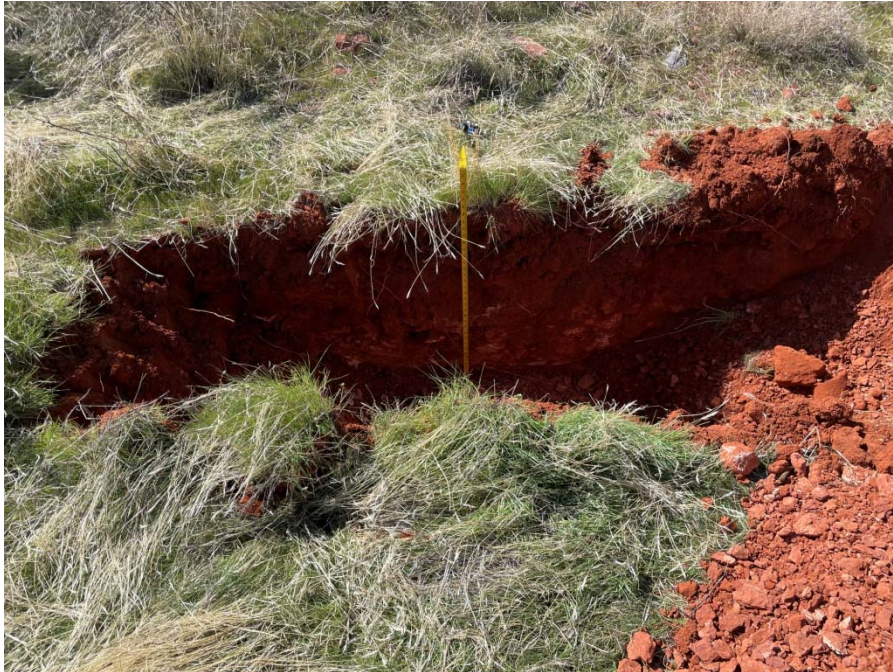
Photo 19 – Excavated Test Pit 10. Test Pit 10 was terminated at a depth of 2.0 feet due to backhoe refusal on hard mudstone bedrock. The red soils encountered to a depth of 1.0 feet consist of red silty sandy gravel with cobbles, medium dense, damp, low PI. From 1.0 to 2.0 feet, the soils became lighter in color, clayey silty gravel with cobbles, some sand, dense, slightly damp, PI of 5, probable highly weathered mudstone bedrock.

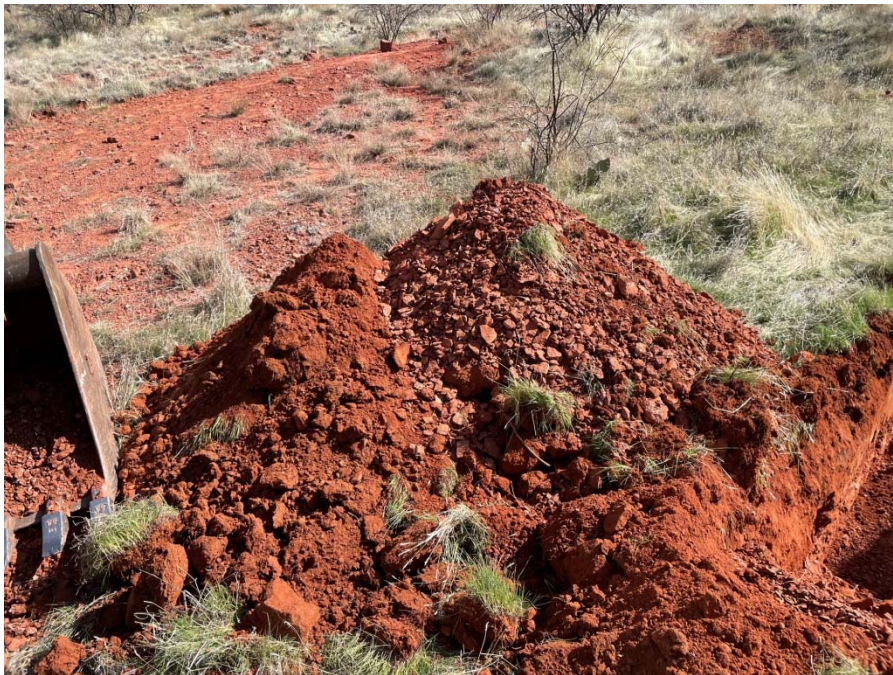
Photo 20 – View of material excavated from Test Pit 10 over the depth range of 0.0 to 2.0 feet.
