Sedona Historic Property Inventory Form**PROPERTY INFORMATION**

Address:	20 Bear Wallow Lane	Survey Site #:	
Historic Name:		Zoning:	Oak Creek Heritage District
APN #:	401-12-016C	Acres:	1.16
County:	Coconino	Subdivision:	Hart's Village
Owner name:	115 Schnebly LLC R. D. Olson Development	Owner Address:	520 Newport Center Drive Suite 600 Newport Beach, CA 92660

Address:	65 Schnebly Hill Road	Survey Site #:	
Historic Name:		Zoning:	Oak Creek Heritage District
APN #:	401-18-002C	Acres:	0.9
County:	Coconino	Subdivision:	Hart's Village
Owner name:	115 Schnebly LLC R. D. Olson Development	Owner Address:	520 Newport Center Drive Suite 600 Newport Beach, CA 92660

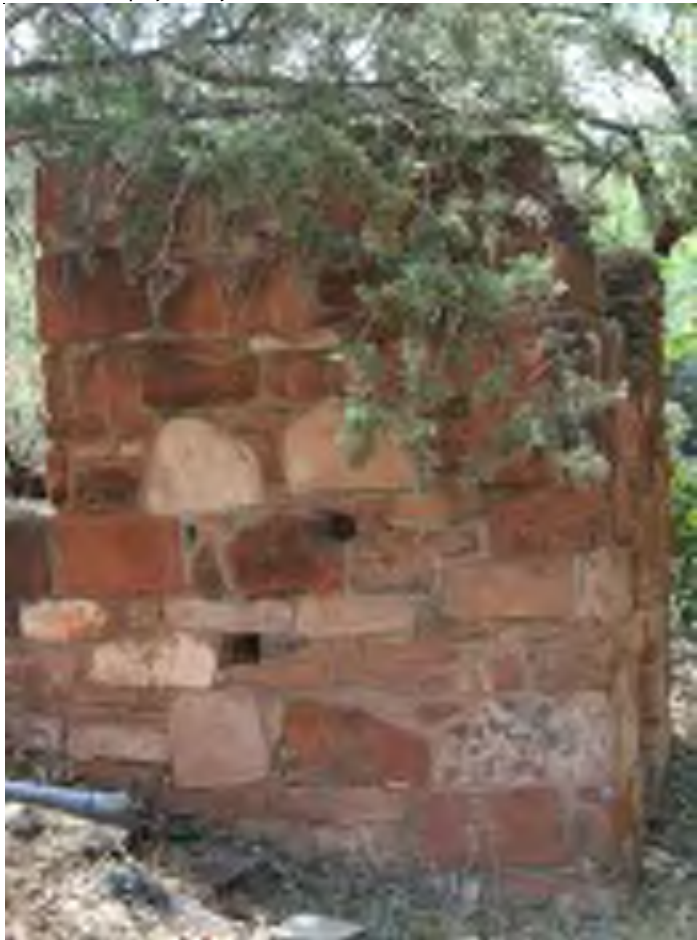
Describe: The only structure on this parcel is a seep well on the southwest corner of the property. The square housing for the seep well is a ruin. It is constructed of dressed, mortared Moenkopi Sandstone and concrete. The purpose of this seep well was to provide water prior to and after the availability of electricity. Rather than drill a well, the seep well was designed as catchment for water that seeps out of the ground.

The housing for the seep well is currently in ruin. Pipes have been removed or altered, a large hole at the base of the housing gives direct access to the well, which does hold water, and large pieces of the building are missing or lying on the ground.

Individually, the Property <u>is</u> eligible:		Individually, the Property <u>is not</u> eligible:	X
Property <u>is</u> eligible as a contributor to a potential historic district:		Property <u>is not</u> eligible as a contributor to a potential historic district:	
More information needed to evaluate:			
<i>If not considered eligible, state reason:</i> The structure has lost context and integrity and is a ruin.

Seep Well Housing, 65 Schnebly Hill Road

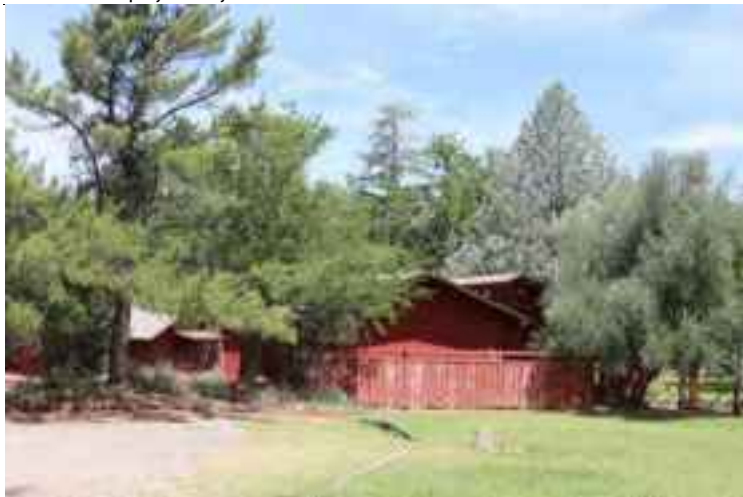
Good <i>(well maintained, no serious problems apparent):</i>		Poor <i>(major problems; imminent threat):</i>	
Fair <i>(some problems apparent):</i>	X	Ruin/Uninhabitable:	
<p><i>Describe:</i> This wood frame, wood sided dwelling is approximately 70 years old and has been a rental for the last twenty plus years. Although maintained, the building is currently vacant and so recent maintenance has been scaled back. It is weathered on the exterior with deteriorated wood at the bottom of the walls. The roof needs some slight repairs. Otherwise, the condition is fair and livable.</p>

Converted Garage and Main Dwelling, 95 Schnebly Hill Road

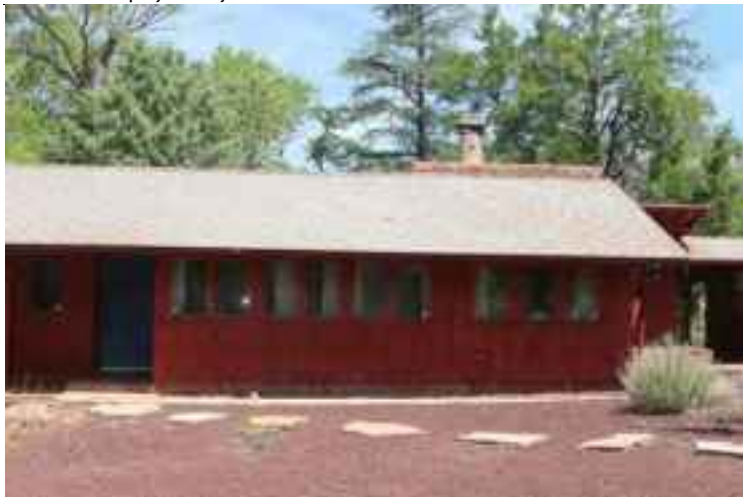
Dwelling, Front Elevation Showing Chimney, 95 Schnebly Hill Road

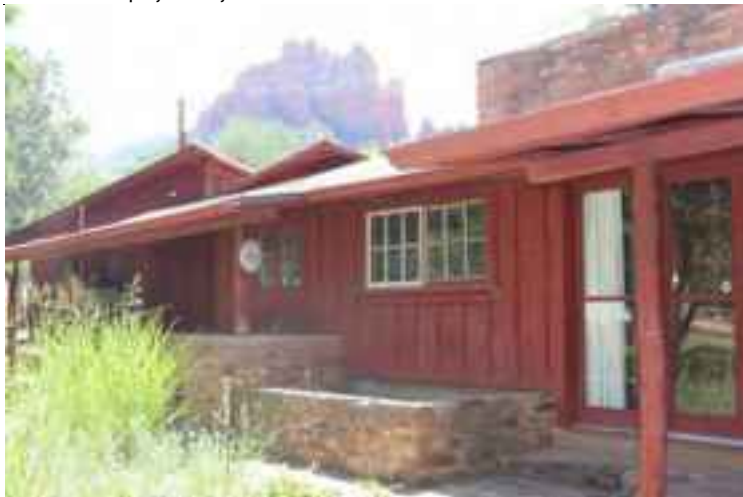
Dwelling, Rear Elevation, 95 Schnebly Hill Road

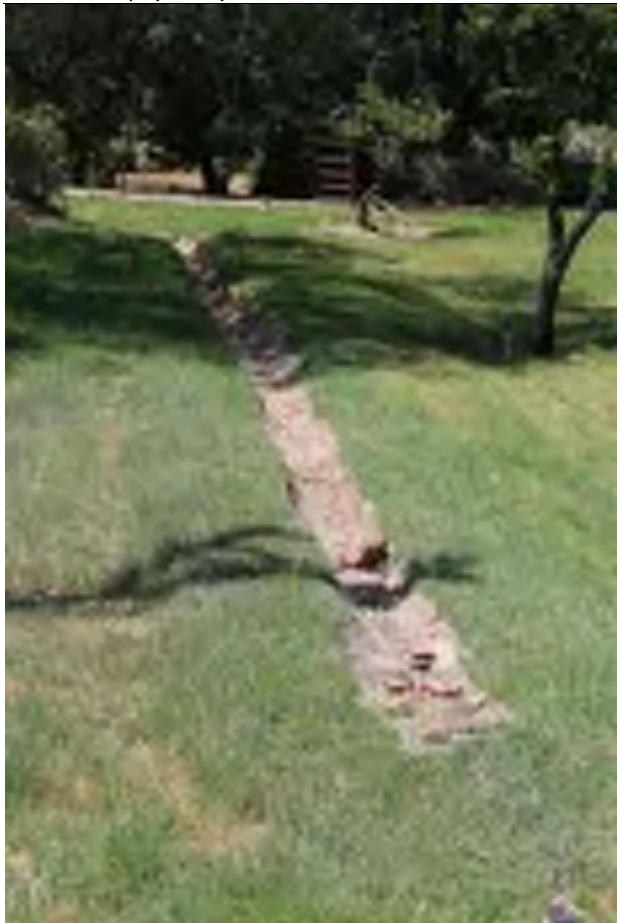
The Farley/Steele Ditch has not been in use since 1948. The ditch has deteriorated to the extent that only parts of it are visible and none of the ditch is in use. On this parcel, the sections of ditch are clearly defined as there is concrete lining and corrugated metal pipe extant.

Concrete Lined Section of the Farley/Steele Ditch, 105 Schnebly Hill Road

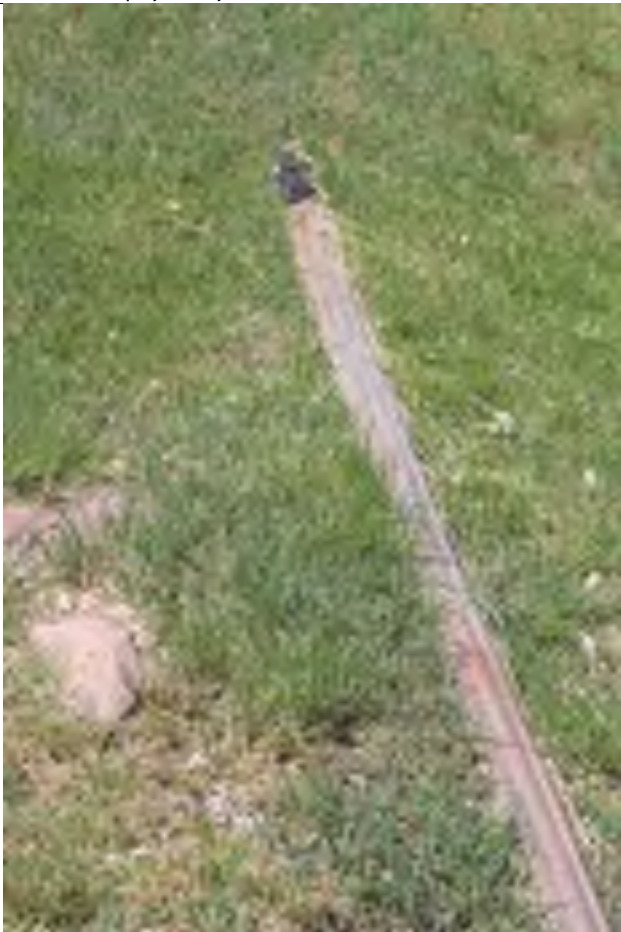
Corrugated Pipe Section of the Farley/Steele Ditch, 105 Schnebly Hill Road

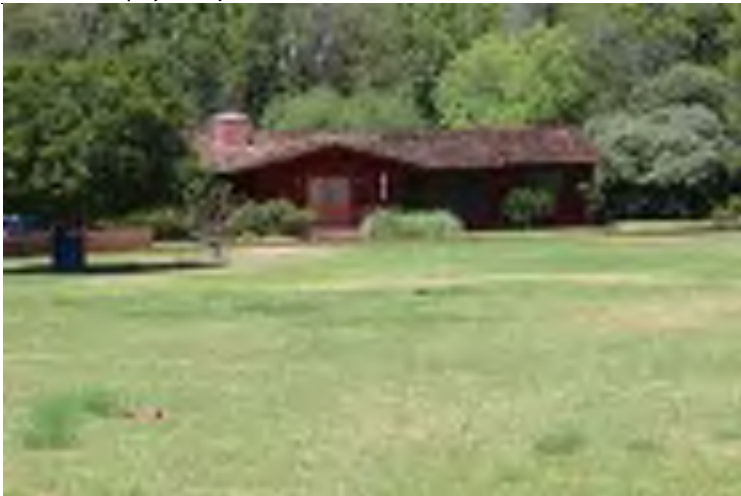
Good <i>(well maintained, no serious problems apparent):</i>	X	Poor <i>(major problems; imminent threat):</i>	
Fair <i>(some problems apparent):</i>		Ruin/Uninhabitable:	
<i>Describe:</i> Structural Condition is good and property is well maintained. The only apparent problems are the condition of the double front doors which are exposed to the weather and are somewhat weathered and faded, and the shake roof, which is very weathered, but does not leak.

Dwelling, 115 Schnebly Hill Road

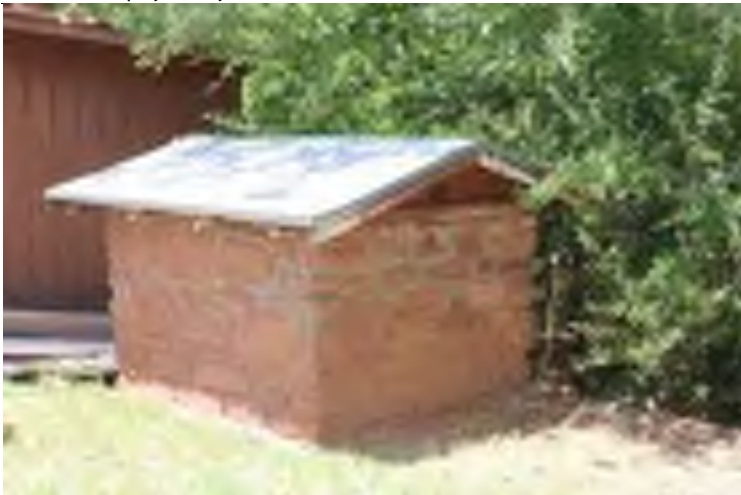
Historic Water Storage Tank Building, not in use, 115 Schnebly Hill Road

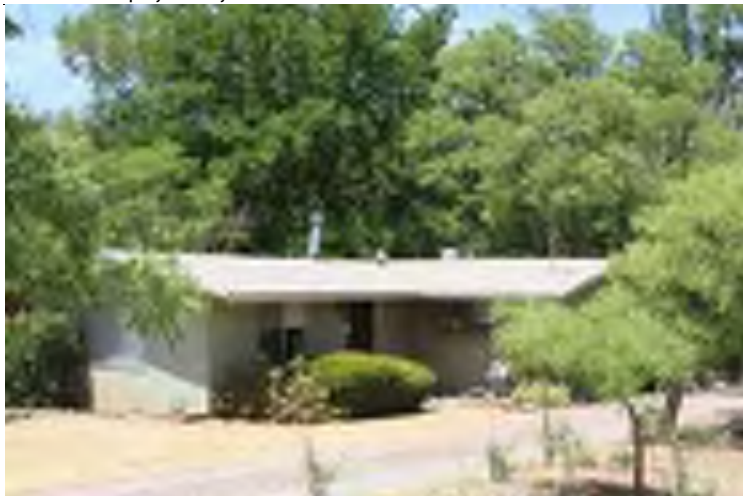
Good <i>(well maintained, no serious problems apparent):</i>	X	Poor <i>(major problems; imminent threat):</i>	
Fair <i>(some problems apparent):</i>		Ruin/Uninhabitable:	
<i>Describe:</i> This 1970s Ranch style dwelling appears to be well maintained. Roof, foundation, paint, windows and landscaping appear to be in good condition.

Dwelling, Front Elevation, 165A Schnebly Hill Road

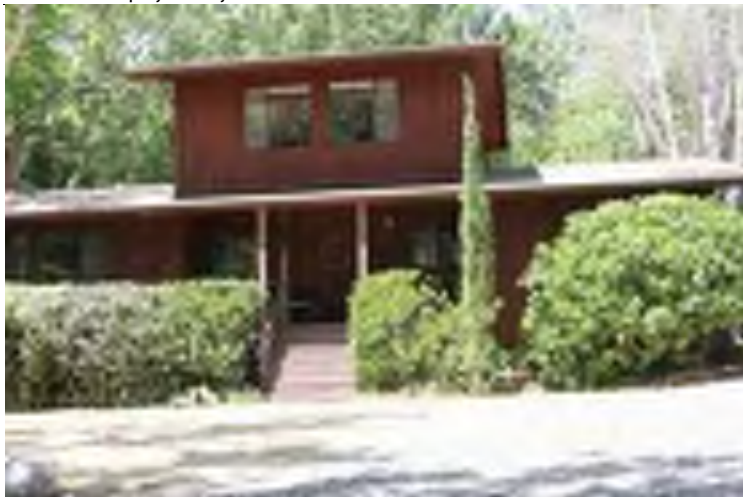
Workmanship appears to be very good. Horizontal siding on the one story section of the dwelling is mitered at the corners and well fitted. The board and batt siding on the dormer is artistically patterned. Condition of the building overall is good and well maintained.

Dwelling, Front Elevation, 165B Schnebly Hill Road
