The City of Sedona, Arizona is issuing **Addendum #5** to the plans, specifications, and Special Conditions as originally issued at the time of solicitation for bids for the **Improvements at Ranger Station Project**. For any bid to be considered responsible and responsive, receipt of this addendum must be acknowledged.

**BUILDING CONDITION
ASSESSMENT REPORT**

**SEDONA RANGER STATION
Ranger Residence and Barn**

Prepared by
Otwell Associates, Architects

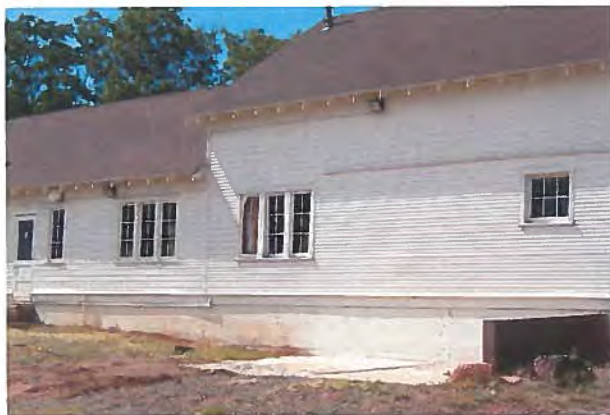
Foundation at the Barn

Some of the stones in the foundation of the Ranger Residence need to be replaced and repointing is needed throughout. The ventilation in the crawl space of the Ranger Residence is inadequate by current code requirements. Several vents are located at one end of the crawl space with no vents on the opposite walls, thus little or no cross ventilation is achieved. The new screens at the crawl space vents are not installed in an aesthetically appropriate manner. The foundation of the Barn is in good condition.

Replace stones and repoint stone masonry at the Ranger Residence. Installation of additional crawl space vents is recommended at the Ranger Residence to meet current code requirements. No work required on the Barn foundation. Provide wood trim at crawl space screens to cover exposed edges.

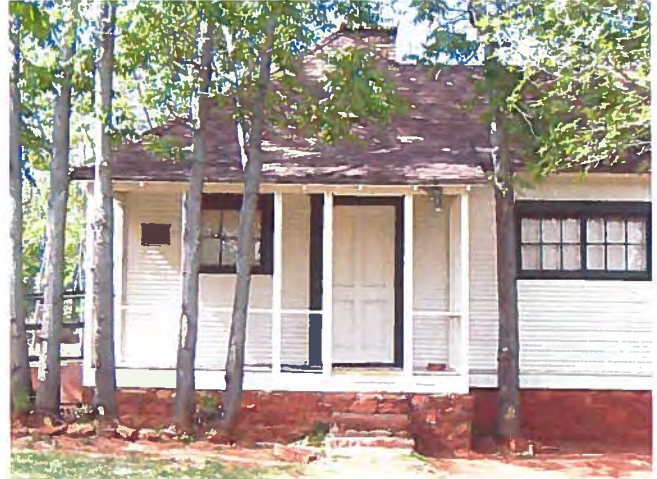
Porch railing and stair at the Ranger Residence

The south stair at the Ranger Residence does not meet current code requirements.

There are no handrails at either stair. The stair treads are uneven and the rise and run vary greatly. There is no landing at the north entry door, which swings outward, and therefore this entrance does not meet code requirements. There is no stairway or landing at the door of the southeast corner bedroom and therefore this egress is not an accessible route.

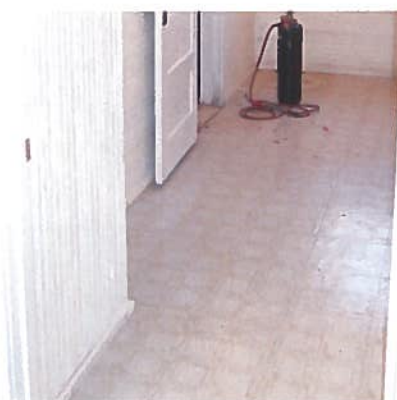
Bathroom floor - Ranger Residence

The flooring in the Ranger Residence is carpet and linoleum over a wood floor. The floor of the Barn is concrete at the first floor and wood plank at the second floor.

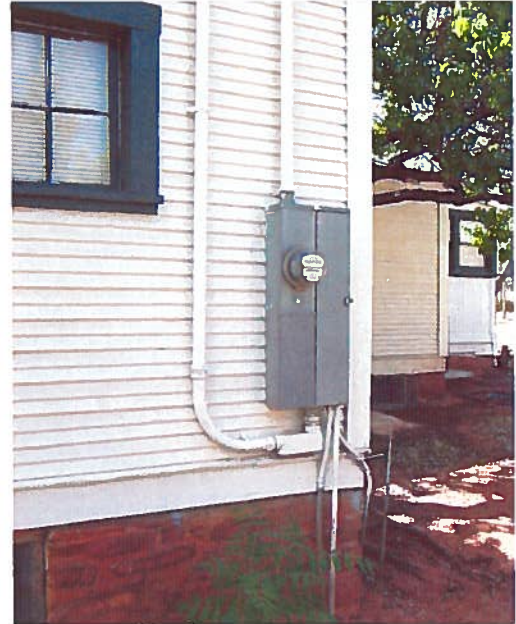
Electrical meter - Ranger Residence

The electrical service supply for both buildings is via an overhead drop. The electrical meter for the Ranger Residence is located on the east side of the building and at the north side of the Barn. The service supply for each building is 120-240 volts/200 amps. Circuit protection is provided by circuit breakers at each building. The wiring for both buildings is copper.
