**GEOTECHNICAL EVALUATION
CHAPEL HILLS WATER CAMPUS
MALLARD DRIVE AND STATE ROUTE 179
SEDONA, ARIZONA**

Arizona Water Company
7580 North Dobson Road, Suite 200
Scottsdale, Arizona 85256

Ninyo & Moore
Geotechnical and Environmental Sciences Consultants
3202 East Harbour Drive
Phoenix, Arizona 85034

October 31, 2016
Project No. 603971001

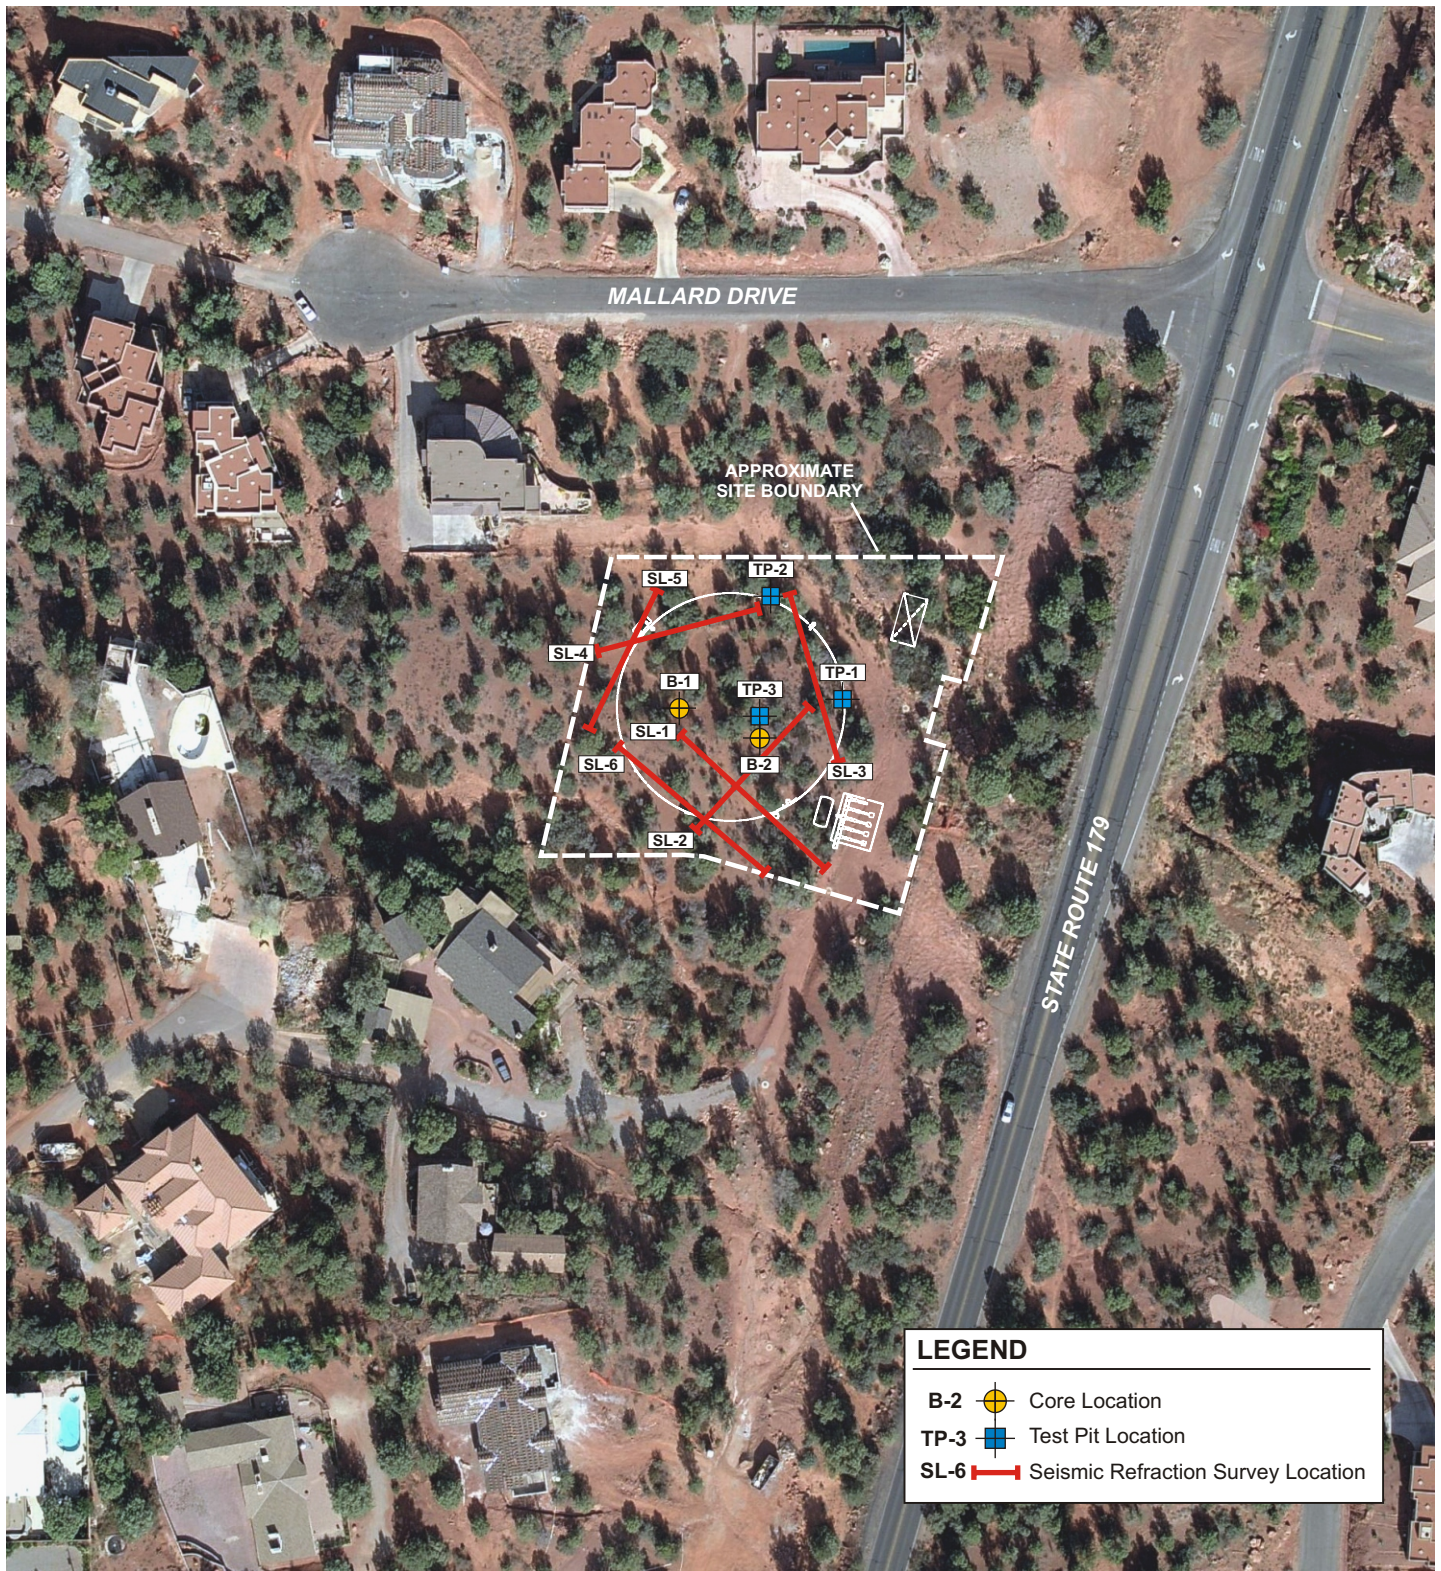
Source: Pictometry, 05/11.

Ninyo & Moore conducted a subsurface exploration at the site to evaluate the subsurface conditions and to collect soil samples for laboratory testing. The exploration consisted of excavating, drilling, logging, and sampling three exploratory test pits (denoted as TP-1, TP-2, and TP-3) using a rubber-tired backhoe, and two borings (denoted as B-1 and B-2) using rock coring equipment. The test pits extended to depth ranging from approximately 2 to 3.5 feet below ground surface and encountered excavation refusal on bedrock. The borings extended to depth of 30 to 31 feet below ground surface. The test pits and borings were situated in the approximate locations depicted on Figure 2.

Ninyo and Moore personnel conducted seismic refraction surveys at the site on November 15, 2012 and December 13, 2012, to evaluate the approximate depth to bedrock and rippability characteristics of the near surface materials. The seismic refraction data were collected with a SmartSeis S12, high performance exploration seismograph and 12 vertical component geophones. A 16-pound hammer and metal plate were used as the seismic wave source. A total of 6 seismic refraction traverses were performed, and the approximate locations of the traverses are depicted on Figure 2. The results of our seismic refraction surveys are presented in Appendix C.

Ninyo and Moore personnel conducted seismic refraction surveys at the site on November 15, 2012 and December 13, 2012, to evaluate the approximate depth to bedrock and rippability characteristics of the near surface materials. The seismic refraction data were collected with a SmartSeis S12, high performance exploration seismograph and 12 vertical component geophones. A 16-pound hammer and metal plate were used as the seismic wave source. A total of six seismic refraction traverses were performed, and the approximate locations of the traverses are depicted on Figure 2.

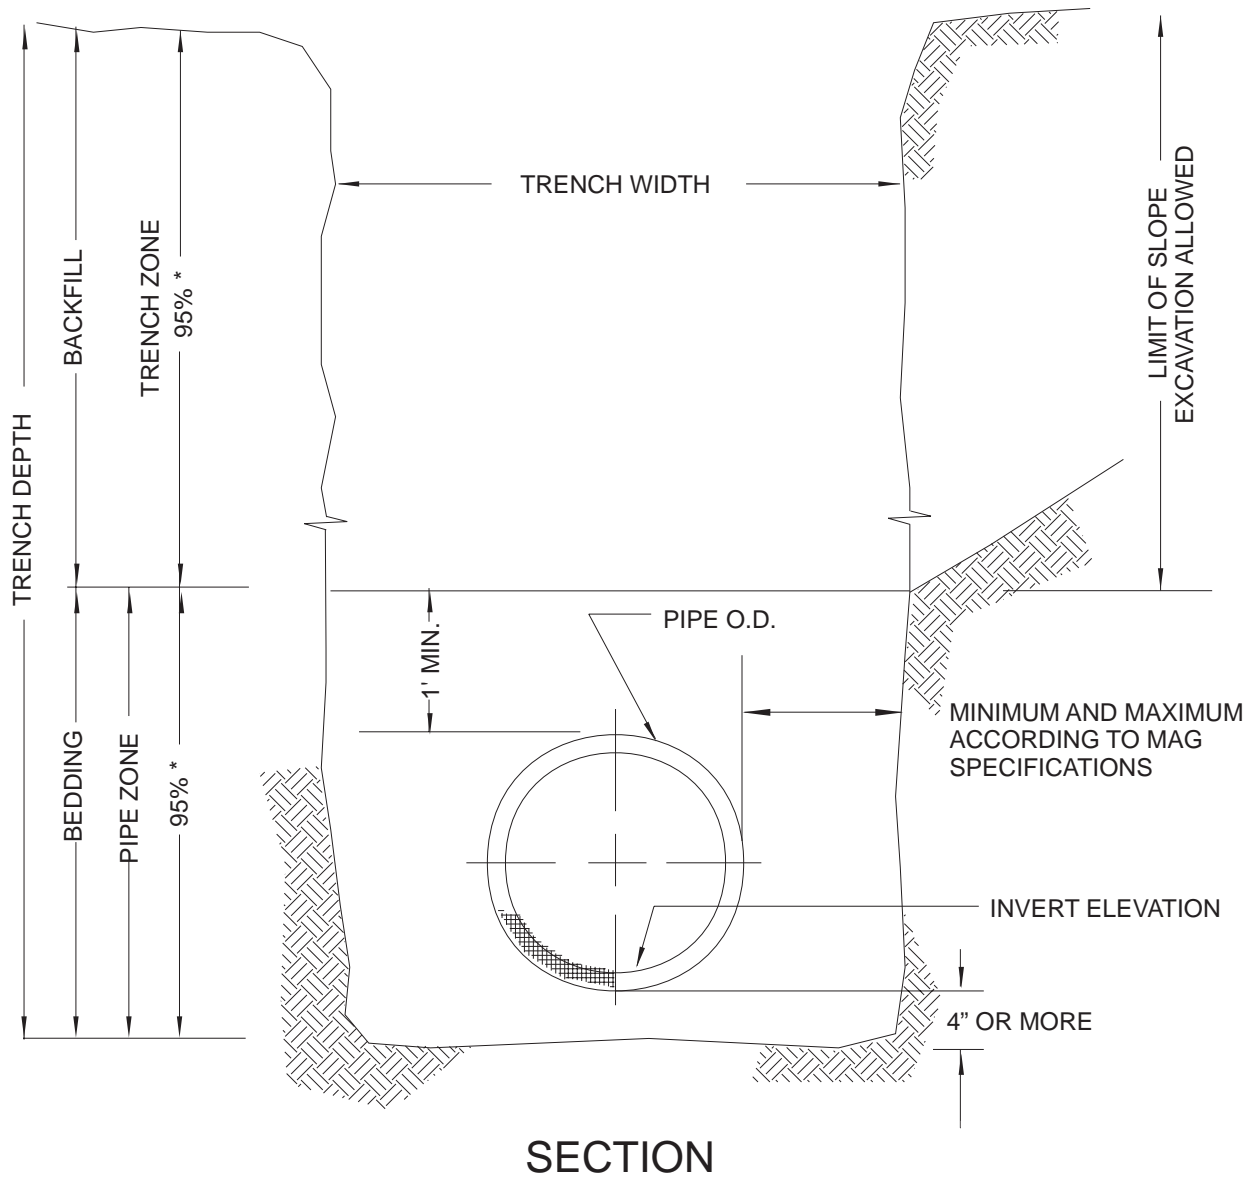
<p>PIPE BEDDING GUIDELINES</p>	<p>FIGURE</p>
<p>PROJECT NO: 603971001</p>	<p>DATE: 10/16</p>	<p>GEOTECHNICAL EVALUATION CHAPEL HILLS WATER CAMPUS - MALLARD DRIVE AND STATE ROUTE 179 SEDONA, ARIZONA</p>	<p>3</p>

SECTION

We recommend that the new underground utilities be supported on 4 inches or more of granular bedding material such as sand and gravel, or crushed rock meeting the requirements in MAG. This bedding/pipe-zone backfill should extend 1 foot above the pipe crown (Figure 3). Care should be taken not to allow voids to form beneath the pipe, (i.e., the pipe haunches should be continuously supported), to avoid damaging the pipelines. This may involve fill placement by hand or small compaction equipment. The bedding/pipe-zone should be placed in horizontal lifts no more than approximately 8 inches in loose thickness and compacted by appropriate mechanical methods, to a relative compaction of 95 percent, (as evaluated by ASTM D 698), and at a moisture content generally near the laboratory optimum.

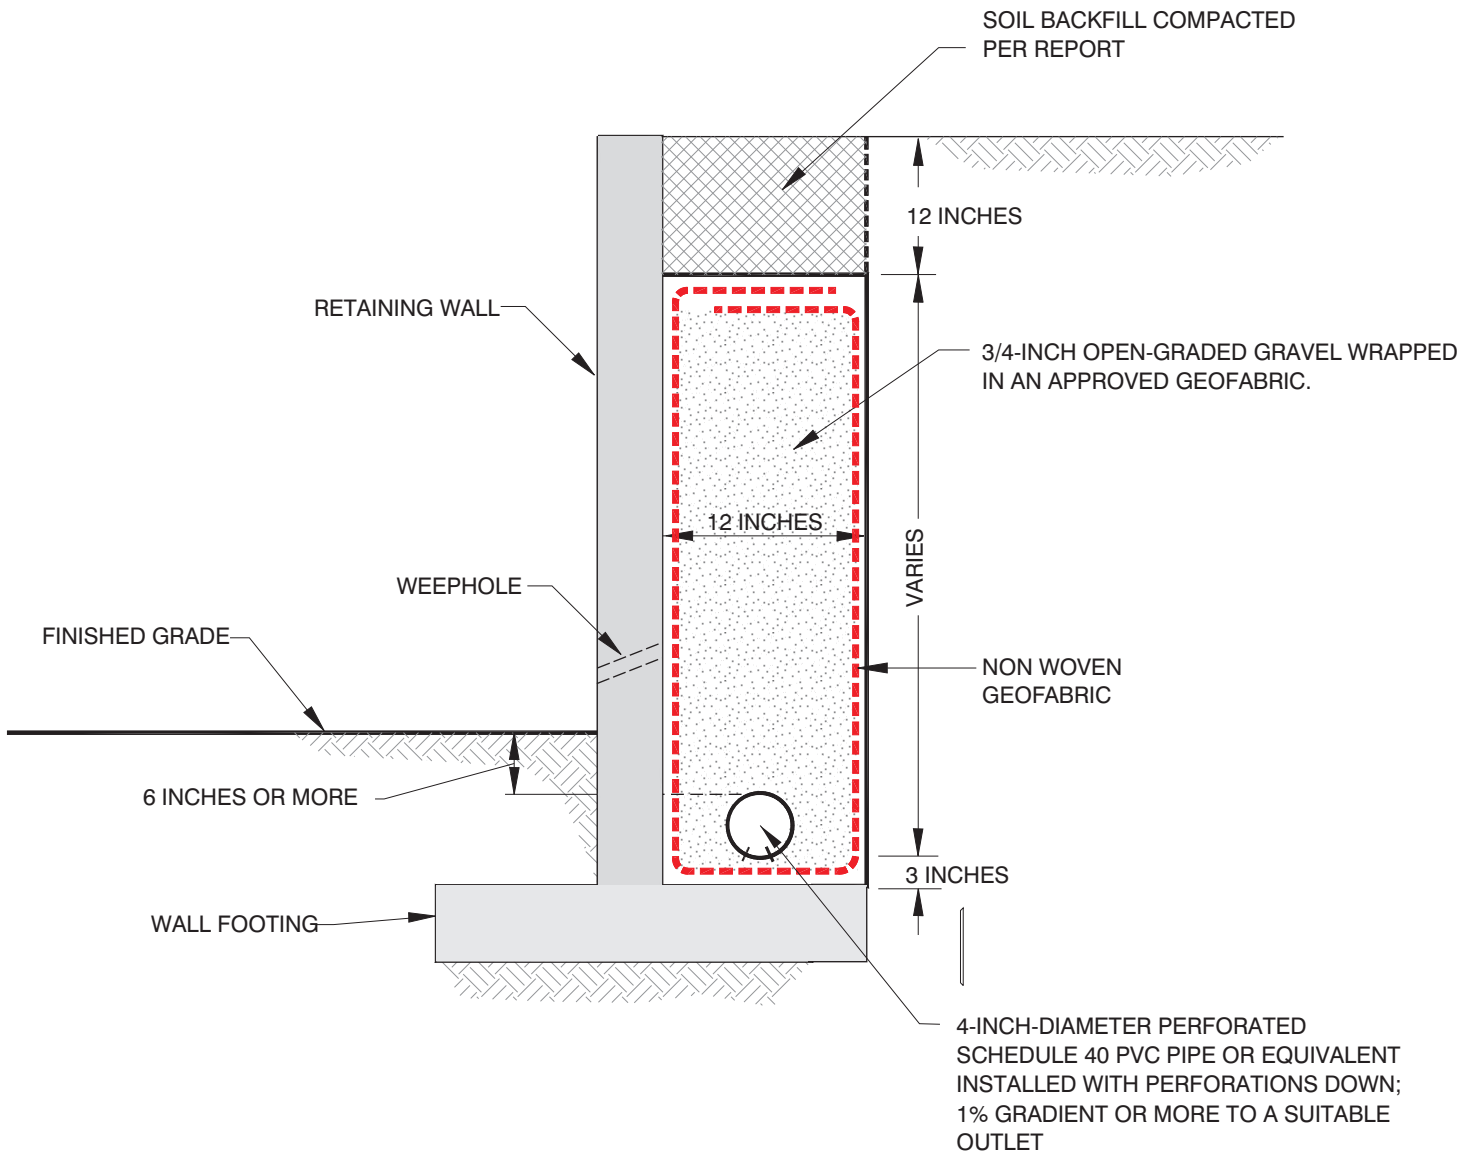
IN LIEU OF THE WRAPPED OPEN-GRADED GRAVEL, A GEOCOMPOSITE DRAINAGE MAT ATTACHED TO THE WALL AND DISCHARGING INTO THE DRAIN PIPE OR WEEP HOLES MAY BE CONSIDERED.

Measures should be taken so that moisture does not build up behind retaining walls. Back drainage measures should include free-draining backfill material and perforated drainpipes or weep holes. Drainpipes should outlet away from structures, and retaining walls should be waterproofed in accordance with the recommendations of the project civil engineer or architect. Retaining wall drainage guidelines are presented on Figure 4. To reduce the potential for water- and sulfate/salt-related damage to the retaining walls, particular care should be taken in the selection of the appropriate type of waterproofing material to be utilized and in the application of this material.

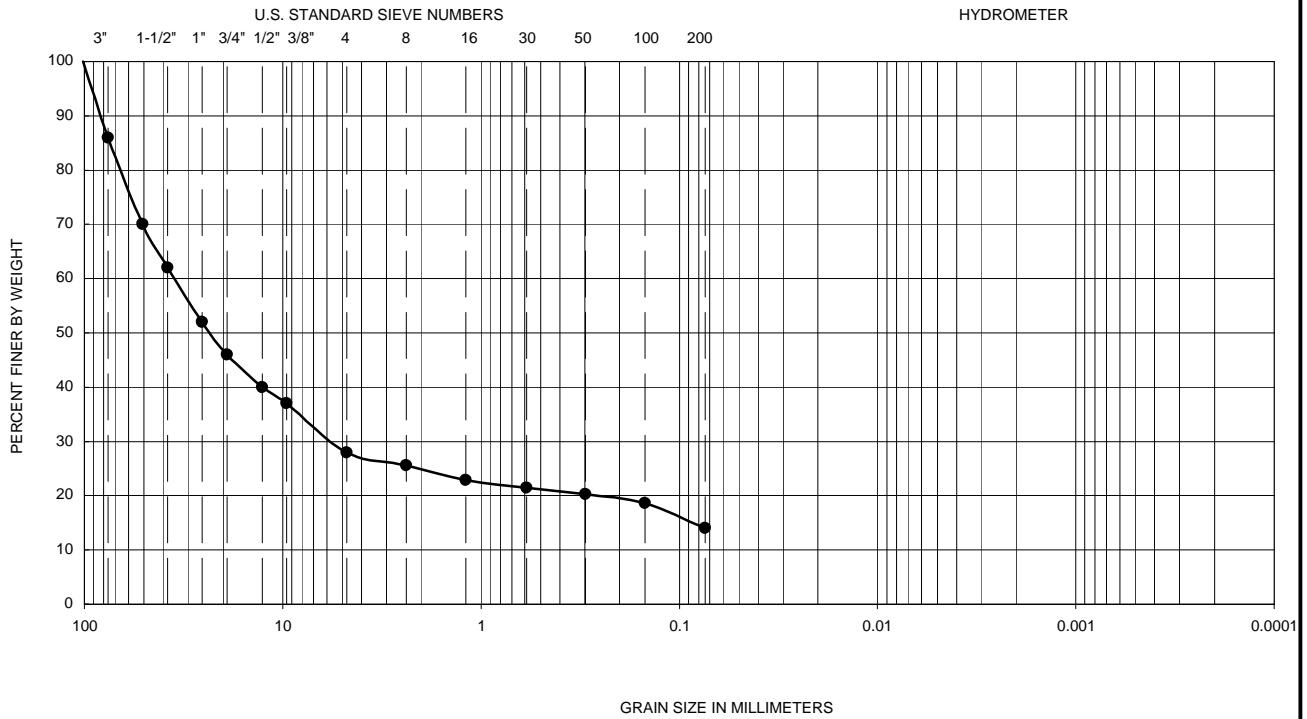
Symbol	Hole No.	Depth (ft)	Liquid Limit	Plastic Limit	Plasticity Index	D ₁₀	D ₃₀	D ₆₀	C _u	C _c	Passing No. 200 (%)	U.S.C.S
●	TP-1	0-2	--	--	NP	--	--	--	--	--	14	GM

PERFORMED IN GENERAL ACCORDANCE WITH ASTM D 422

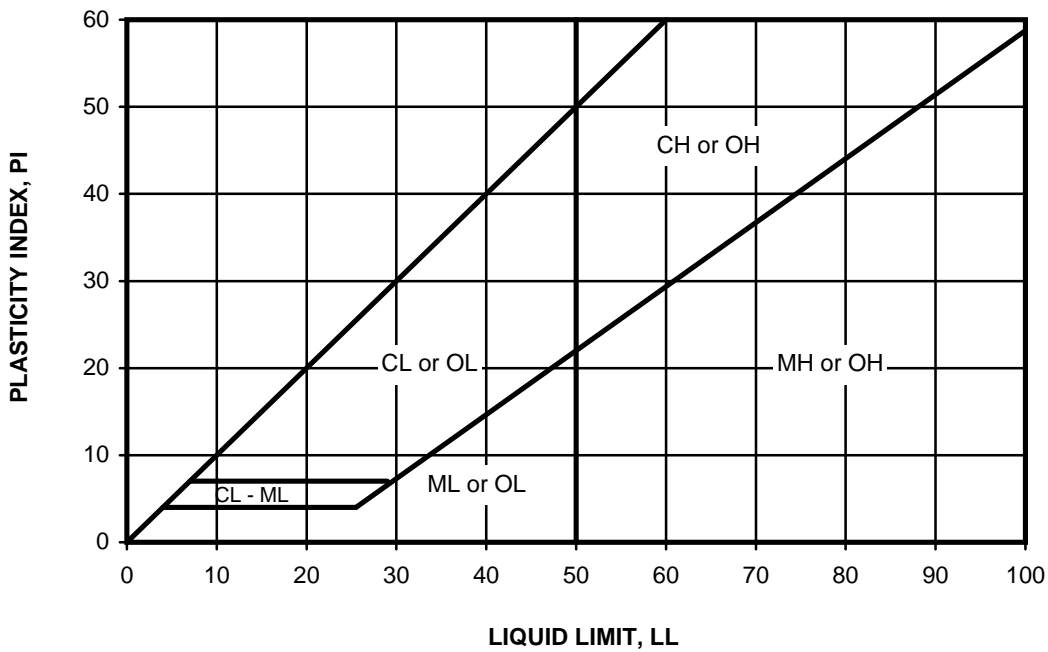
<i>Ninyo & Moore</i>		ATTERBERG LIMITS TEST RESULTS		FIGURE B-2
PROJECT NO.	DATE	CHAPEL HILLS WATER CAMPUS MALLARD DRIVE AND STATE ROUTE 179 SEDONA, ARIZONA		
603971001	10/16

SYMBOL	LOCATION	DEPTH (FT)	LIQUID LIMIT, LL	PLASTIC LIMIT, PL	PLASTICITY INDEX, PI	USCS CLASSIFICATION (Fraction Finer Than No. 40 Sieve)	USCS (Entire Sample)
	TP-1	0-2	--	--	NP	ML	GM

NP - INDICATES NON-PLASTIC

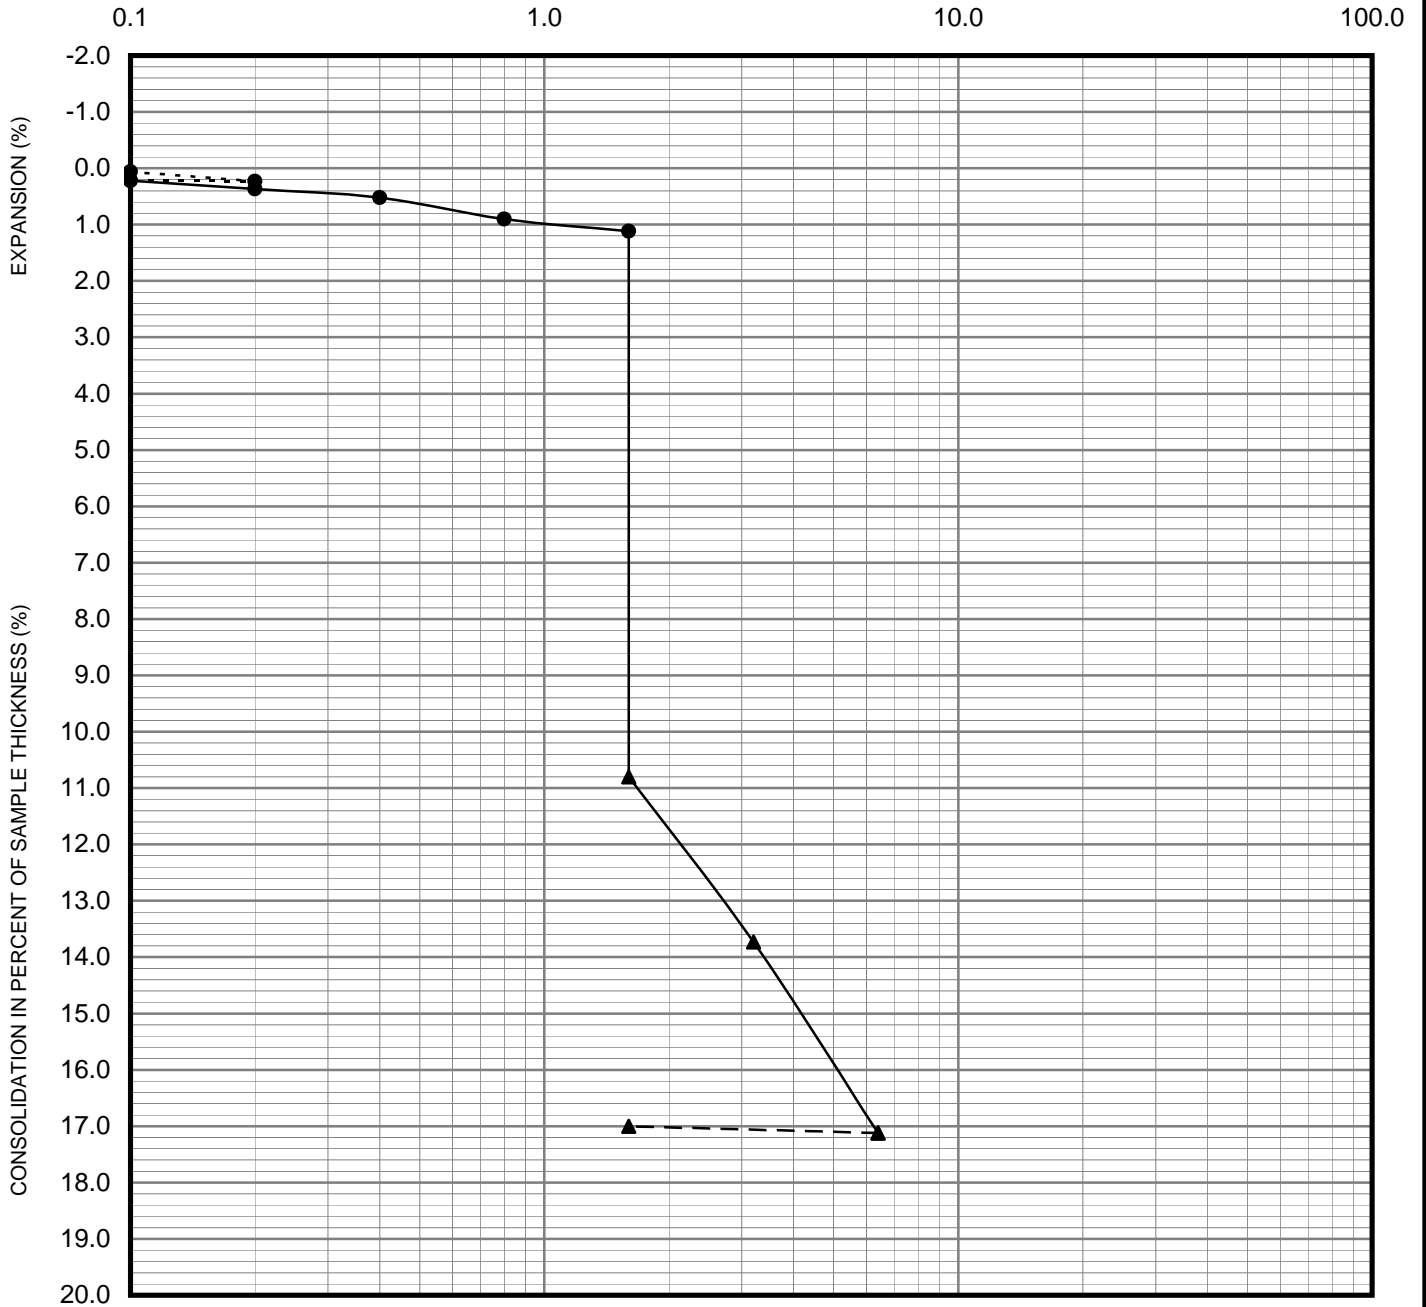
STRESS IN KIPS PER SQUARE FOOT

- Seating Cycle
 - Loading Prior to Inundation
 - ▲— Loading After Inundation
 - ▲--- Rebound Cycle
- Sample Location TP-2
 Depth (ft.) 1-2
 Soil Type SM

PERFORMED IN GENERAL ACCORDANCE WITH ASTM D 2435

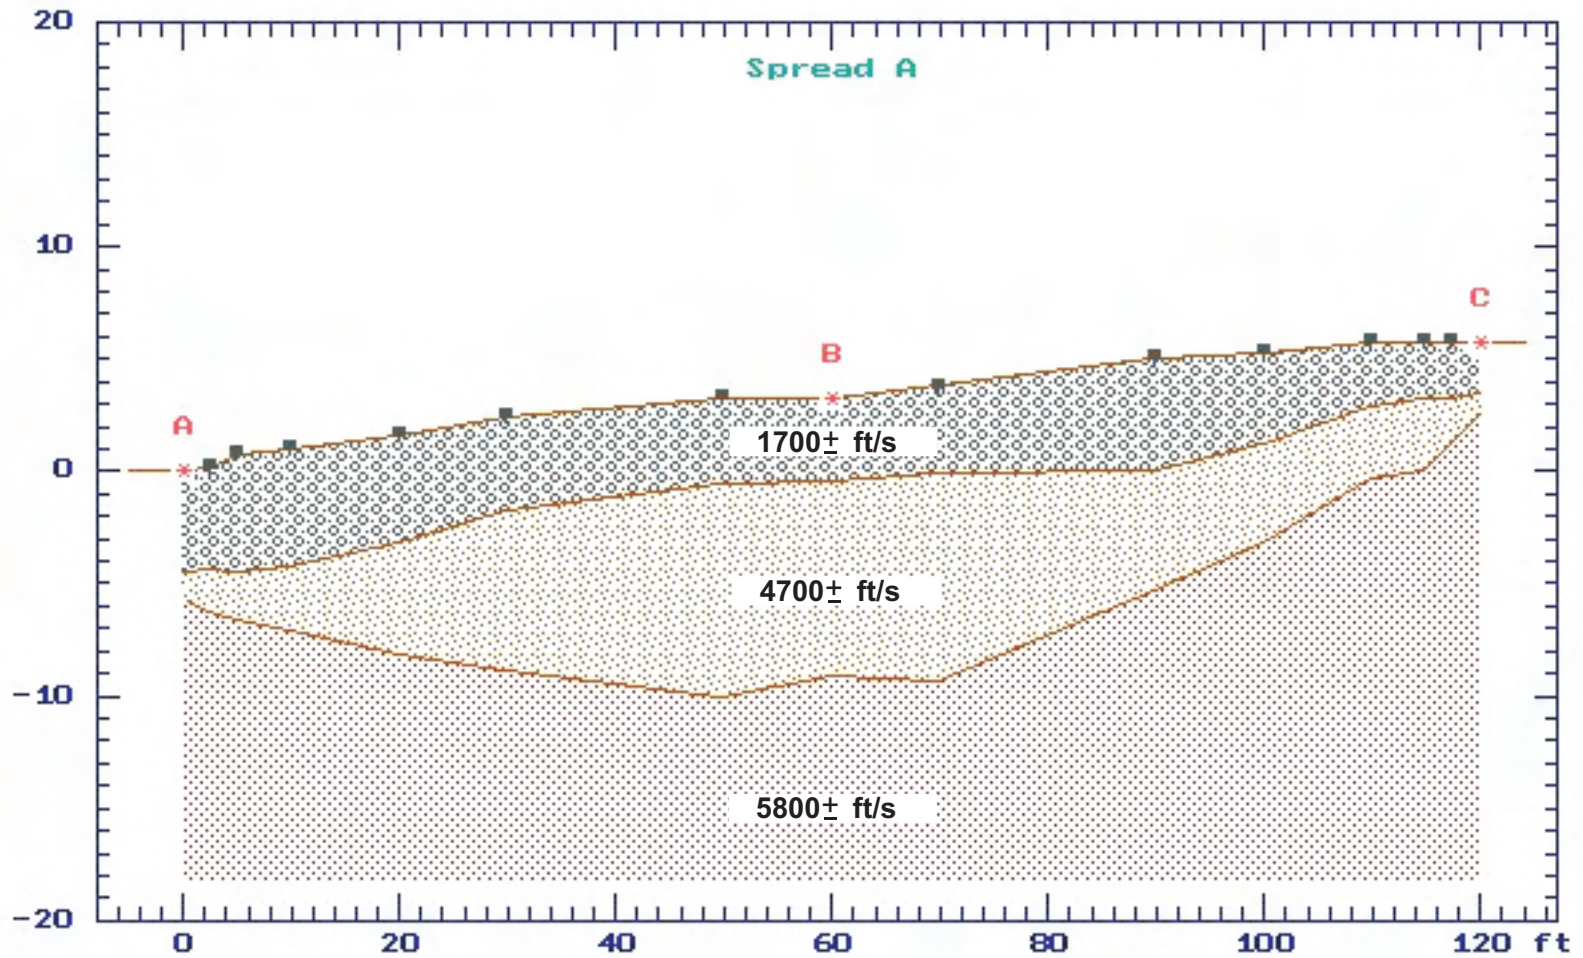
CHAPEL HILLS WATER CAMPUS, SEISMIC REFRACTION SURVEY, SL-1

SEISMIC REFRACTION SURVEY

Traverse No. And Length	Approximate Velocity Feet/Second	Approximate Depth to Bottom of Layer (range in feet below ground surface)	Qualitative Rippability
SL-1 120 feet	V1 = 1,700 V2 = 4,700 V3 = 5,800	2-6 6-13 --	Easy Ripping Difficult Ripping, Possible Blasting Very Difficult Ripping, Probable Blasting
SL-2 100 feet	V1 = 1,300 V2 = 4,800 V3 = 5,800	<1-5 7-20 --	Easy Ripping Difficult Ripping, Possible Blasting Very Difficult Ripping, Probable Blasting
SL-3 100 feet	V1 = 1,500 V2 = 3,600 V3 = 5,300	2-4 13-18 --	Easy Ripping Moderate Ripping Very Difficult Ripping, Probable Blasting
SL-4 120 feet	V1 = 1,100 V2 = 4,100 V3 = 5,900	2-4 20-25 --	Easy Ripping Difficult Ripping, Possible Blasting Very Difficult Ripping, Probable Blasting
SL-5 90 feet	V1 = 1,500 V2 = 4,500 V3 = 5,500	1-5 9-14 --	Easy Ripping Difficult Ripping, Possible Blasting Very Difficult Ripping, Probable Blasting
SL-6 120 feet	V1 = 1,200 V2 = 3,100 V3 = 5,800	1-7 8-14 --	Easy Ripping Moderate Ripping Very Difficult Ripping, Probable Blasting

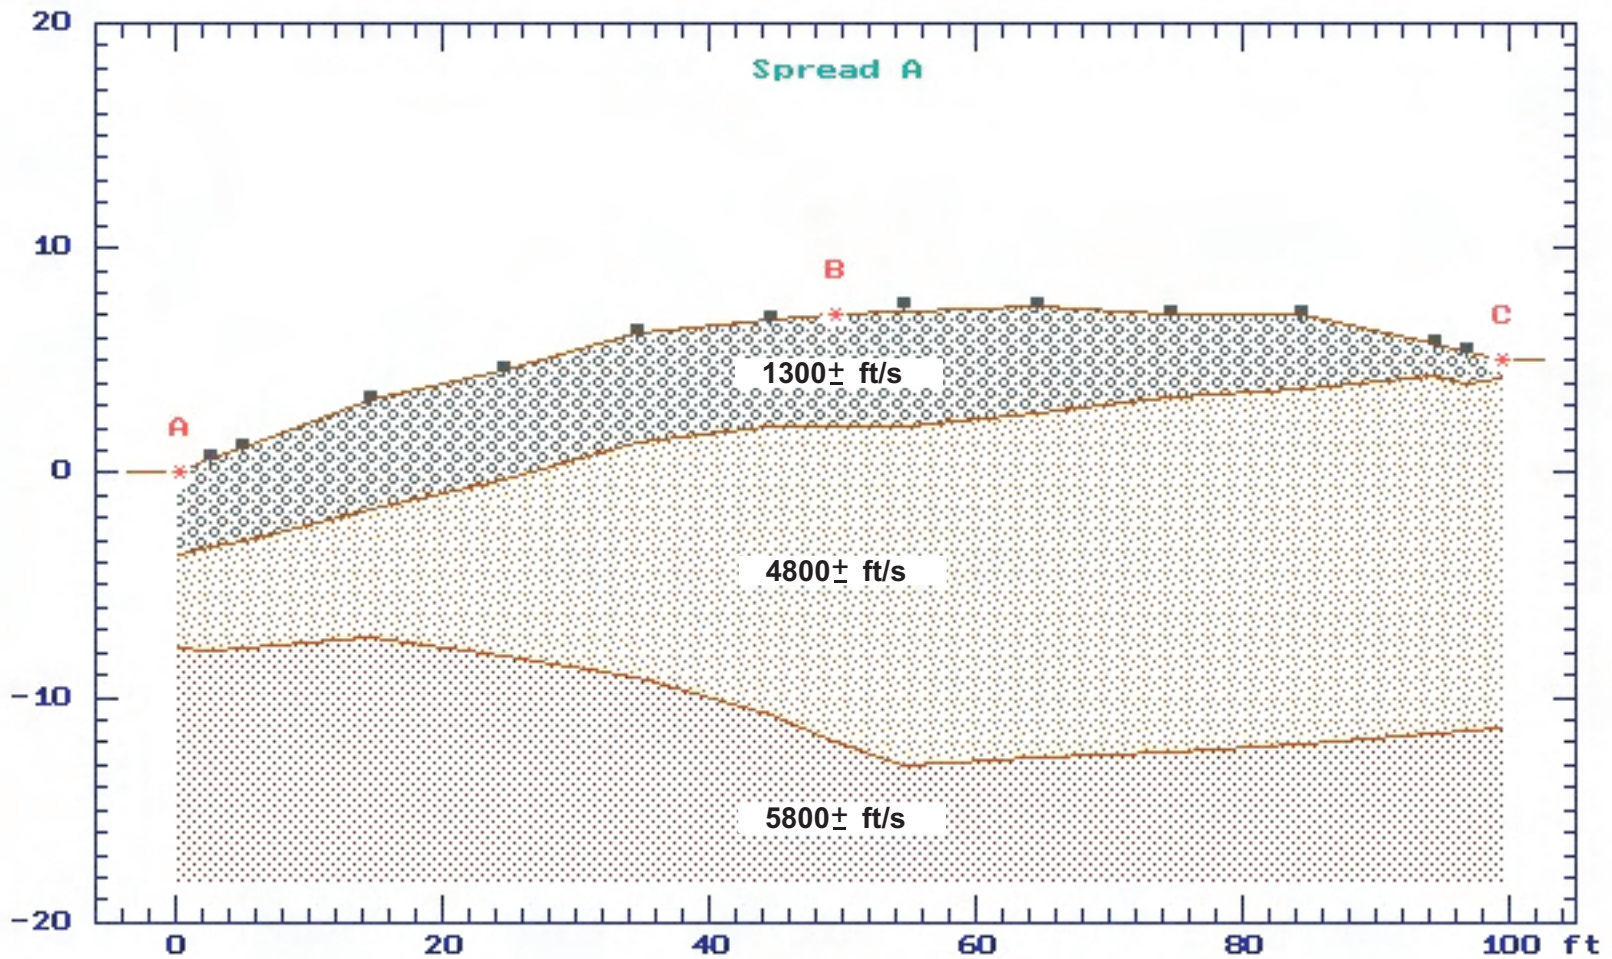
CHAPEL HILLS WATER CAMPUS, SEISMIC REFRACTION SURVEY, SL-2

SEISMIC REFRACTION SURVEY

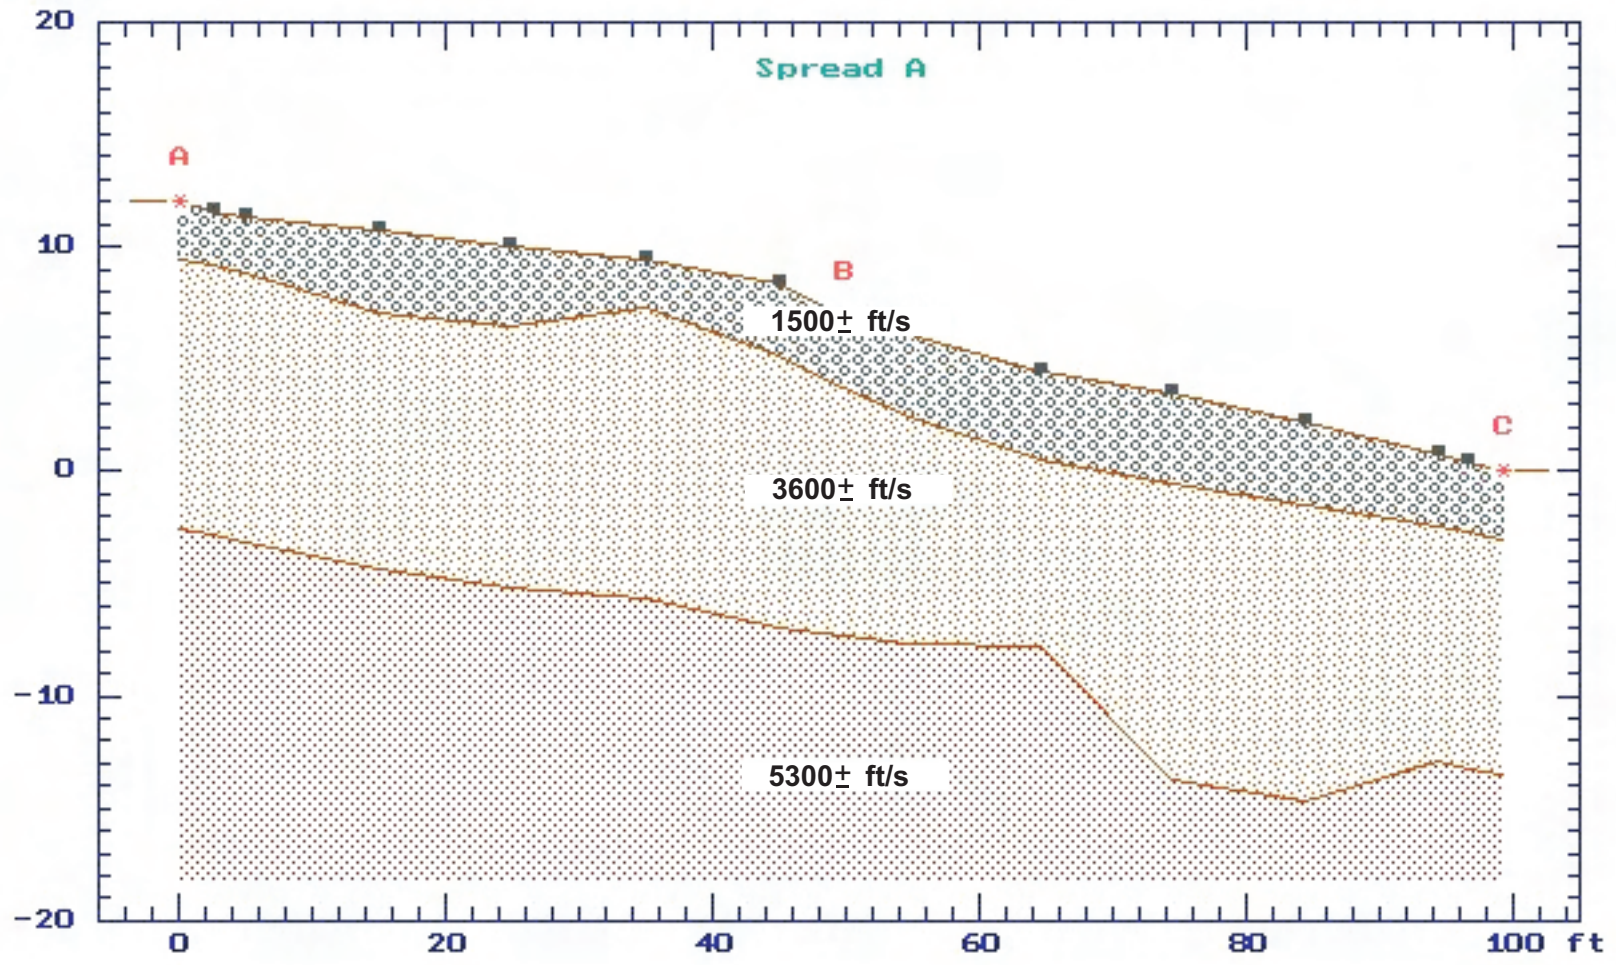
CHAPEL HILLS WATER CAMPUS, SEISMIC REFRACTION SURVEY, SL-3

SEISMIC REFRACTION SURVEY

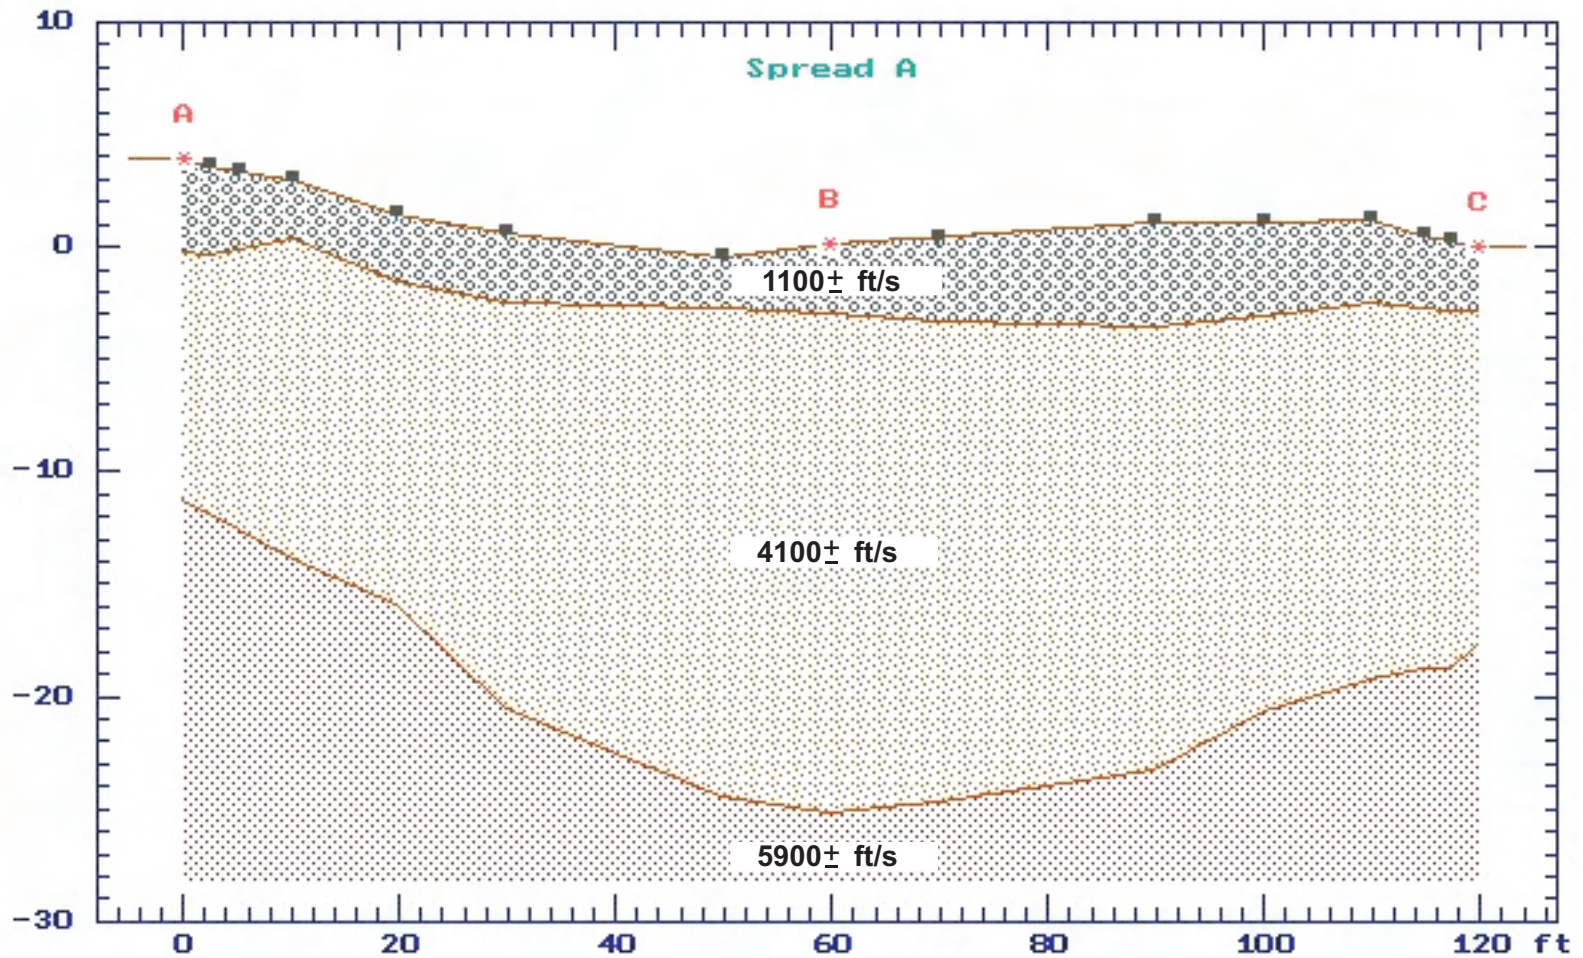
CHAPEL HILLS WATER CAMPUS, SEISMIC REFRACTION SURVEY, SL-4

SEISMIC REFRACTION SURVEY

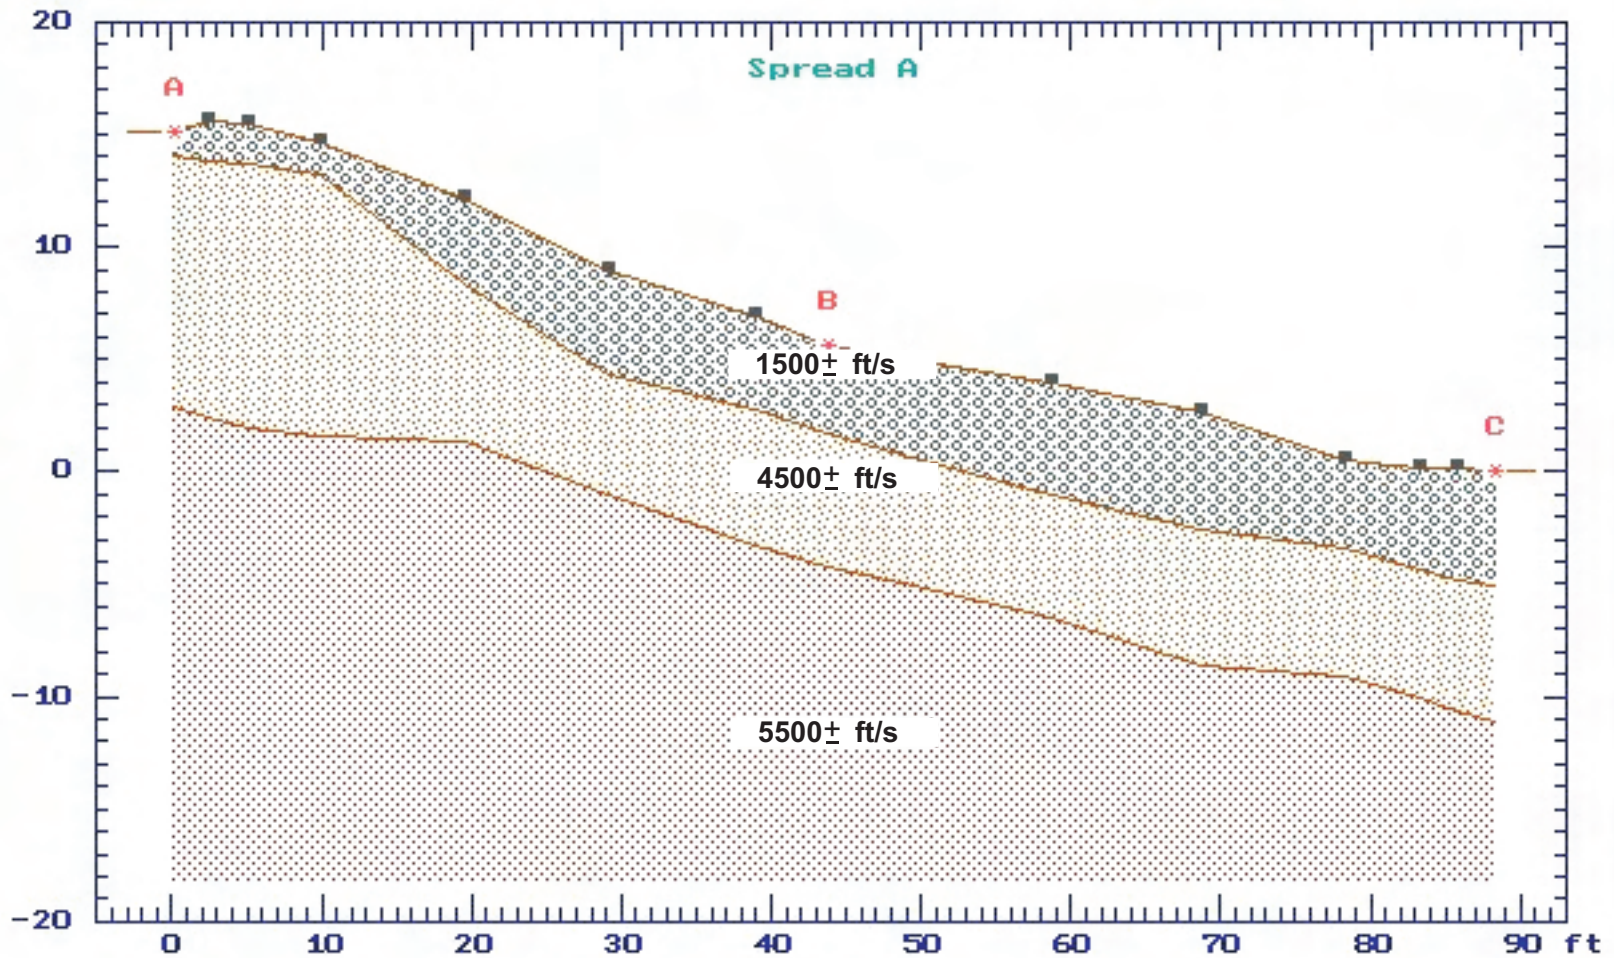
CHAPEL HILLS WATER CAMPUS, SEISMIC REFRACTION SURVEY, SL-5

SEISMIC REFRACTION SURVEY

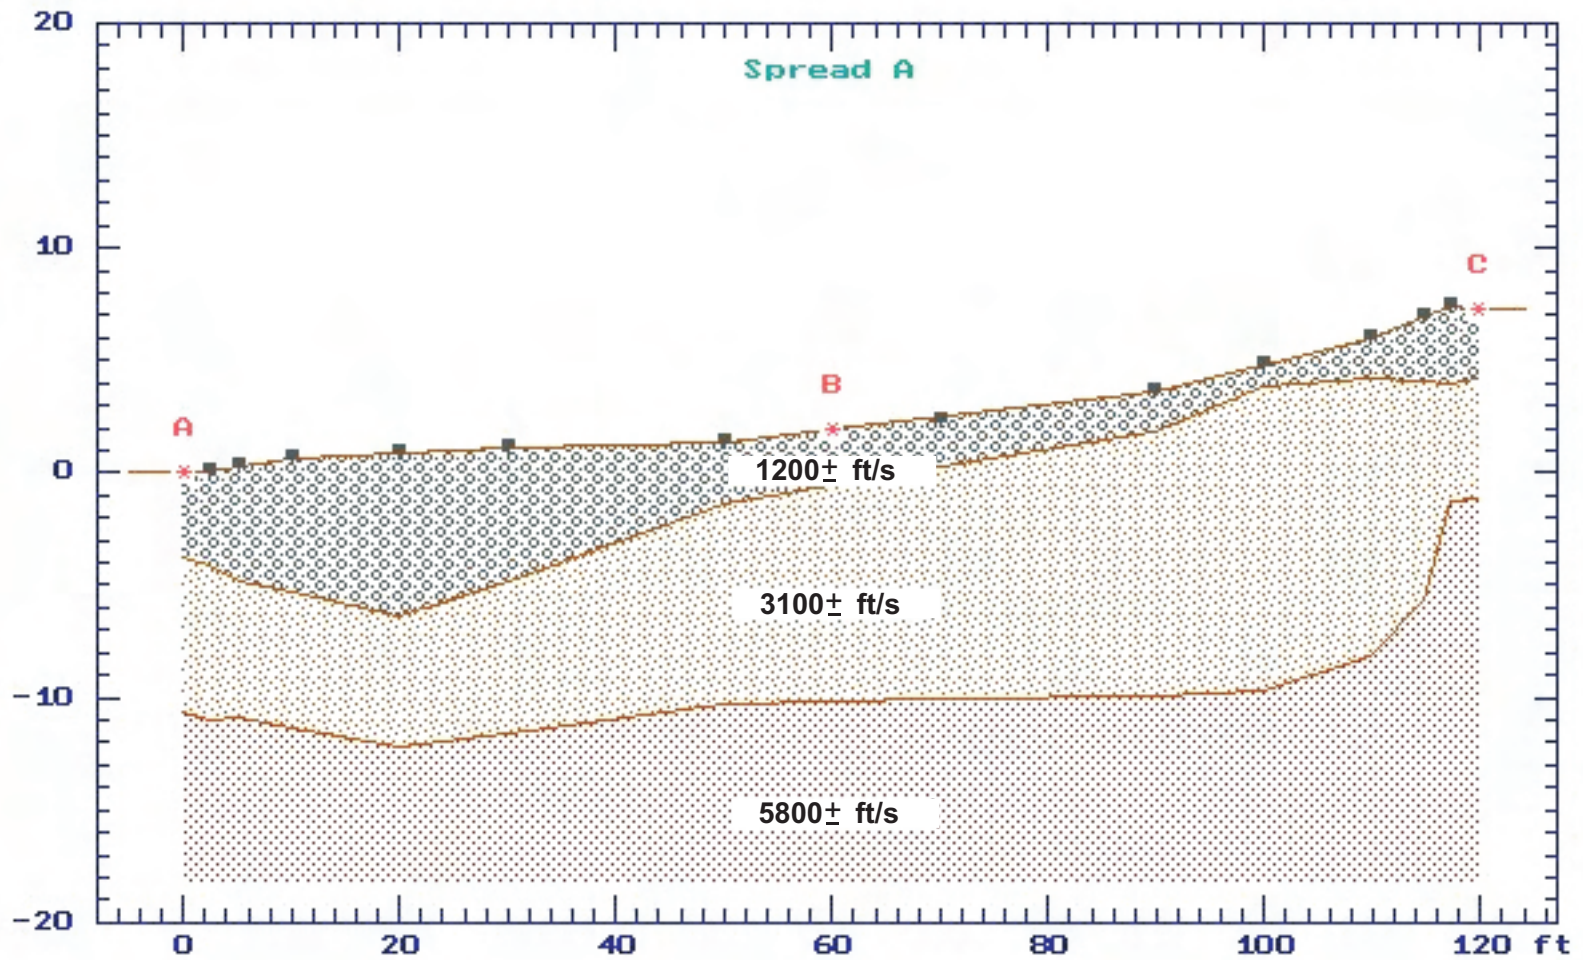
CHAPEL HILLS WATER CAMPUS, SEISMIC REFRACTION SURVEY, SL-6

SEISMIC REFRACTION SURVEY

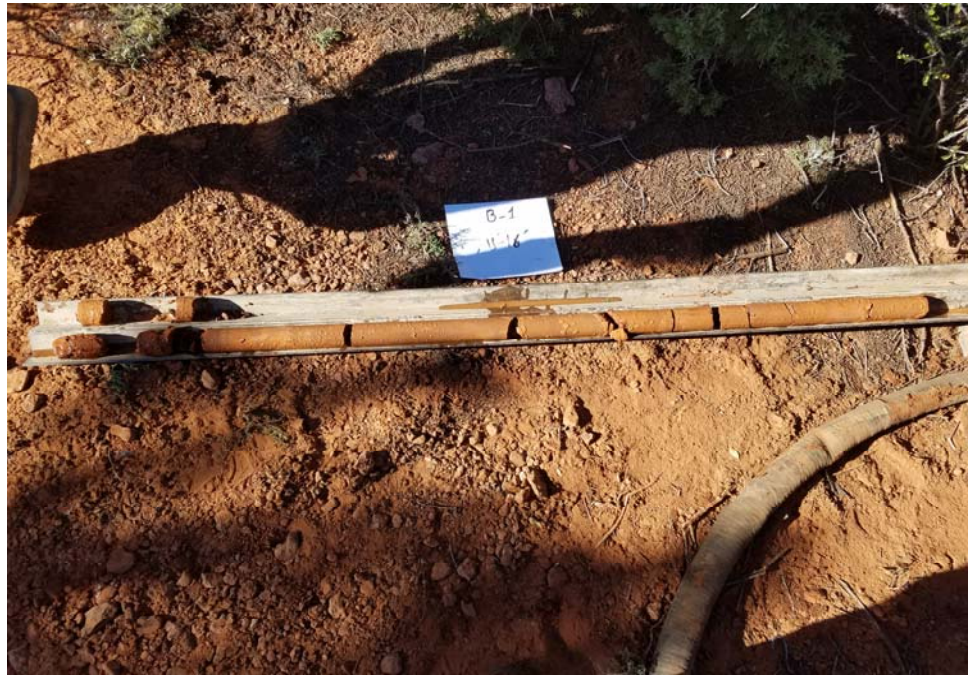
Photograph 1: Sample cores B-1, 11 through 16 feet.

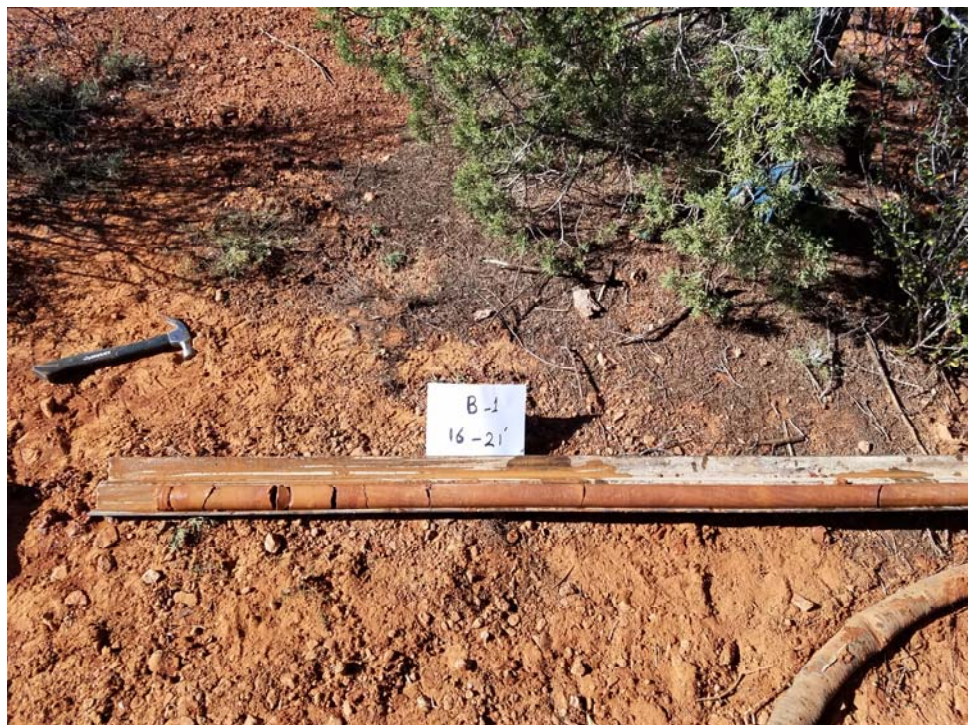
Photograph 2: Sample cores B-1, 16 through 21 feet.

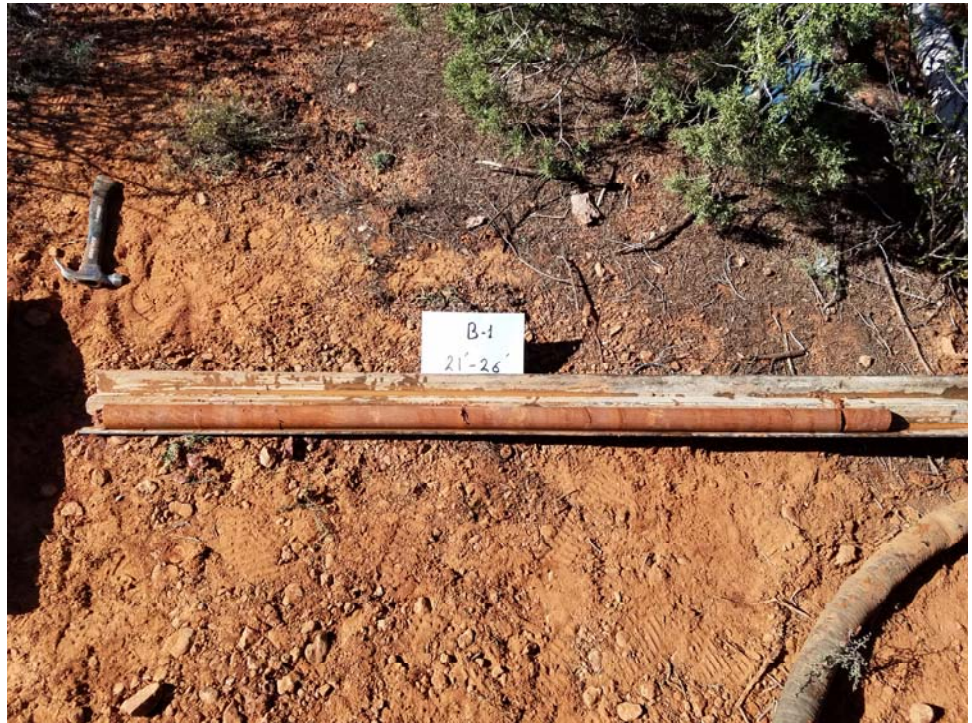
Photograph 3: Sample cores B-1, 21 through 26 feet.

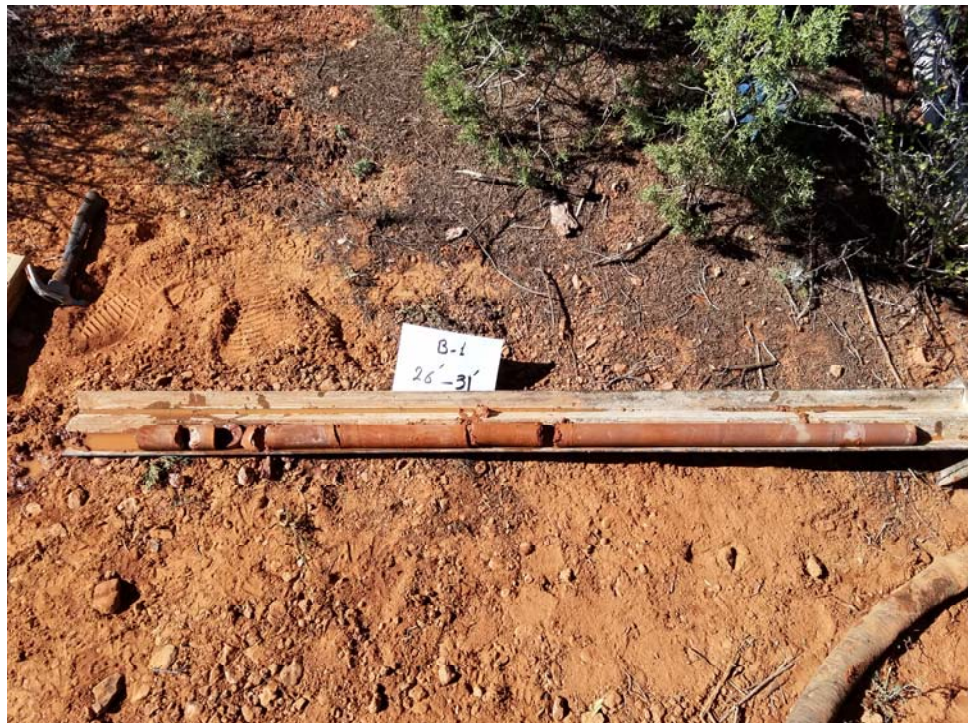
Photograph 4: Sample cores B-1, 26 through 31 feet.
