**GEOTECHNICAL EVALUATION
CHAPEL HILLS WATER CAMPUS
MALLARD DRIVE AND STATE ROUTE 179
SEDONA, ARIZONA**

Arizona Water Company
7580 North Dobson Road, Suite 200
Scottsdale, Arizona 85256

Ninyo & Moore
Geotechnical and Environmental Sciences Consultants
3202 East Harbour Drive
Phoenix, Arizona 85034

October 31, 2016
Project No. 603971001

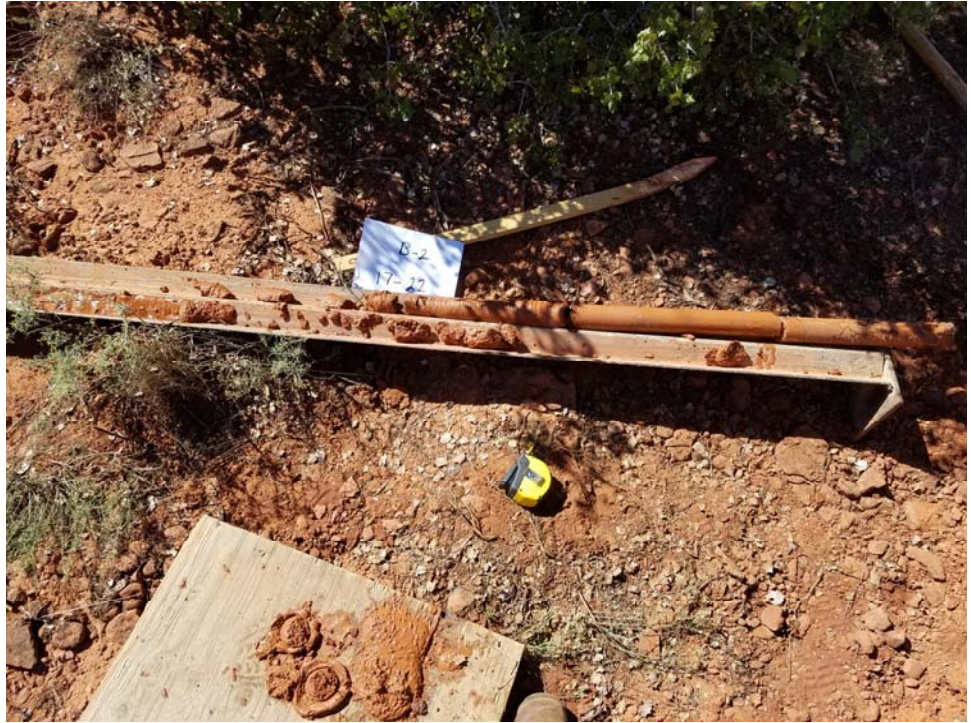
Photograph 5: Sample cores B-2, 17 through 22 feet.

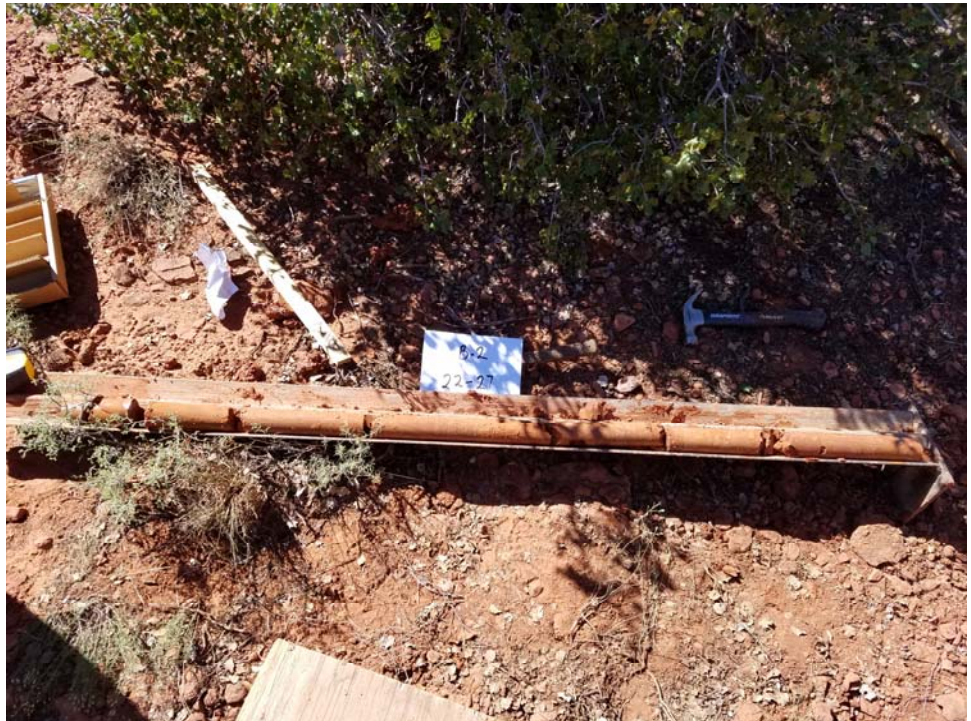
Photograph 6: Sample cores B-2, 22 through 27 feet.

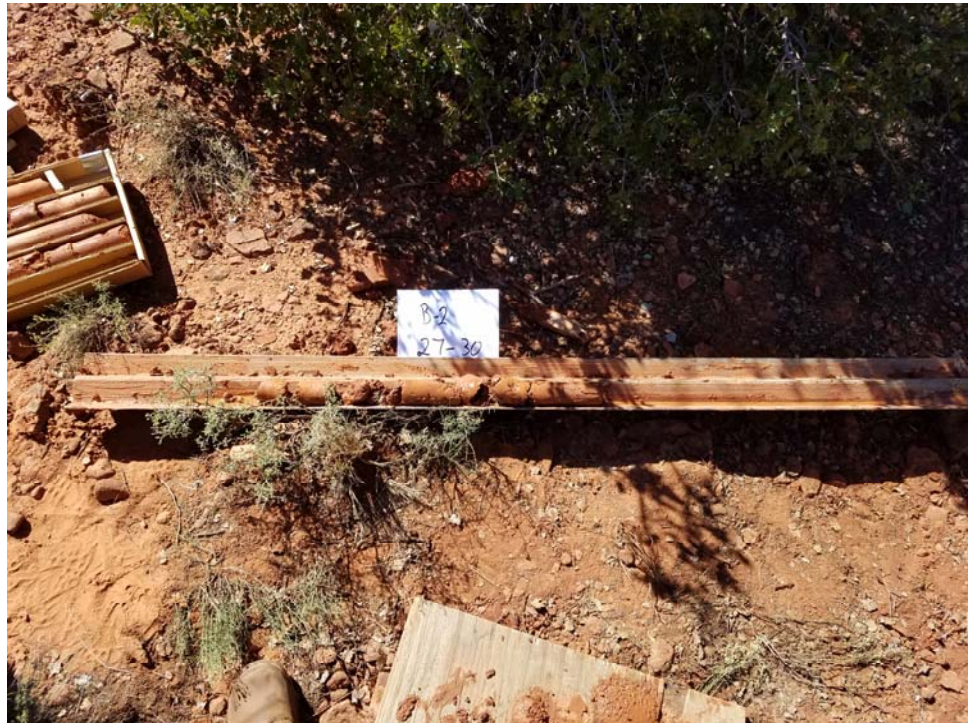
Photograph 7: Sample cores B-2, 27 through 30 feet.
