# City of Sedona WWTP

## CSAMT Survey

December 2009

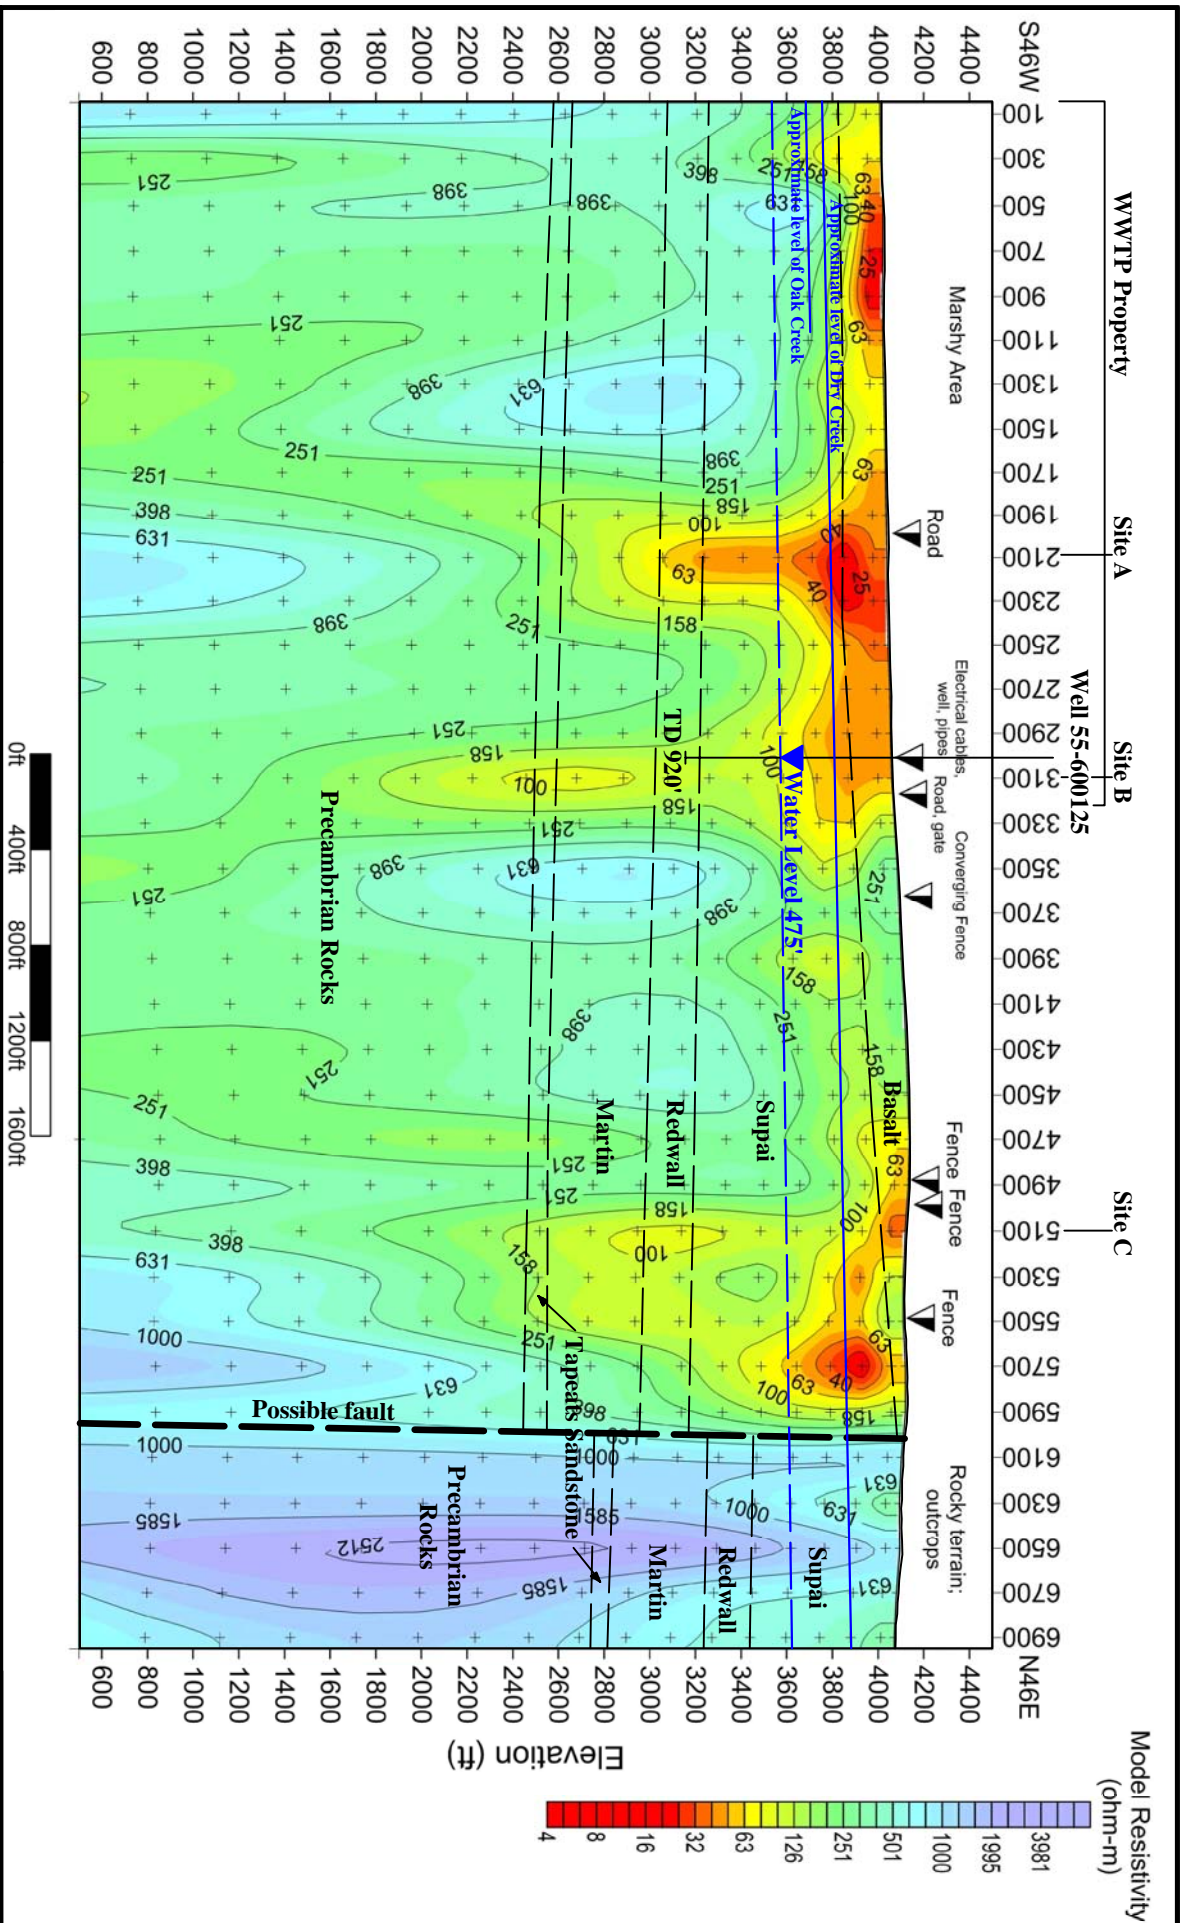
Figure 3

**Line 1 CSAMT Cross-Section**  
**City of Sedona Recharge Project**

Line 1 (*Figure 3*) shows two separate prominent low resistivity zones at and near the surface. The first is between Stations 0 and 3400 and the second between Stations 4500 and 5900. The first zone roughly corresponds to the locations of the present and past 'rapid infiltration basins' (RIB's) between about Stations 400 and 3000 (*Photos 1, 2, and 3*), and the wetlands between Stations 0 and 400. The low resistivity zone visible in *Figure 3* likely represents water that has infiltrated from these basins. It is interesting to note that although these basins have been used for several years the lowest resistivity values are mostly within about 200 feet of the surface (with two notable exceptions). This configuration further supports the conclusion explained in the *Groundwater Recharge Feasibility Evaluation* that the surface materials (alluvium and basalt) possess infiltration rates that are too low to support appreciable surface recharge. Because even some amount of infiltration is expected to have occurred since the RIB's entered service, the observation that there appears to be very little infiltration below about 200 feet suggests that water may instead flow predominantly laterally in the near-surface, probably towards the southwest parallel to the slope of the land surface. Another alternative is that possibly a large part of the infiltrated water is infiltrating into the subsurface preferentially below Station 2100. Here, there is a prominent vertical low resistivity anomaly that extends down to at least 1,000 feet below the surface (3,000 feet elevation) and probably at least another

The second near-surface prominent low resistivity zone is north of the WWTP between Stations 4500 and 5900. On the surface a tan-colored alluvial deposit is exposed between Stations 3600 to 5500 (*Photo 4*). It is mostly fine quartz sand and silt but also contains rounded cobbles of basalt and the Supai Formation, and it is not clear if this represents the basalt conglomerating portion of the Verde Formation or if it is a younger Quaternary alluvial deposit. Whatever its origin it is relatively thin, up to a few meters thick, as revealed in the highway roadcuts immediately to the east. These sedimentary deposits overlie basalt here and both occupy a fairly level area near the top of a small divide. It is possible that the deposits here act as a 'sponge' and preferentially collect precipitation and allow it to infiltrate more readily than the steeper areas to the north and south. It is also possible that the position of the low resistivity zone is more influenced by the position of the possible fault as inferred below Station 6000.

One of the reasons for extending Line 1 north of the WWTP was to verify the existence of the fault mapped by DeWitt and others (2008), also shown as the Dry Creek fault(s) in Burgess and Niple (2008). In the highway road-cut exposure on the west side of the highway in about the middle of the curve it certainly appears that reddish tan conglomerate on the north is faulted and down-dropped against basalt on the south (*Photo 5*). This exposure is isolated and there are no good exposures of the contact to the northwest. The exposures to the southeast do not reveal a fault, but instead show the contact between the basalt and the Supai Formation (*Photo 6*) as conformable and wrapping around the exposed hills. Therefore, it is possible that this fault possesses only a limited amount of offset (a few meters) which is only visible in the clean road-cut. Even so, this limited offset apparently is enough to change the groundwater characteristics on either side of the fault. Below Station 6000 in *Figure 3* there is a rather abrupt change in the resistivity values from southwest to the northeast. Values are lower to the southwest, and values are consistently higher to the northeast. The change occurs immediately northwest of the fault exposure in the road-cut. These data are mutually supportive and suggest that there is a real structure here below Station 6000. It is interesting to observe that the Supai and Redwall Formations both show high resistivity values north of the fault, especially considering that the drainage of Dry Creek is only about ½ mile to the east. This may indicate that the permeabilities of these formations in this area are sufficiently small to preclude major seepage into these rocks from Dry Creek, or it could indicate that groundwater flow is mostly to the south from Dry Creek and not to the southwest. The prominent low resistivity feature south of the fault centered below Station 5700 could also represent groundwater either ponding adjacent to or flowing laterally along the fault.

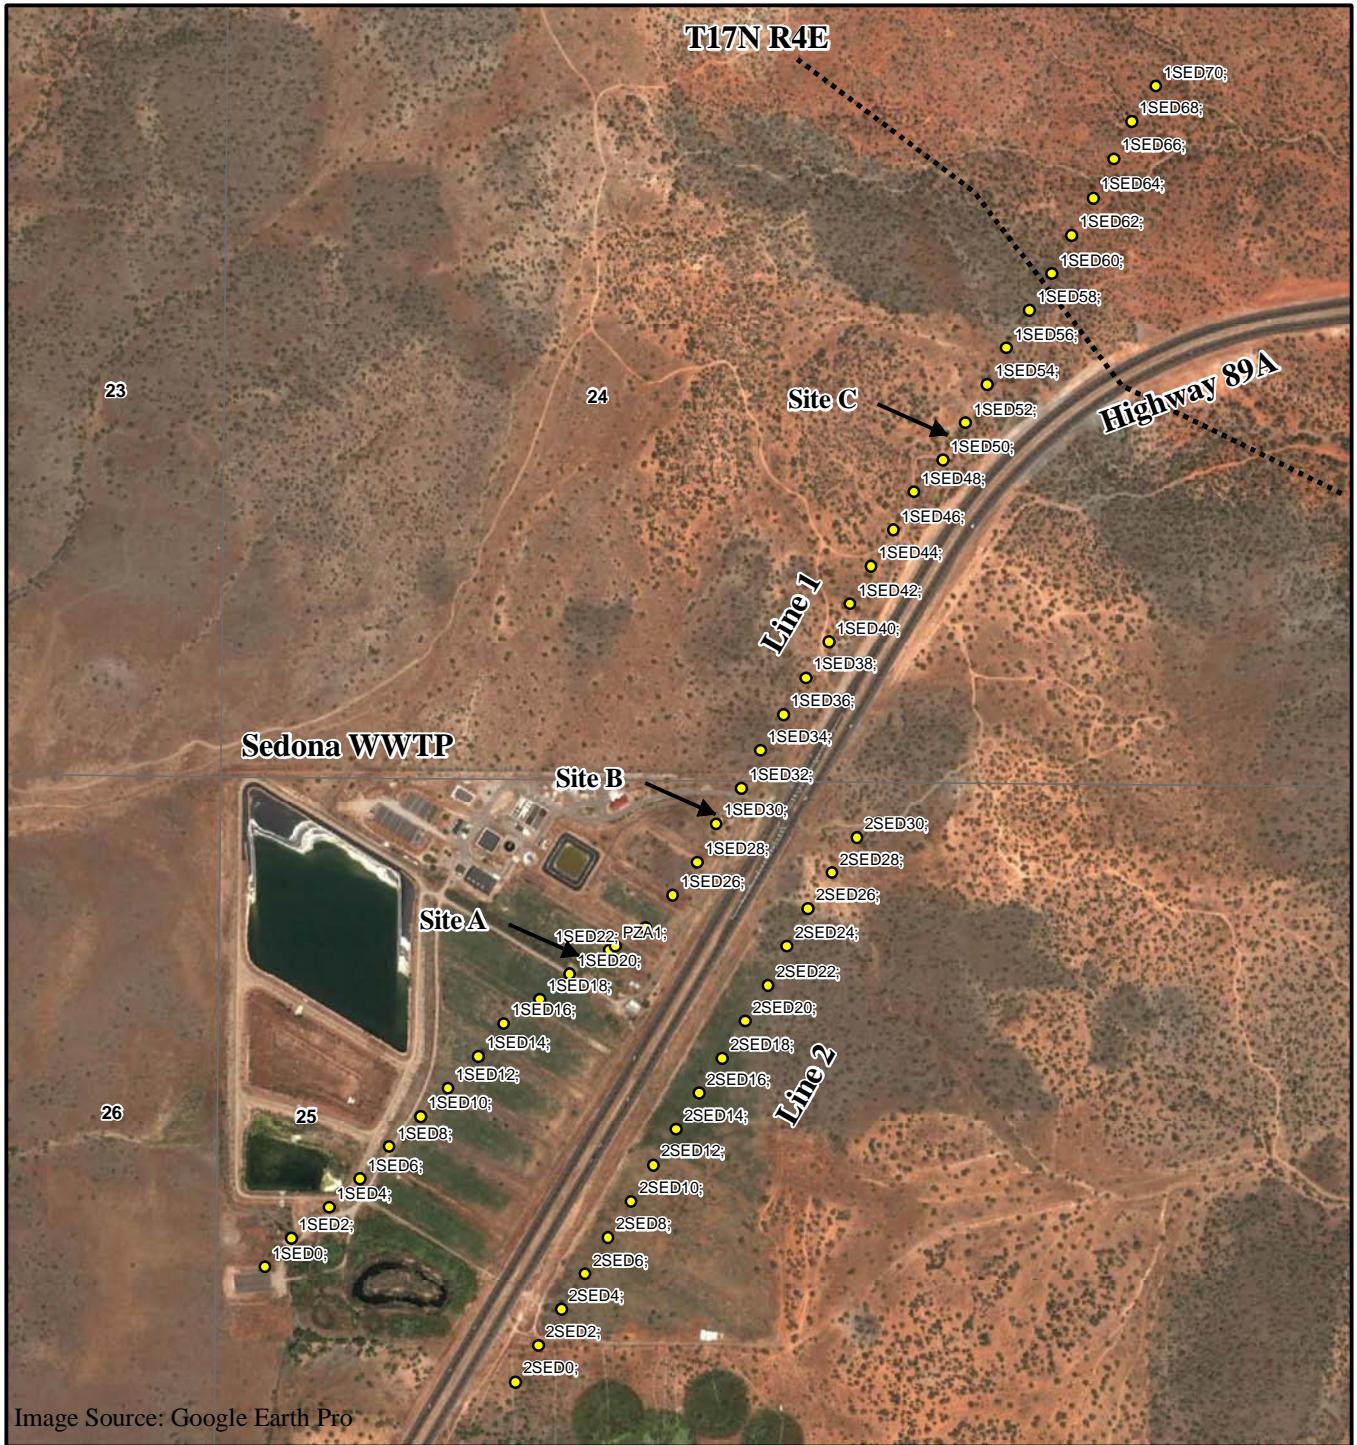
Figure 4

**Map Showing Station Numbers  
for Lines 1 & 2  
City of Sedona Recharge Project**

Line 2 is roughly parallel to Line 1 but is on the east side of State Route 89A (*Figures 1 and 4*). It starts about 200 feet south of the property and ends about 400 feet north of the northeast side of the property. It crosses the graded flat fields here which are supplied by a sprinkler system. *Figure 5* shows a low resistivity zone near the surface and roughly parallel to the surface to a depth of about 400 to 500 feet. A deeper low resistivity zone extends downward beneath about Stations 2700 and 3000 to depths of about 1,500 feet (2,600 feet elevation). The position of Station 2900 is only a few hundred yards immediately east of the potable water well location on Line 1 at Station 3000, which also shows a deeper low resistivity feature. The low resistivity projection below Station 1700 is also only a few hundred yards immediately east of the prominent deep low resistivity zone on Line 1 at Station 2100. These two observations support the conclusion that the deep low resistivity features on Lines 1 and 2 are real and that they probably represent a fracture system oriented northwest-southeast that intersects, in part, both cross-sections. It is quite possible that the deeper anomalies below Station 5100 on Line 1 also project in a northwest-southeast direction. It is also possible that the fracture system, and associated low resistivity anomaly, project both southeast of Line 2 and northwest of Line 1. The anomaly beneath Station 1700 on Line 2 is weak, however, and, based on the trend from Line 1, may not exist southeast of Line 2. The anomaly below Station 2900, however, still appears rather strong and may indicate a prominent through-going fracture system.

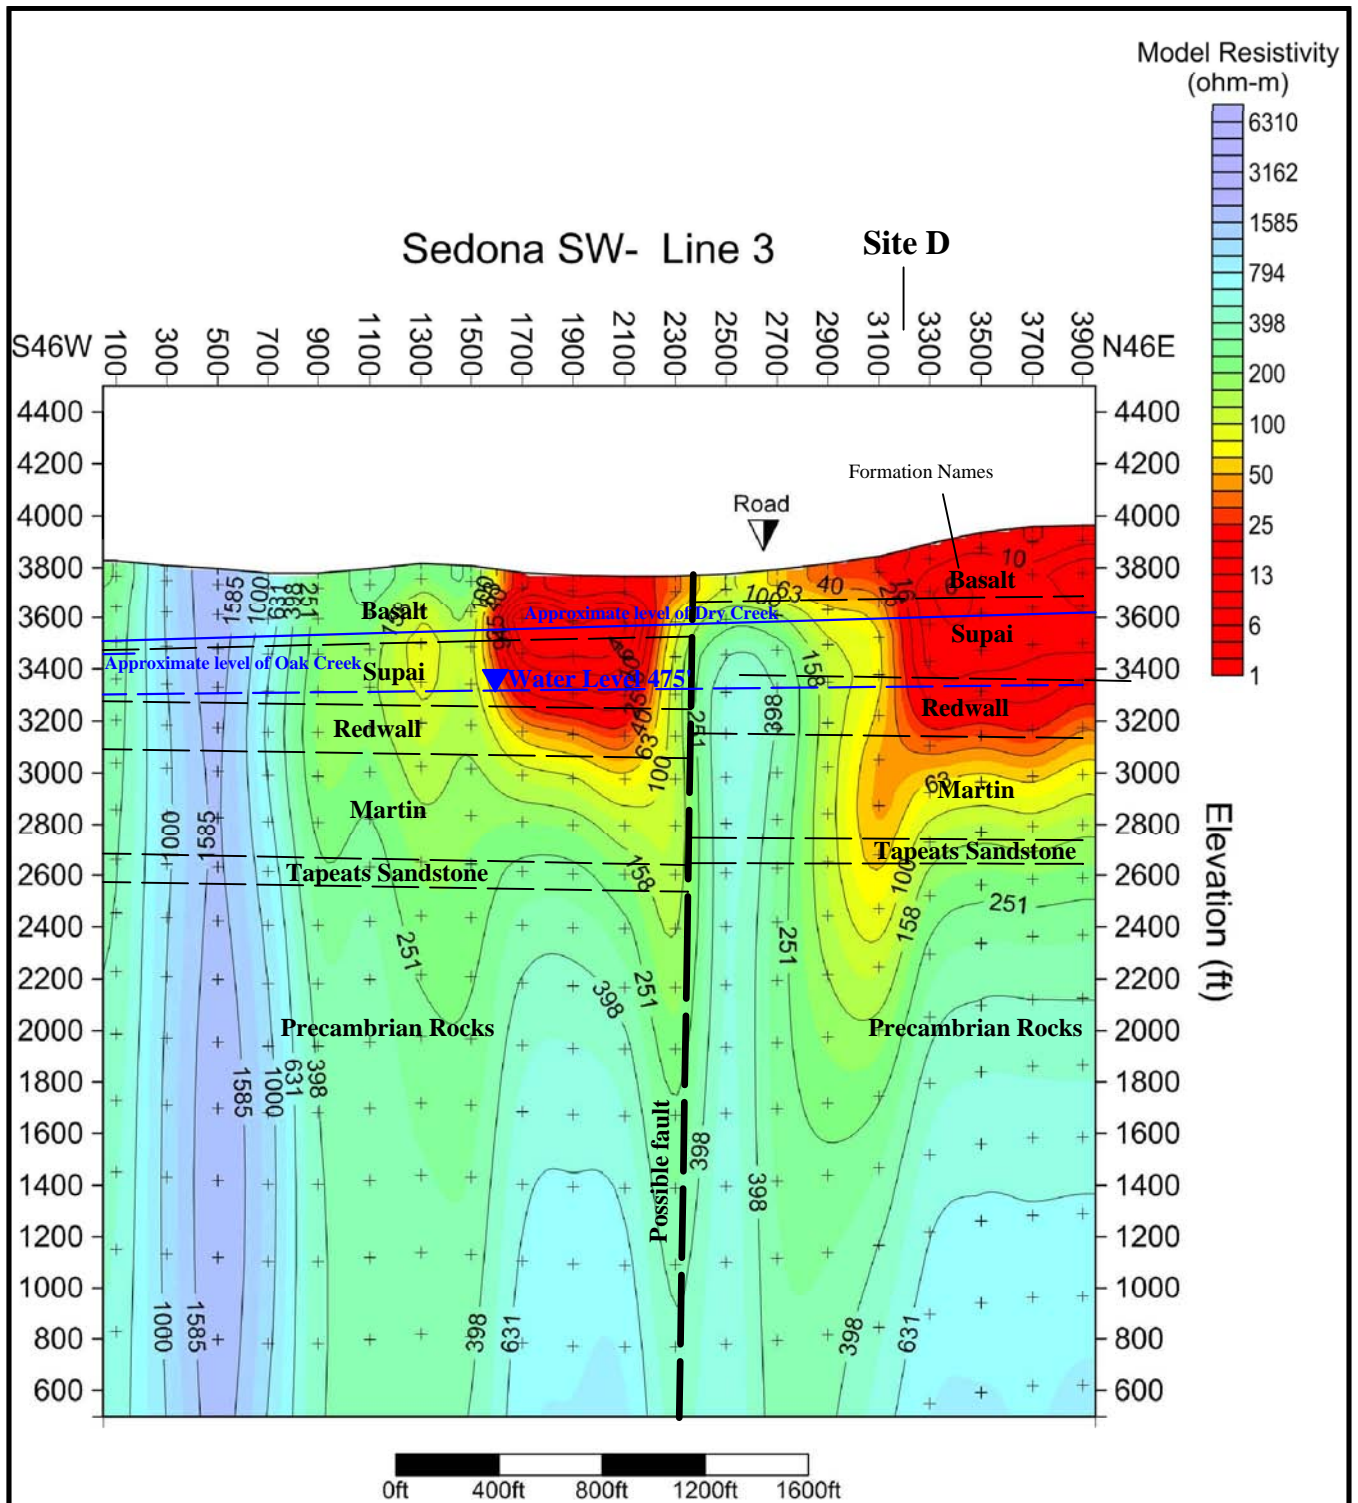
Figure 7

Line 3 CSAMT Cross-Section  
City of Sedona Recharge Project

Line 3 shows two dramatic low resistivity anomalies, the first between Stations 1500 and 2300 and the second between Stations 2900 and 4000 where the line ends (*Figures 6 and 7*).

These anomalies extend mostly to about 3,000 feet elevation, or about 800 to 1,000 feet beneath the surface, and become much weaker below this depth. On the surface, basalt is exposed between Stations 0 and about 2400 (*Photo 7*). A thick layer of tan-colored sand and silt is partly exposed between Stations 2400 and 3200, where it forms the smooth, easily erodable slope north of the road and appears to both underlain and overlain by basalt. North of Station 3200 to 4000 basalt is again exposed on the surface.

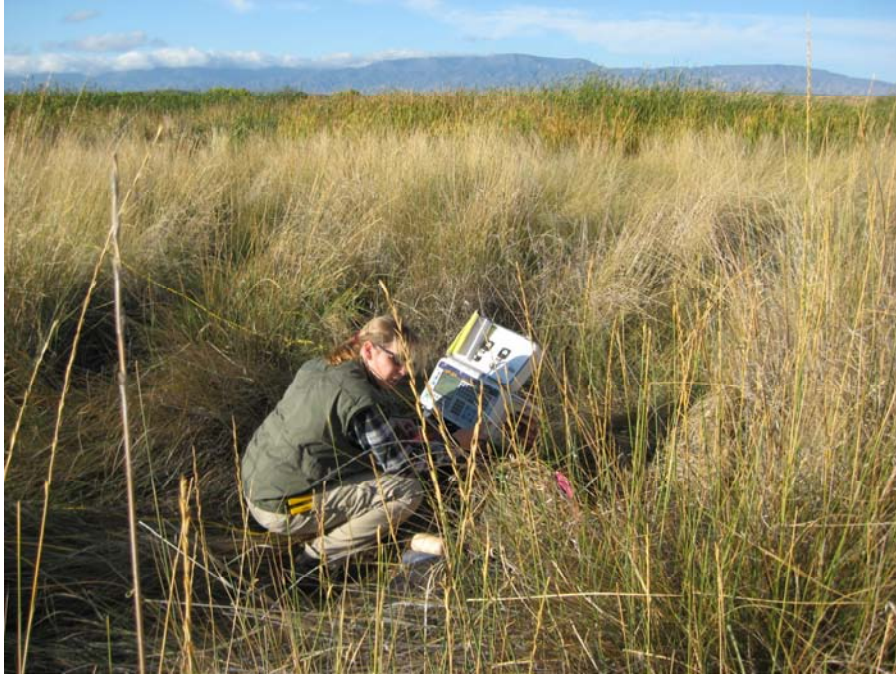
**Photo 3.** Receiver set-up in the rapid infiltration basins. Wires continue along line of sight through marshes in the distance.

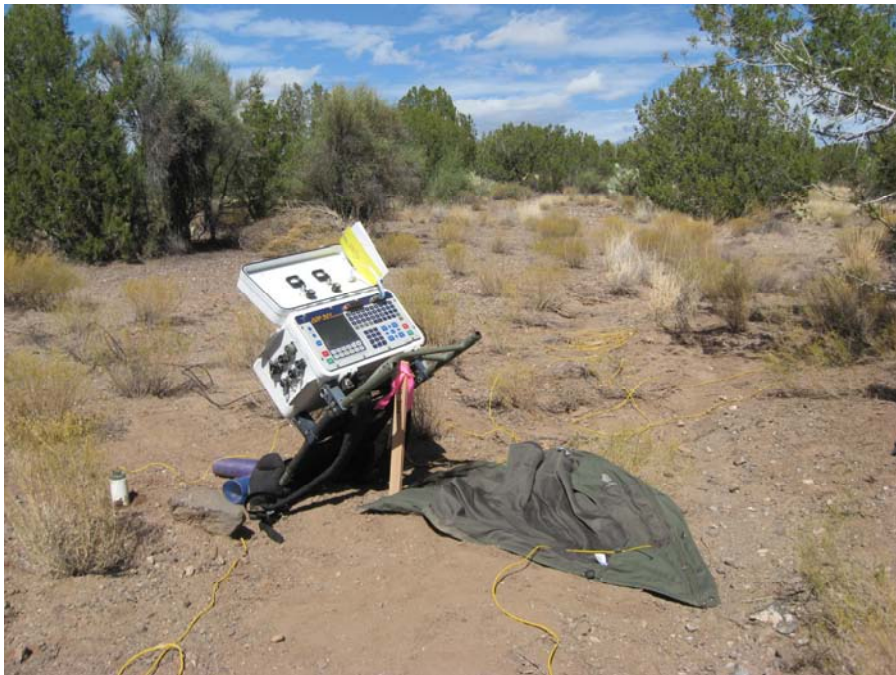
**Photo 4.** A good view of the portable receiver set up to record data a few hundred feet north of the potable water well. Note electrode in the ground.

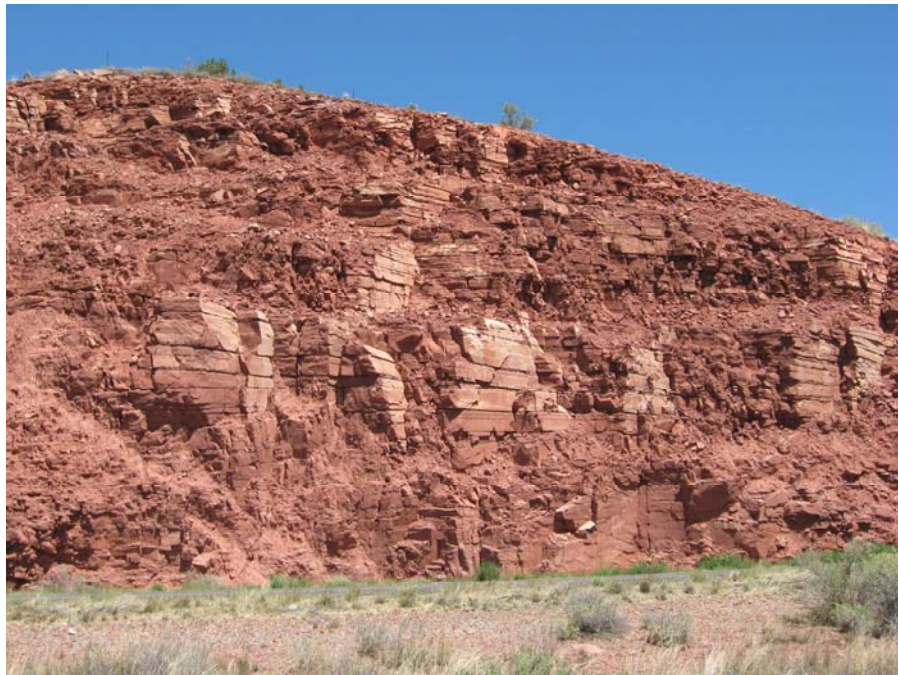
**Photo 6.** Exposure of fine-grained sandstone and siltstone in the middle part of the Supai Formation along Highway 89A north of the WWTP.
