Improvement Plan for the Oak Creek Watershed, Arizona

Prepared by the Oak Creek Watershed Council
For Arizona Department of Environmental Quality
In partial fulfillment of
CWA § 319H contract no. EV09-0035, Project 11T03

August 31, 2012

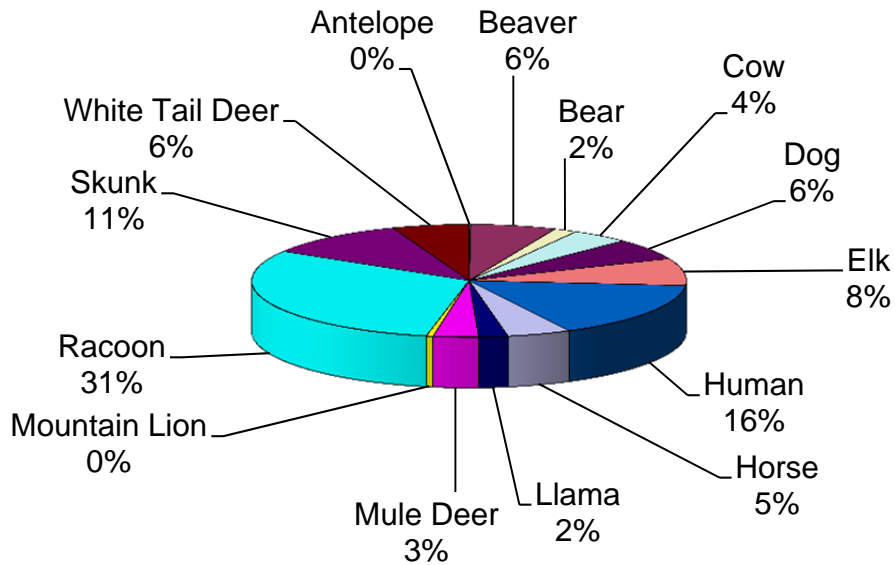
Figure 1. Distribution of *E. coli* by species compiled from Oak Creek Canyon as a whole (OCCTF 2002).

Southam et al. (2000) found that human-related sources [ie. from human waste and that of their pets and livestock, including human (16%), dog (6%), horse (5%), cow (4%), and llama (2%)] accounted for about 33% of *E. coli* found in waters of Oak Creek on average. It is important to note that Southam's 33% attributed to human activity is an average; human contribution to *E. coli* in Oak Creek water on individual days ranged from 0 to 70%. It is also important to note that Southam (2000) found single fecal release events, indicated by low *E. coli* diversity index, suggest that a single animal (or human) can cause a direct impact to *E. coli* reservoirs in stream sediments, which in turn may contaminate water when sediment is disturbed. The highest amount of *E. coli* concentration attributed to human source in a sediment reservoir was 125,020 cfu/100ml downstream of Slide Rock State Park on September 6, 1999.

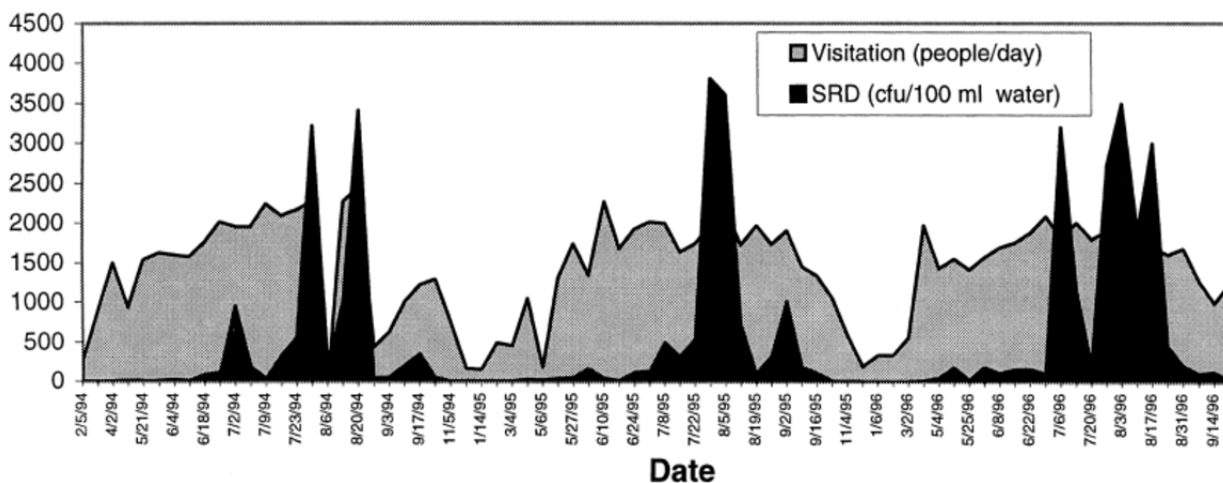
Figure 4. Visitors at site Slide Rock State Park from 1994 to 1996 compared to fecal coliform counts of cfu/100 ml at the Slide Rock downstream (SRD) site. Note the convergence of visitors and fecal coliform during the late summer months during all 3 years. Also, note the improvement of water quality after site closure due to a forest fire (early August, 1994) (Crabill et al. 1999). The largest exceedances occurred during late July and early August when there were not any stormflow events to stir the sediment, so the effect is seen to be due to sediments being disturbed by recreators.

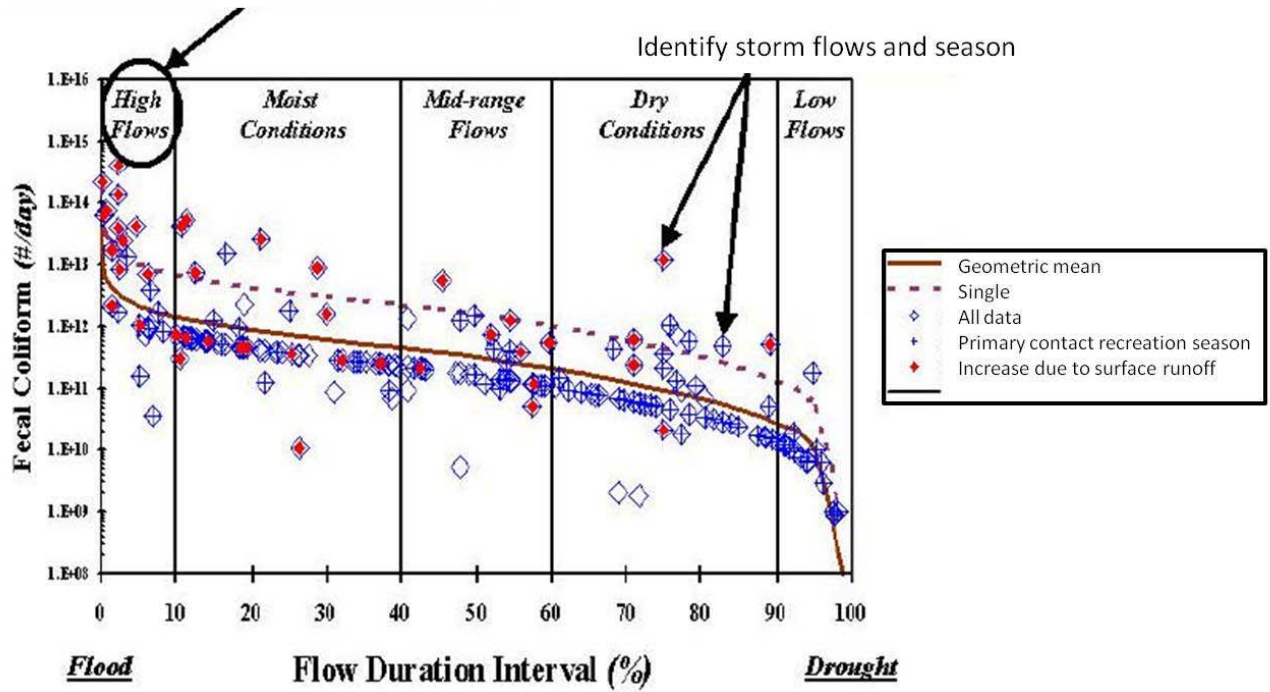
Figure 6. Sample load duration curve (Cleland 2003).

Figure 6 from the 2010 TMDL report demonstrates how *E. coli* concentrations can be strongly related to streamflow, with the higher concentrations corresponding with high flow events, (although the example is from a stream not in Arizona). This is consistent with studies in the Oak Creek watershed which have found that high flows create turbulence that disturbs sediment on the stream floor and increases contact between sediment particles and water so that *E. coli* is released from the sediment into the water (Southam 2000, Crabill 1999). Some increased *E. coli* during high flow events may also be due to flushing of fecal matter from upland surfaces through overland flow. Figure 6, which is used as an example, is a load duration curve from another state. The solid red line on the graph in Figure 6 is the geometric mean of fecal coliform concentrations while the dashed red is the single daily maximum allowed by Arizona water quality standards (Arizona has a geometric mean *E. coli* standard [126 cfu/100 ml] but it is not exceeded enough to cause impairment). Figure 7 is a load duration curve for the reach Slide Rock to Dry Creek in which *E. coli* concentrations that plot above the curve indicate exceedances of the water quality standard.

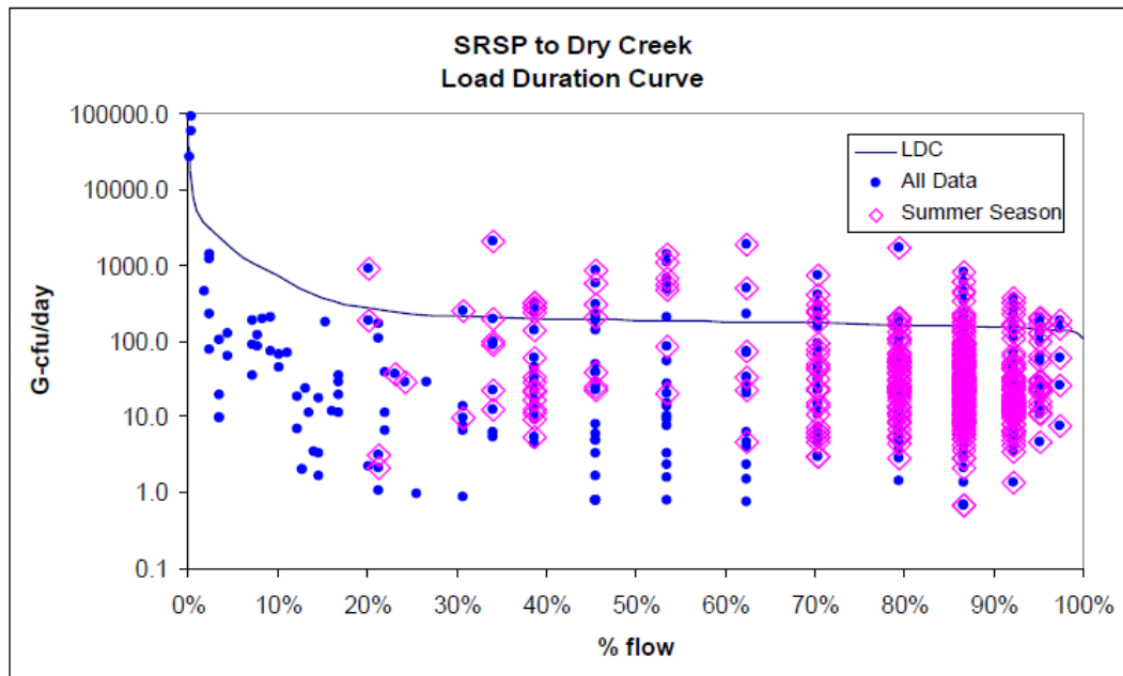
Figure 7. *E. coli* load duration curve, Slide Rock State Park to Dry Creek (ADEQ 2010)

Table 3 shows that the relationship between flow magnitude and *E. coli* concentration is not static but varies by stream segment (eg. Slide Rock State Park has greater *E. coli* loading at low flow than most reaches and greater loading during moist conditions than at high flows; this is because exceedances at Slide Rock are correlated more with recreation than with streamflow, which is not the case in most segments of Oak Creek.). This indicates that, while some BMPs are applicable throughout the watershed, in some stream segments BMPs to reduce *E. coli* loading must be tailored to address the particular bacterial sources and processes. According to the 2010 TMDL, the critical conditions when exceedances are likely to occur are as follows: 1. during the summer months, 2. in places where recreational activity is concentrated and 3. when storm events rapidly increase streamflow.

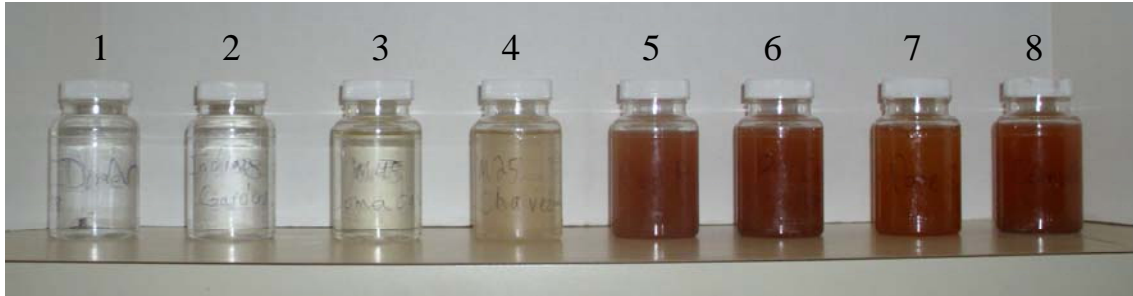
Figure 10. Oak Creek water samples September 15, 2011 following a storm event the night before.

8. Turbidity during storm events seems directly related to the sediment input that increases going downstream (Figure 10).

Site	Stream mile	<i>E. coli</i> (cfu/100 ml)
1. Pine Flats	49.0	0
2. Indian Gardens	40.5	65.4
3. Lomacasi	37.4	426
4. Chavez Crossing Campground	33.9	1,354
5. below Red Rock State Park	27.9	2,489
6. Dry Creek Confluence	22.7	5,794
7. Page Springs Bridge	17.2	506
8. Cornville Bridge	8.9	7,270

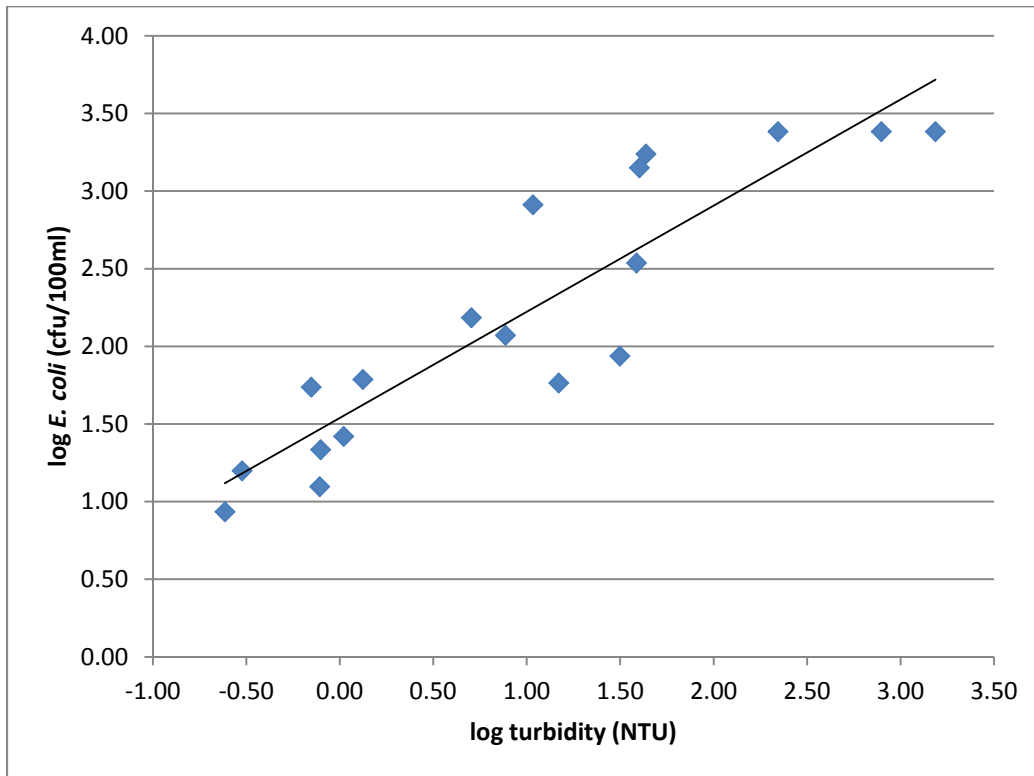
Figure 11. Log *E. coli* concentrations as response to log turbidity, Oak Creek August 2, 2011, $R^2 = 0.87$.

13. The strongest single relationship we found was between *E. coli* concentrations and turbidity in Oak Creek on August 2, 2011 following the storm event on August 1st with an R^2 of 0.87, $n = 10$ (Figure 11). For all creek samples that have both *E. coli* and turbidity data the R^2 is 0.82, $n = 18$. Unfortunately we did not have access to a turbidimeter for the first part of the sampling program, but greater turbidity was visually observed at sites where more *E. coli* was found. This was especially true from Page Springs down to the Verde River confluence, even in the absence storm flow. Investigation of turbidity sources is needed in this reach (eg. irrigation return flows, livestock in stream, low water crossings, etc.).

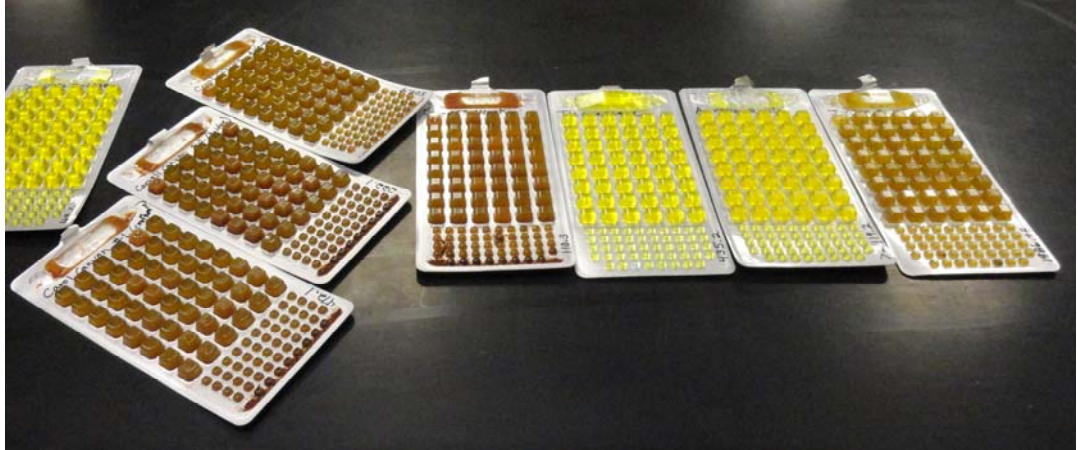
Figure 12. Quanti-trays showing variation in sediment yield among stormwater flow collected from Sedona’s washes on August 1. The darker brown the sample is, the more sediment it holds. From left (downstream) to right (upstream) are Carroll Canyon 1, 2, and 3, Soldier’s Wash, Tlequepaque, Arroyo Roble and Jordan Wash. (The sample on the far left is from Cornville Bridge, where the storm pulse had not reached yet.)

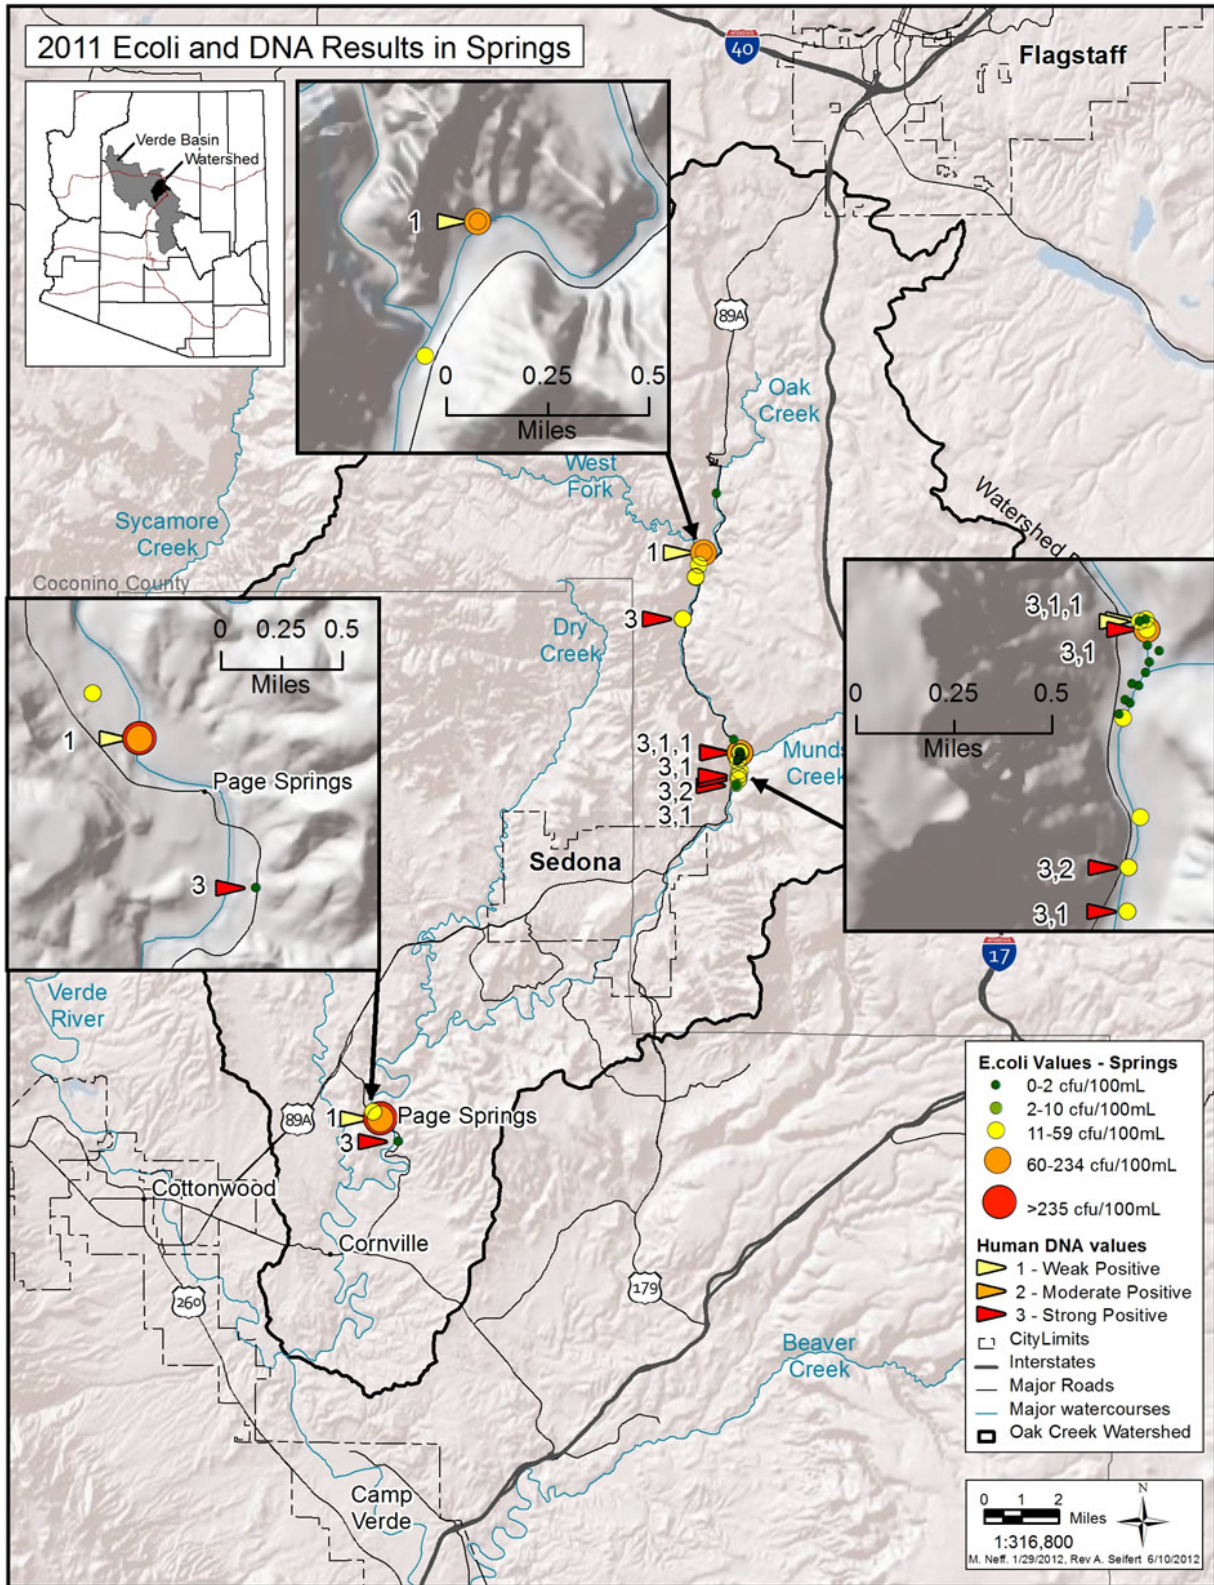
Figure 13. *E. coli* and human DNA test results at springs in Oak Creek watershed. 3= strong positive, 2 = medium positive, 1 = weak positive result for Human DNA.

Human DNA results for 43 samples were that nine were a strong positive (3/3), 5 were a medium positive (2/3), 10 were a weak positive (1/3) and 19 were negative. The samples included 25 spring samples for which 14 were positive for human DNA, of which 10 samples had elevated *E. coli* (15.5 - 116.9 cfu/100 ml, average 61.6 9 cfu/100 ml) and 4 samples did not have elevated *E. coli* but could have contained viruses or bacteriophages associated with septic effluent. These results indicate that interception of septic effluent by groundwater flowing to springs is likely a source of *E. coli* in some springs. Figure 13 is a map showing springs that tested positive for human DNA. Some of these are suspected to have septic influence.

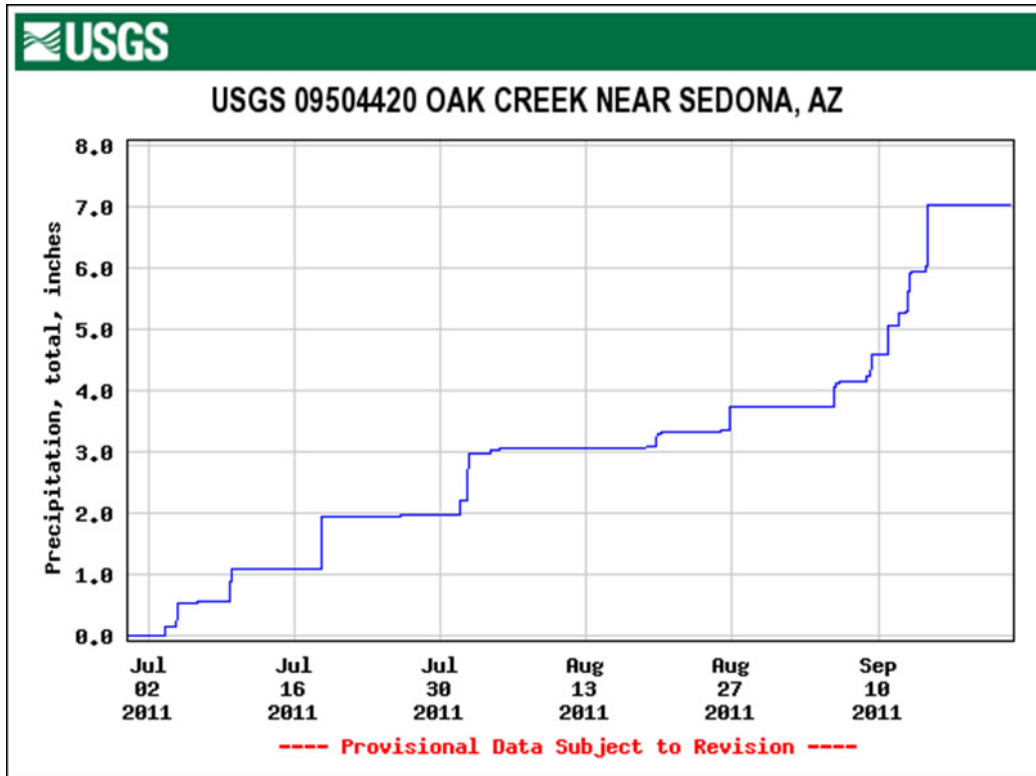
Figure 14. Rainfall July 1 through September 22, 2011 at Oak Creek near Sedona, USGS gage no. 09504420

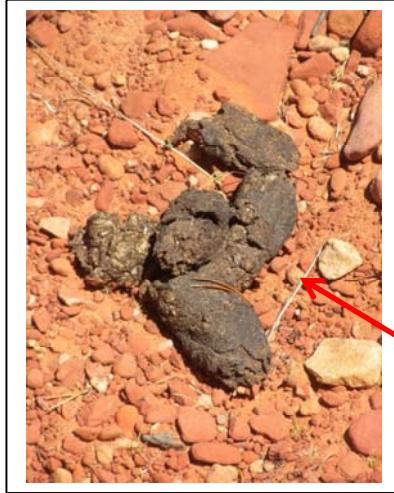
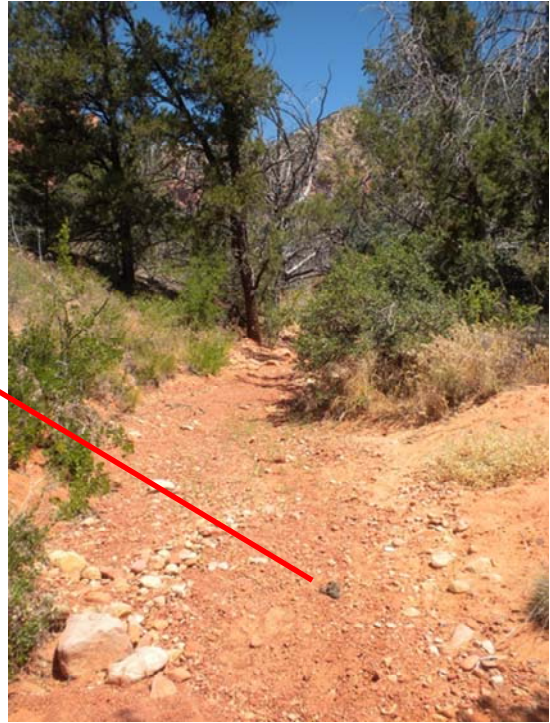
Dog feces in drainage on national forest land upstream of Elf Neighborhood. This drainage is a tributary of Carroll Canyon Wash.

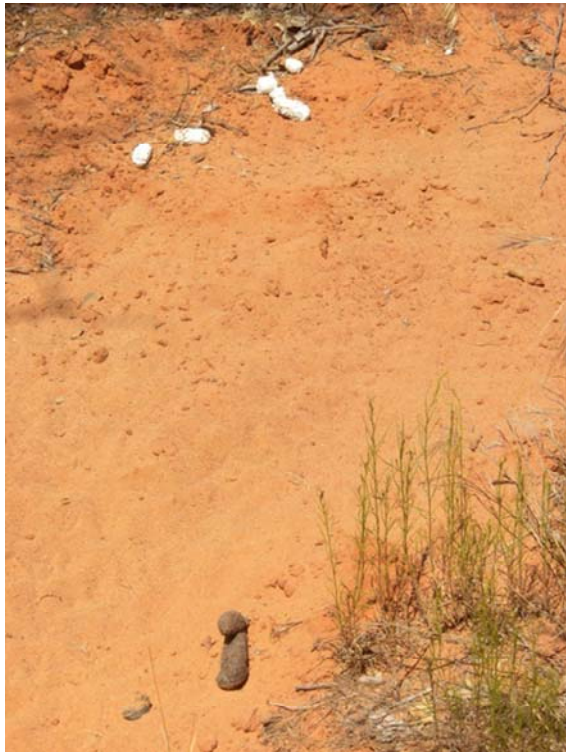
Multiple dog feces in the channel and on the bank. Little Elf drainage

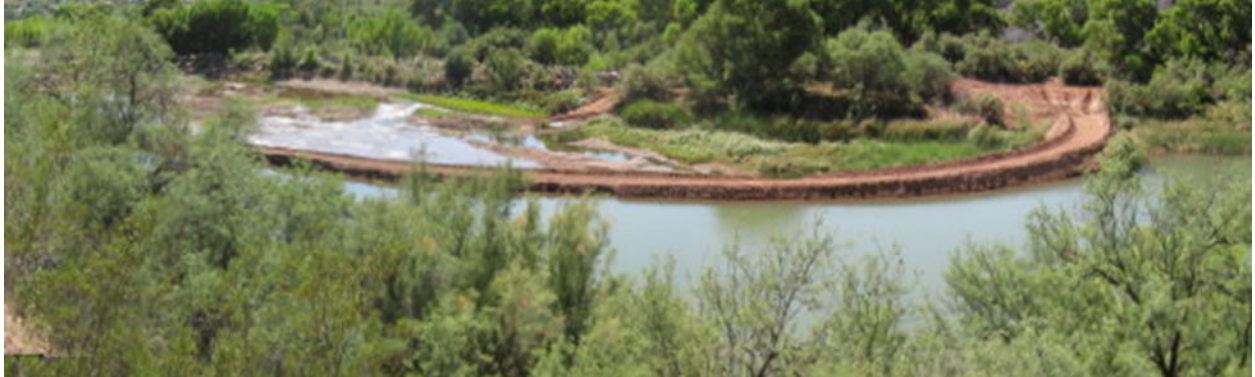
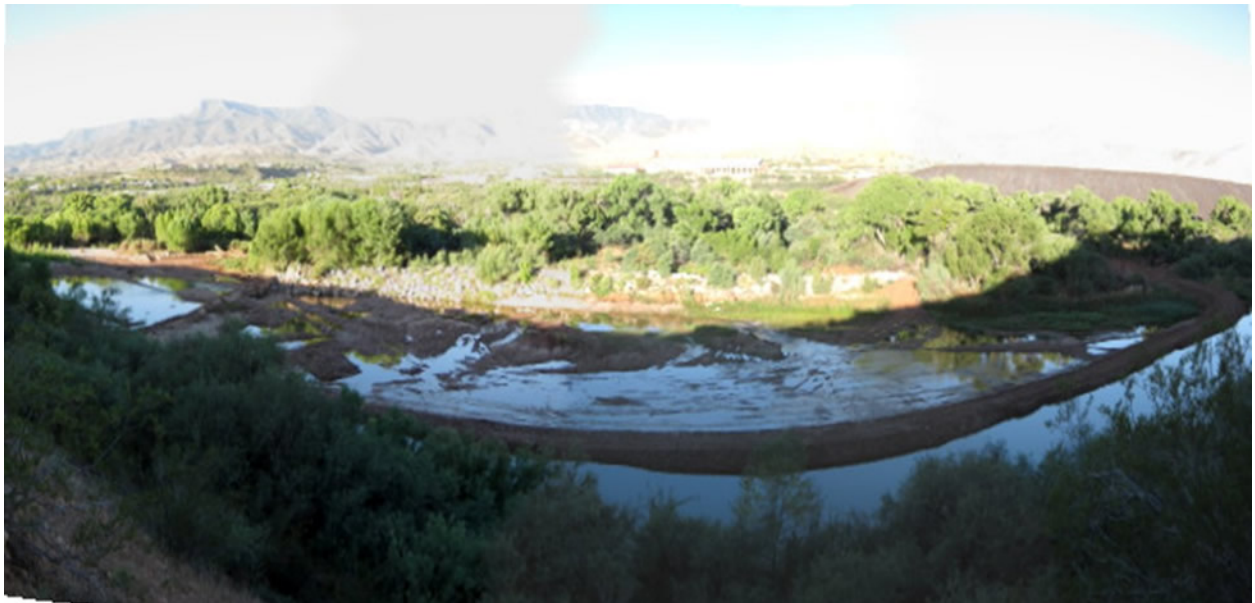
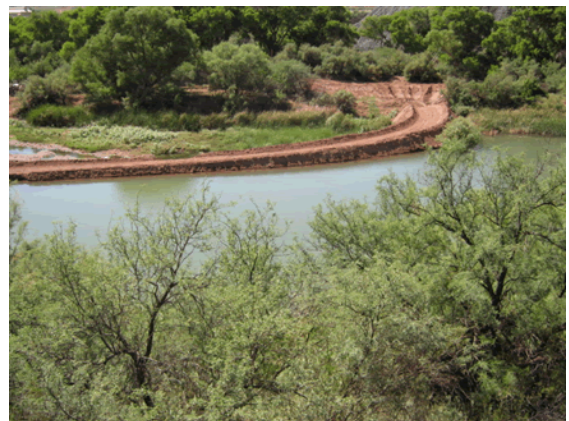
Examples of how excavation of fine-grained material can be very disruptive to the channel. These photos are from the Verde River upstream of Deadhorse Ranch State park.
